Mazda 6 - Compressor malfunction | HELLA

Mazda

6 (GG/GY)

Compressor malfunction

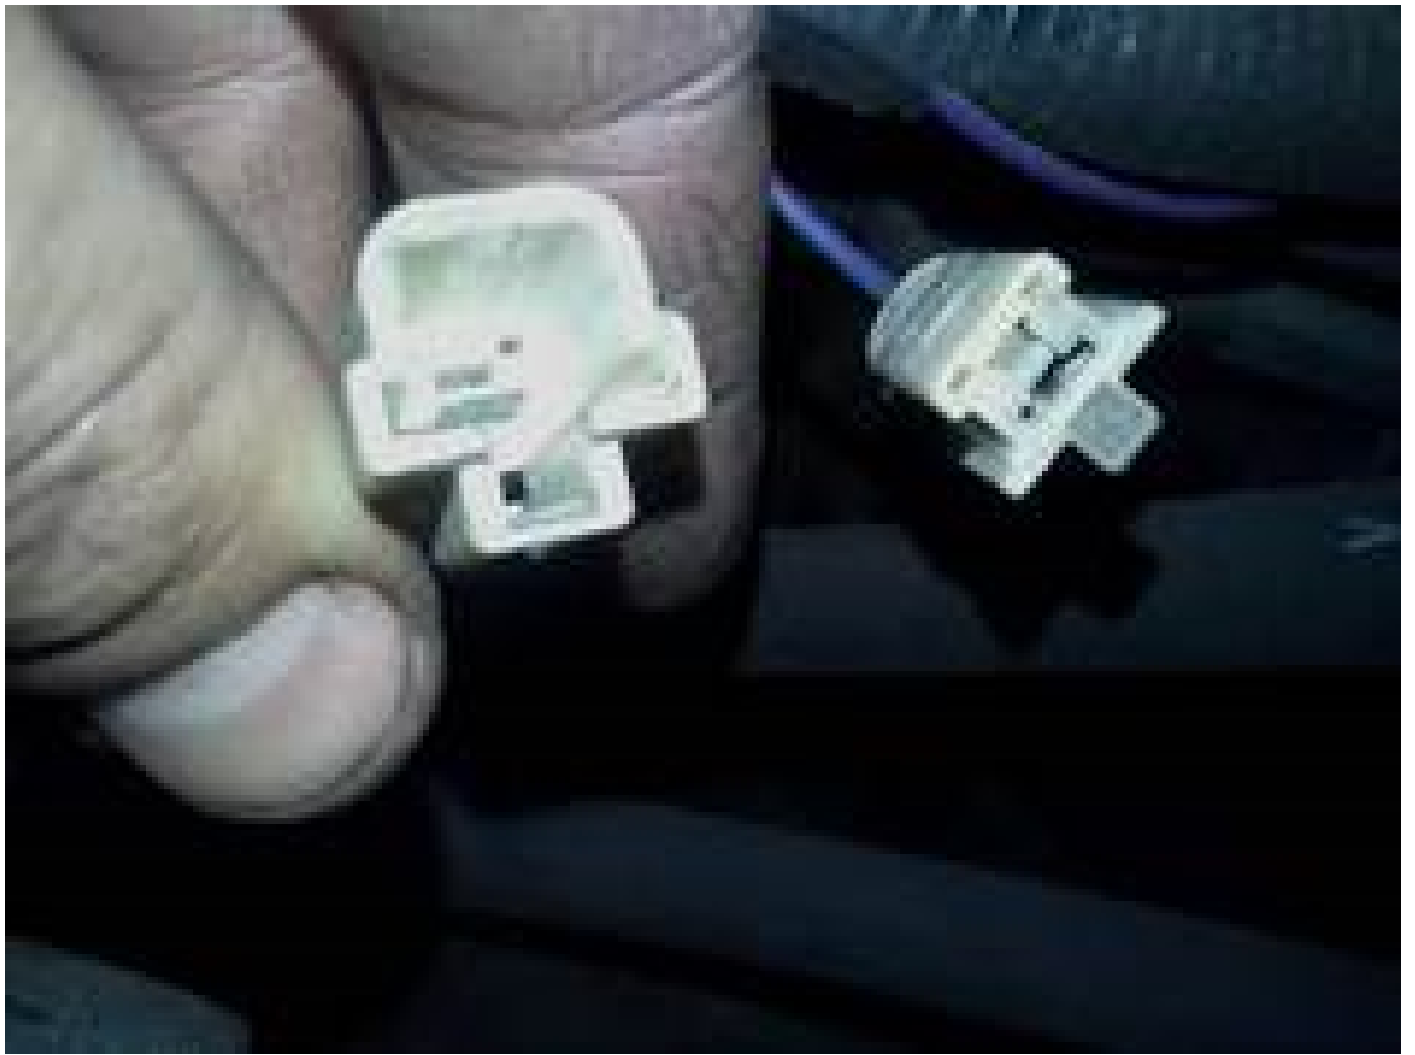
The electrical cable for the magnetic clutch power supply (+) is routed to the compressor through the engine block area.

Water leaking into the connector housing (figure) can cause corrosion to form. This can lead to contact problems or a power failure.

In order to remedy this issue, the damaged electrical connection should be renewed.
