VW Sharan (7M6 / 7M9) - Engine warning light illuminates | HELLA

Sharan (7M6 / 7M9)

Engine: AUY 1.9 TDI

Engine warning light illuminates

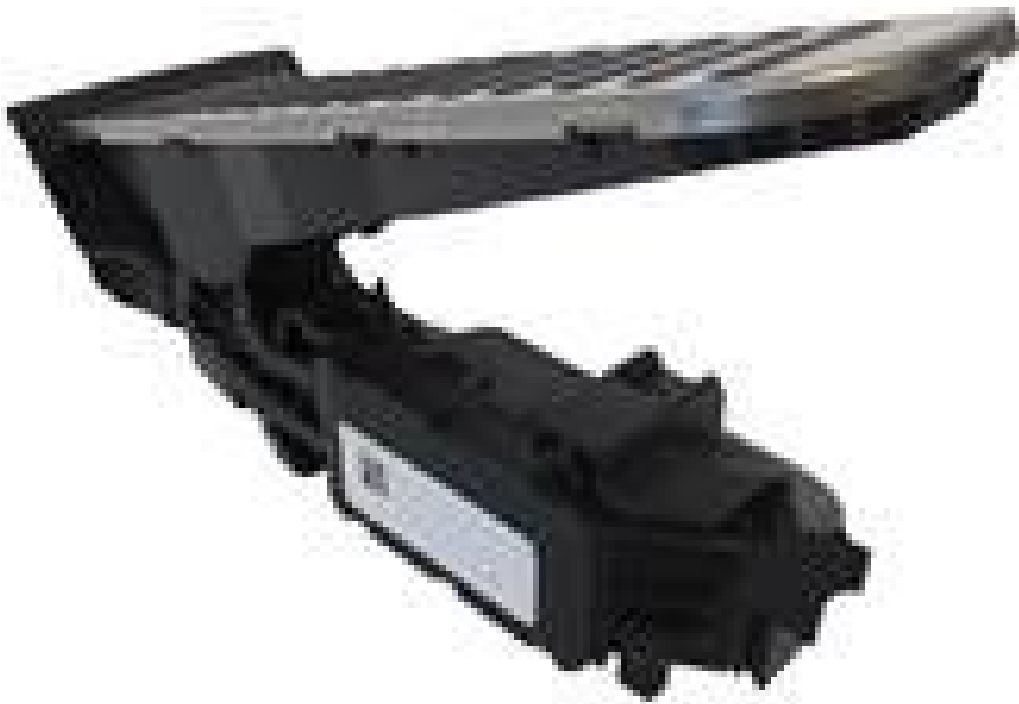
Figure 1

The error codes listed above all refer to an issue in the area of the accelerator pedal sensor (figure 1).

- Check that the accelerator pedal sensor is functioning correctly

(carry out a noise or potentiometer test using an oscilloscope) and replace if necessary.

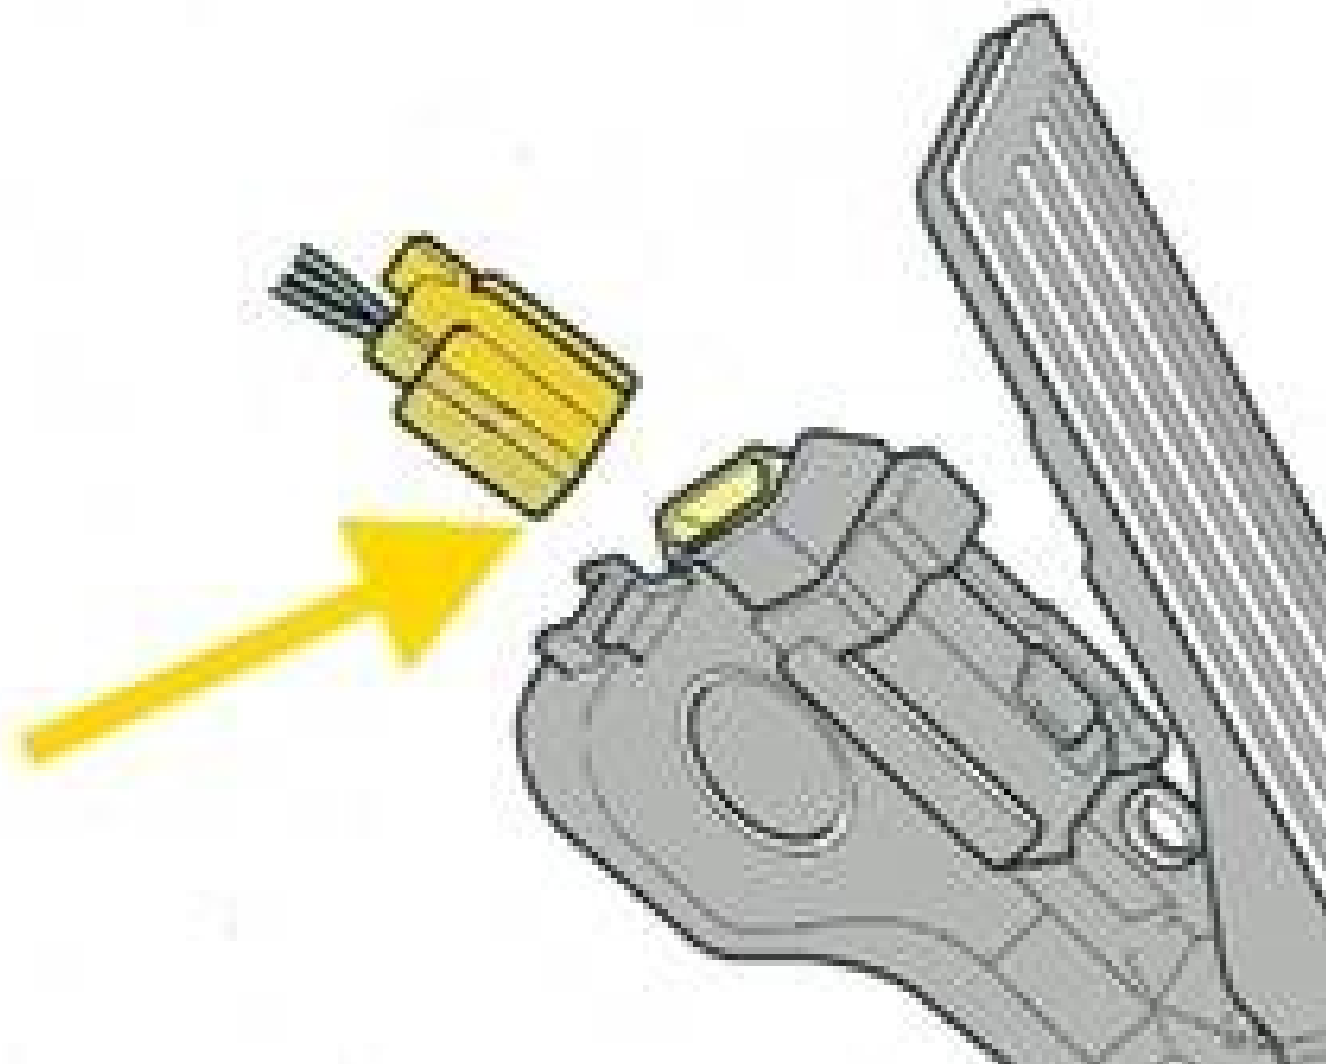
Figure 2

In this case, insufficient contact in the connection between the accelerator pedal sensor and the connector (figure 2) is responsible for the above-mentioned problem.

- Check the plug-type connection for damaged or corroded connector pins (figure 2, figure 3) and replace if necessary

-Single cable: 000 979 025 EA

-Crimp connector: 000 979 940
