Audi A6 - Interior blower not working | HELLA

A6 (4F2/C6)

Interior blower not working

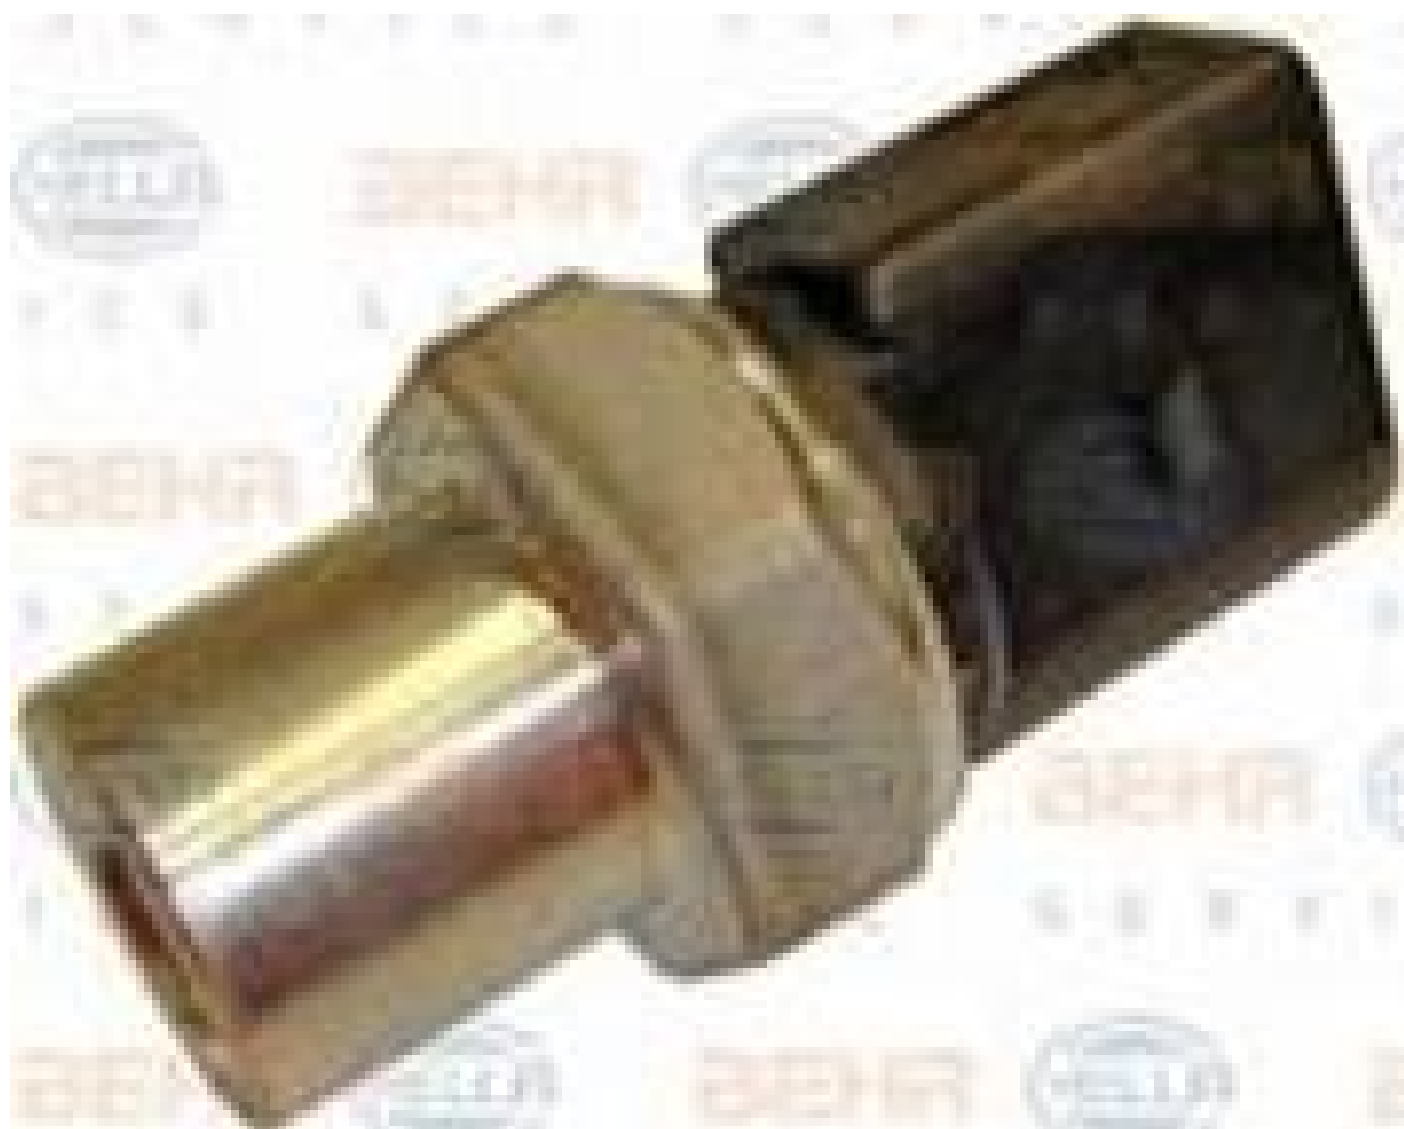
If the interior blower fails on the vehicles mentioned above, the cause may be a faulty pressure sensor in the air-conditioning system.

The blower output stage and the pressure sensor (see figure) use a shared signal line to communicate with the control units (Climatronic). If the sensor fails, communication is disrupted and the blower is no longer activated. The error code 2071 is then stored in the error memory.

If the blower fails, diagnostics should be carried out as follows:

- Check fuses
- Read out the error memory
- Check the parameter for the pressure sensor via the measured value blocks (the parameter should be around 5 bar when the air-conditioning system is filled and switched off)
- Check the control of the sensor and fan as necessary
