BMW 2 Series Active Tourer - various system failures in conjunction with the multifunction steering wheel

Data sheet	
Manufacturer	BMW
Vehicle model	2 Series Active Tourer (F45)
Engine	All
Year of manufacture	2014 - 2017
Symptoms	Failure of various systems in connection with problems on the multifunction steering wheel

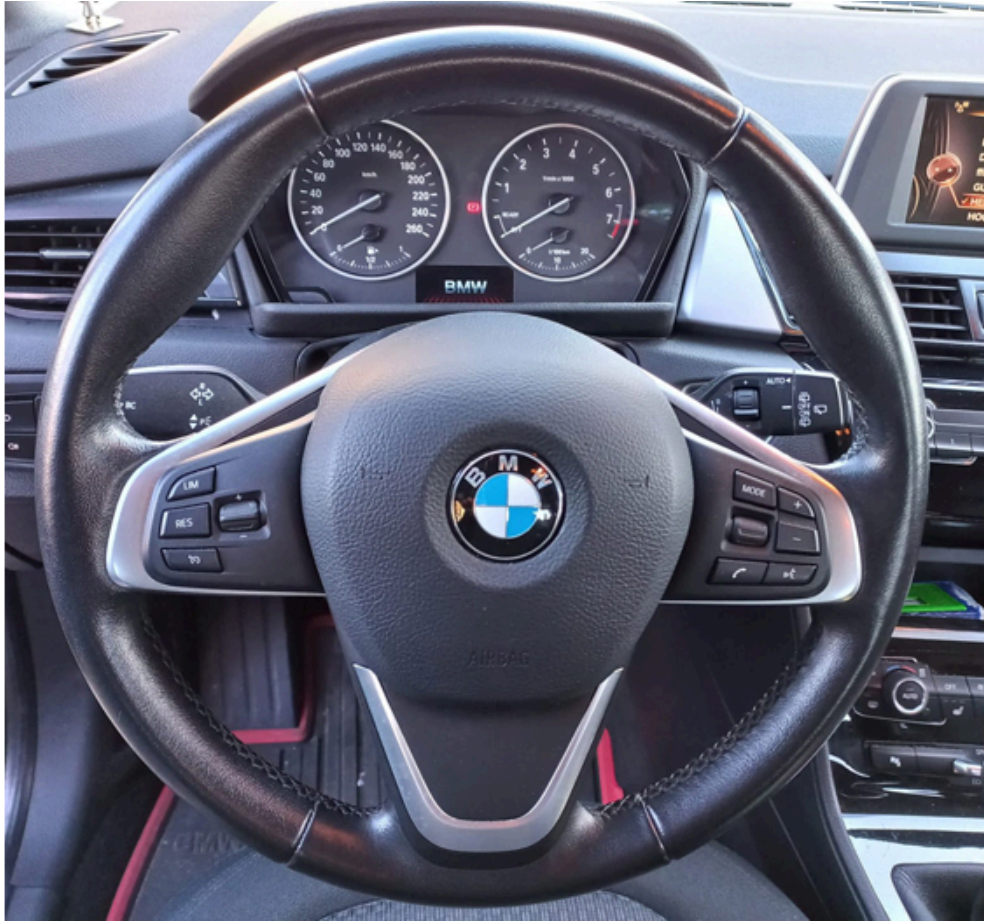
With the above-mentioned vehicle, various failures/malfunctions (cruise control, gear selector) may occur in conjunction with the multifunction steering wheel.

The error message "cruise control failed" may then appear in the instrument cluster. In addition, error code 030410 (MFL LIN slave) may be stored in the control unit.

This may be caused by poor contact between the steering wheel coil spring and the multiple connector on the steering wheel wiring harness.

In order to eliminate the problem, the coil spring and the steering wheel wiring harness must be replaced. As part of this job, it is recommended that you contact the vehicle manufacturer or an authorised BMW workshop.
