# BMW E60 - Headlamp fogging | HELLA

**E60**

## **Headlamp fogging**

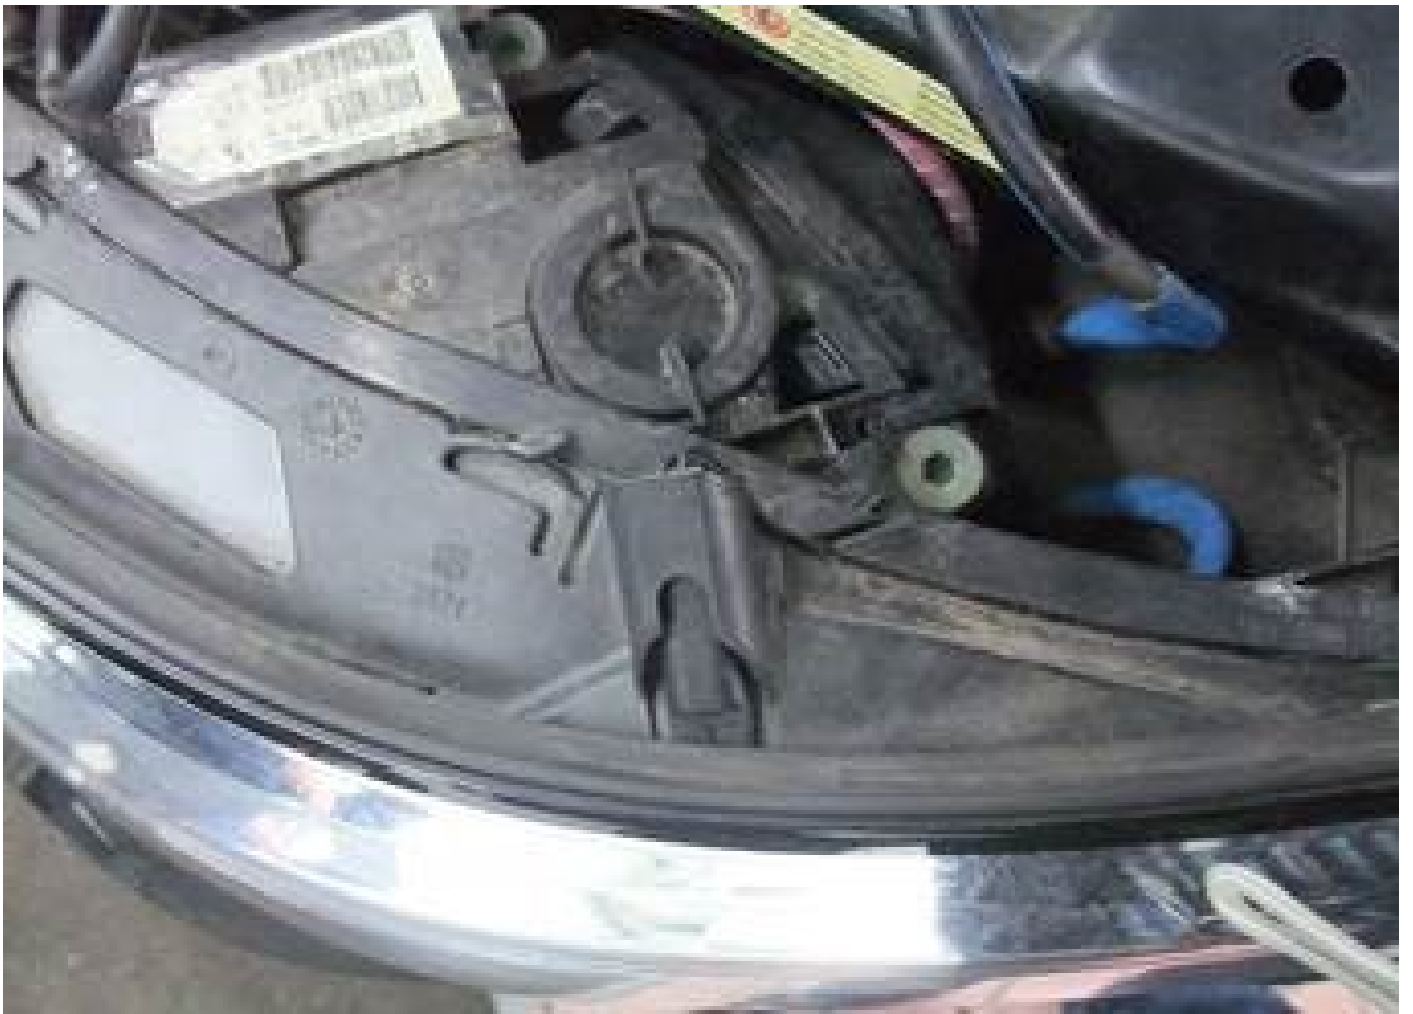
Headlamp top view (Figure 2)

The SML is partially covered by the CW seal.
