# Ford Probe; Explorer, Windstar - compressor failure | HELLA

Type: Probe; Explorer, Windstar.

## Refilling additional coolant oil for models older than 1996 - compressor failure

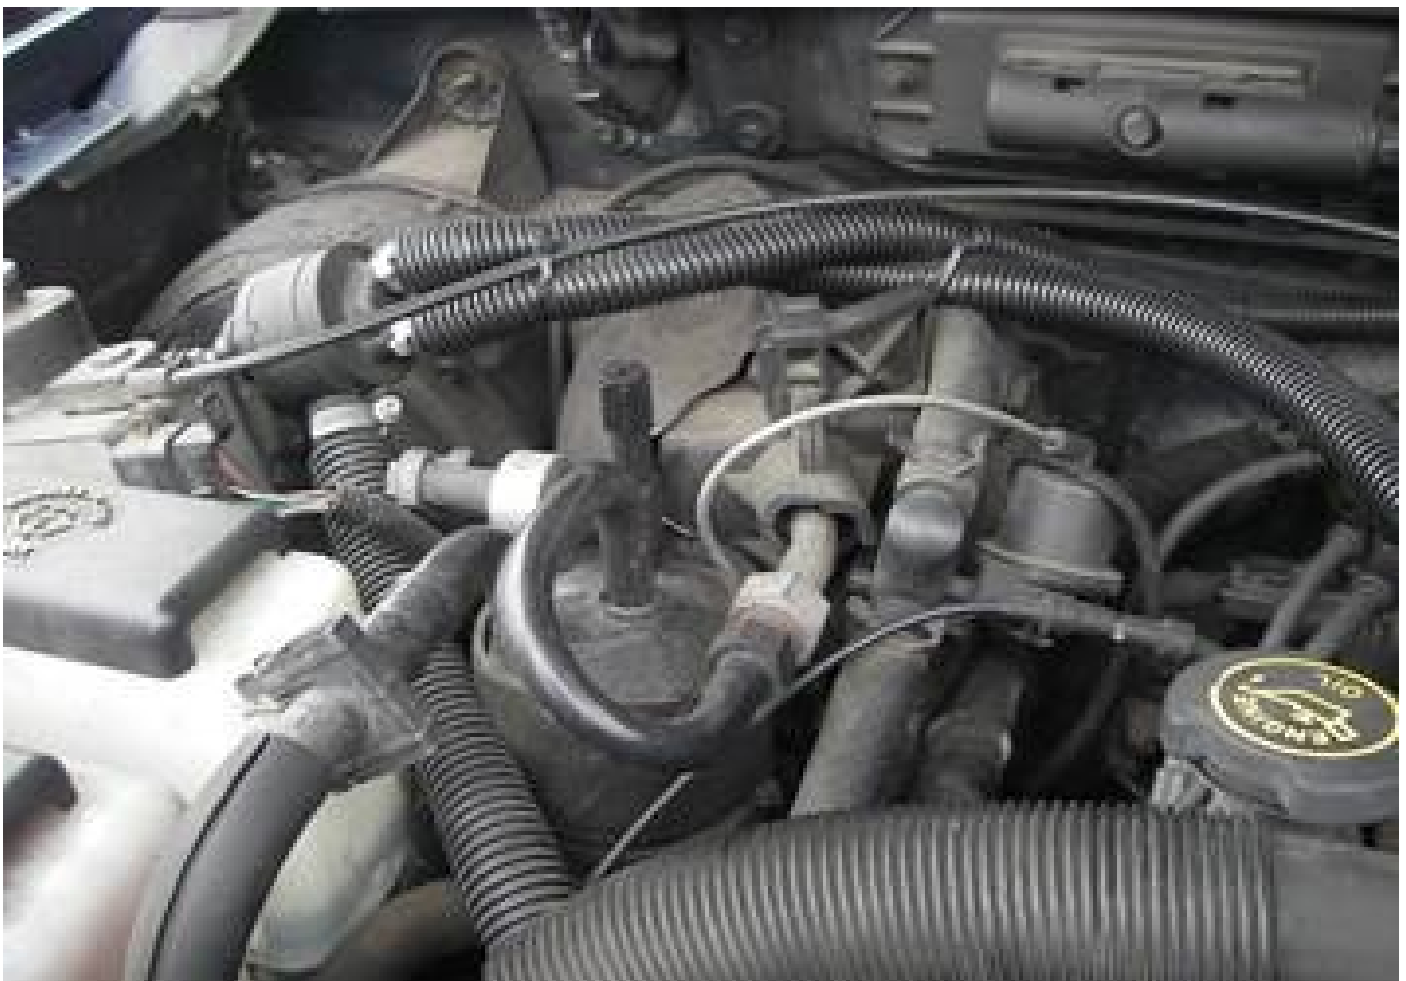
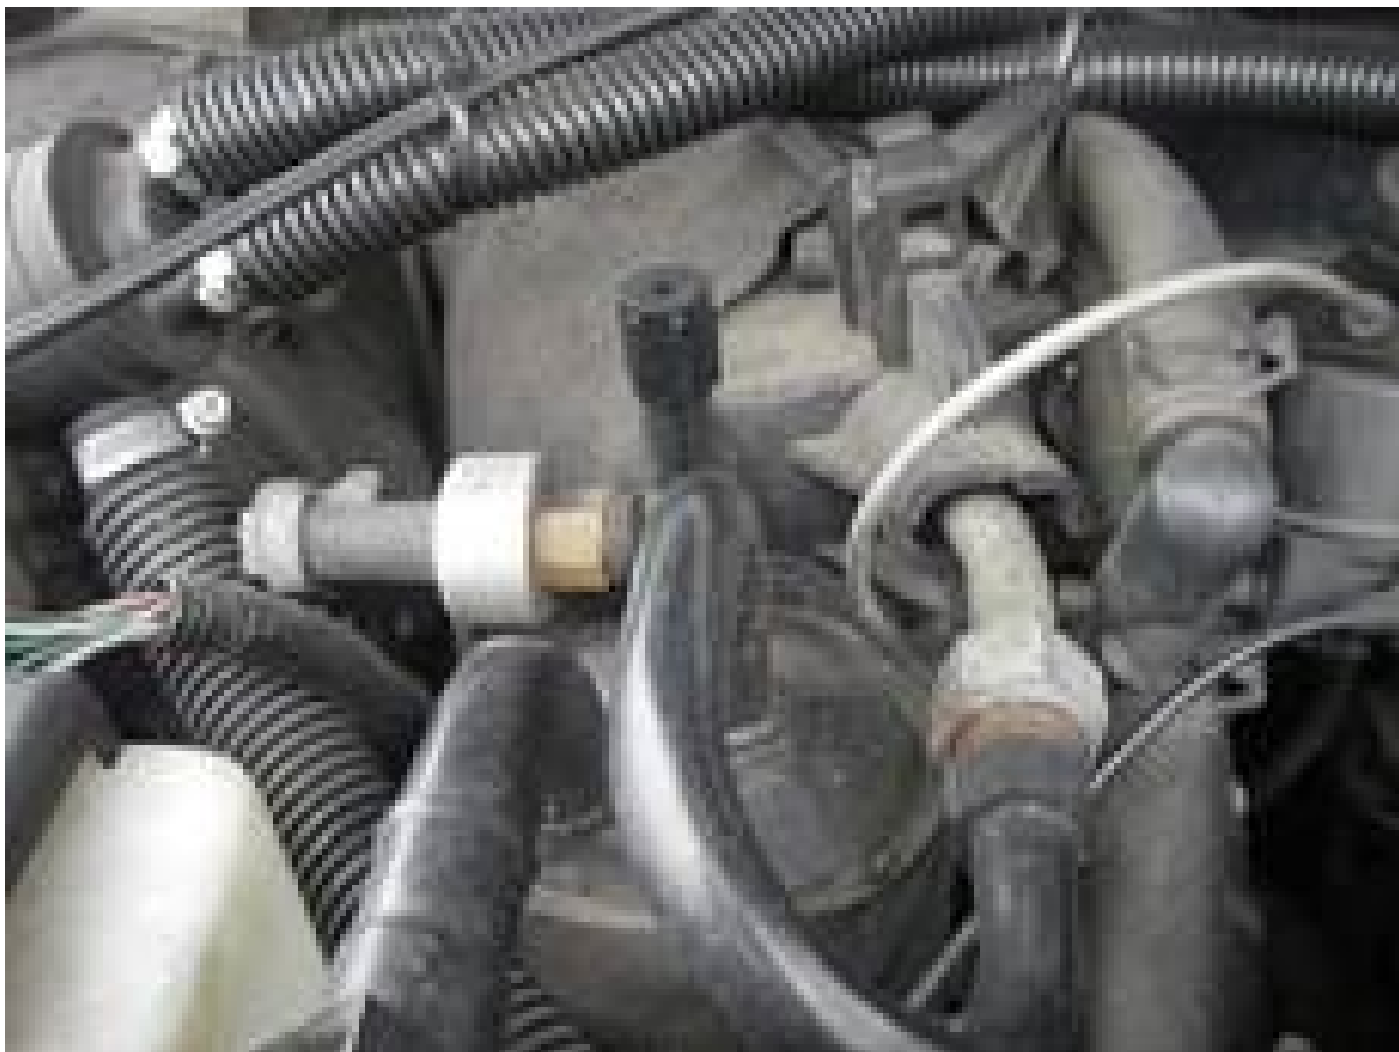
Ford recommends e.g., refilling approx. 60ml of oil during maintenance or minor repairs on the original air conditioning system. This quantity must be added before the system is filled with coolant. Ford's R134a systems can be distinguished from R12 systems by a special sticker on the underside of the motor hood and a beige-coloured ring on the low-pressure switch (see figures).
