Mazda 3 - Cooling capacity diminishes while driving | HELLA

Mazda 3

From model year 2006 onwards

Cooling capacity diminishes while driving

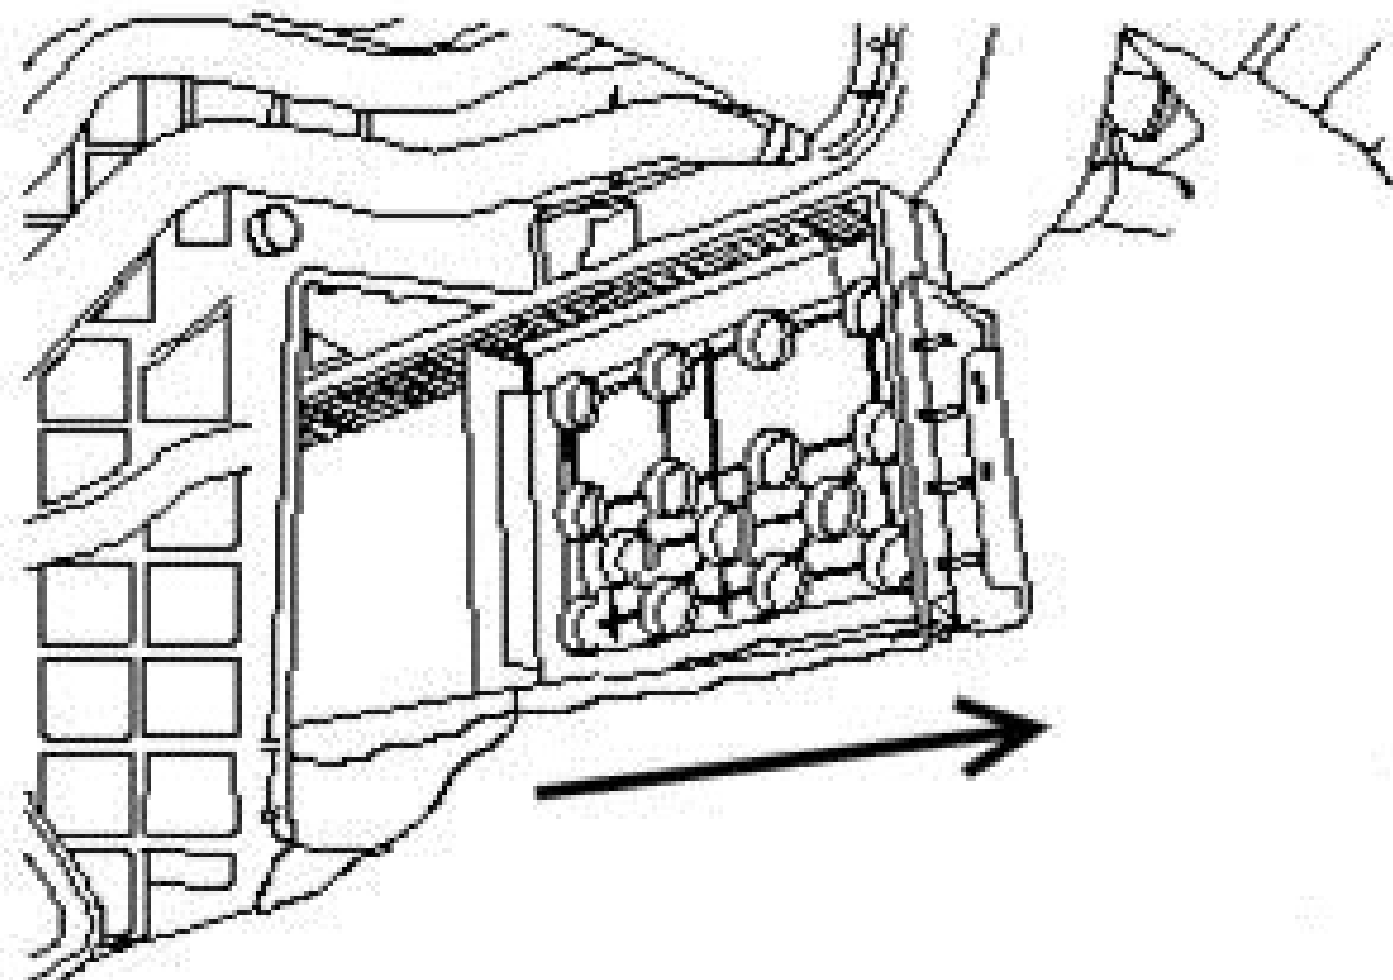
Figure 1

In the course of a longer journey made in one of the above-mentioned vehicles (with the air-conditioning running at full speed), it is possible that the cooling capacity of the air-conditioning system begins to diminish. A reason for this can be the freezing of the evaporator.

Possible causes of this trouble are faulty temperature sensors on the evaporator and also an uneven distribution of air flowing through the evaporator.

- Now take out the upper and lower filters of the air-conditioning system
- Insert the new filters with the diffusion plate (Fig. 1) and make sure that the arrows on the filter are pointing in the direction of the rear (Fig. 2). Replace the cover on the evaporator box
- Connect the short wiring harness including resistance with the plug. Then connect both with the temperature sensor on the evaporator
