Mazda CX5 (KE) - Fault code P0299 boost pressure too low

Data sheet	
Manufacturer	Mazda
Vehicle model	CX5 (KE)
Engine	2.2 CDI Skyactiv-D
Year of manufacture	2011 - 2017
Symptoms	P0299 - Boost pressure too low Poor acceleration behaviour Vehicle activates limp-home mode
Info	This defect may also occur in other models from this manufacturer with the same type of engine.

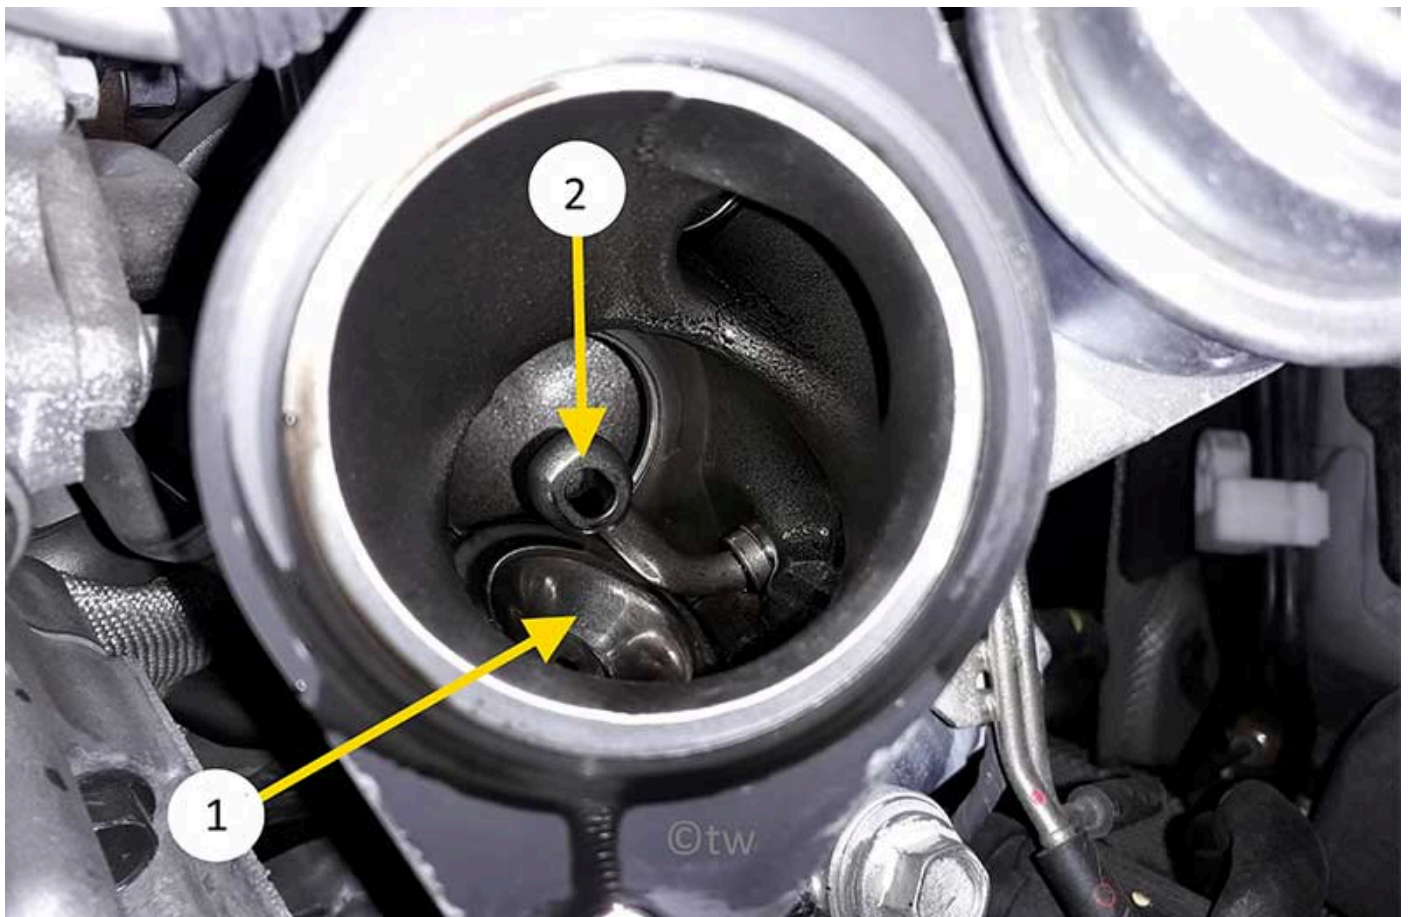
If the fault mentioned above is detected, it may also be related to a defective bypass flap on the small turbocharger. A mechanical defect ensures that the flap does not close properly and thus cannot build up sufficient boost pressure. In this case, the charge air hoses on the turbocharger should be removed and the flap control visually inspected. In our case study, the flap (1) had already completely detached from the lever (2). (Picture)

In a repair case, the complete turbocharger unit must be removed and replaced. The vehicle manufacturer does not offer the option of repairing the bypass flap's operating device.
