Mercedes C-Class - ESP/ABS pilot lamp lights up | HELLA

C-Klasse (W 203)

All vehicles above model year 02/03

ESP/ABS pilot lamp lights up

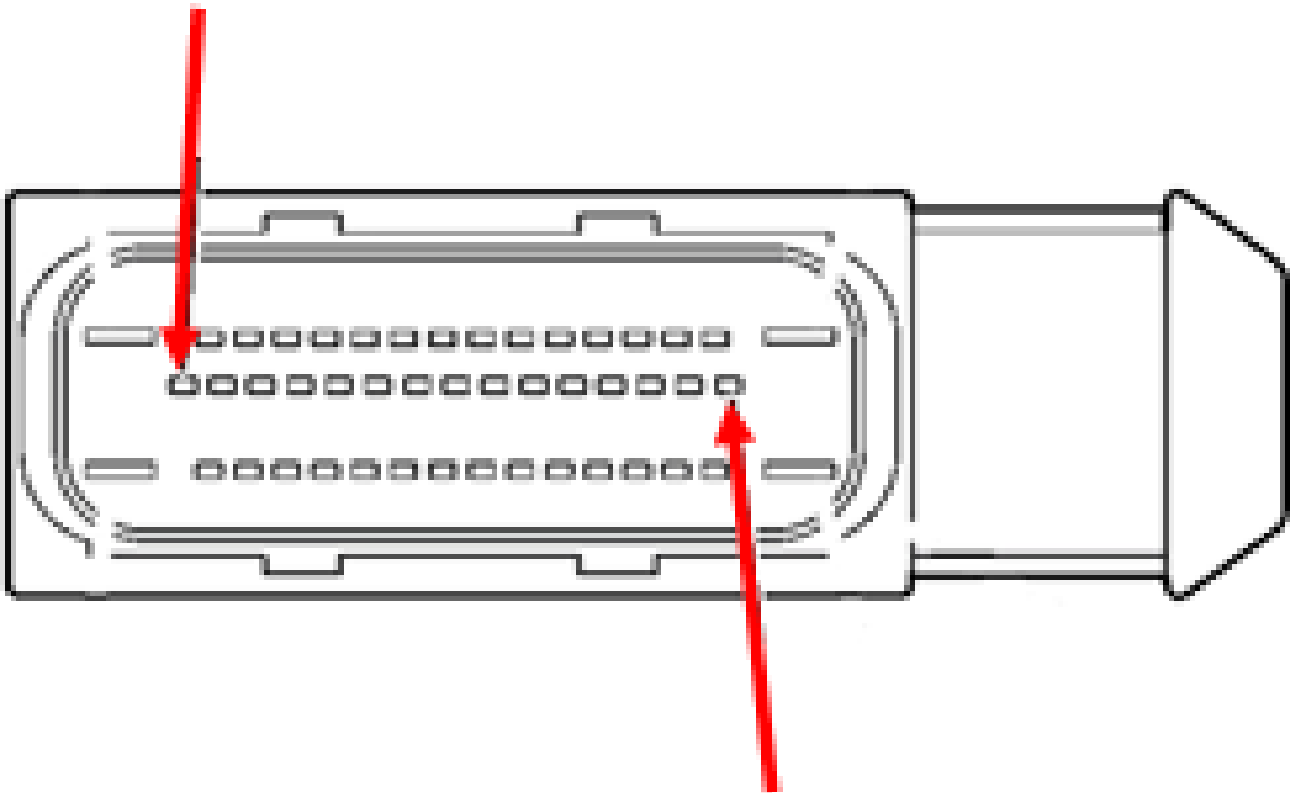
If a customer complains about the above error, this could be caused by a corroded plug connection. Error codes C1140 (steering wheel angle sensor, incorrect signal) and C1145 (ABS wheel speed sensor VR, interruption) may occur.

1. Check connector pins 18, 19 and 20 (all three on the brake pressure sensor) of the plug connection on the ABS/ESP control unit (see Fig.); clean and dry if necessary. The control unit is located in the left side of the engine compartment in the control unit box behind the spring dome.
2. If damage is already severe, use the repair kit to replace the pins.
3. Treat the plug connection with electronic spray or grease before contacting.
4. Check the wiring harness of the brake pressure sensor for continuity. Max. resistance is 0.5 Ohm.
