Mercedes M-Class - Loss of engine power | HELLA

ML 270 CDI (163)

Engine code: 612.963

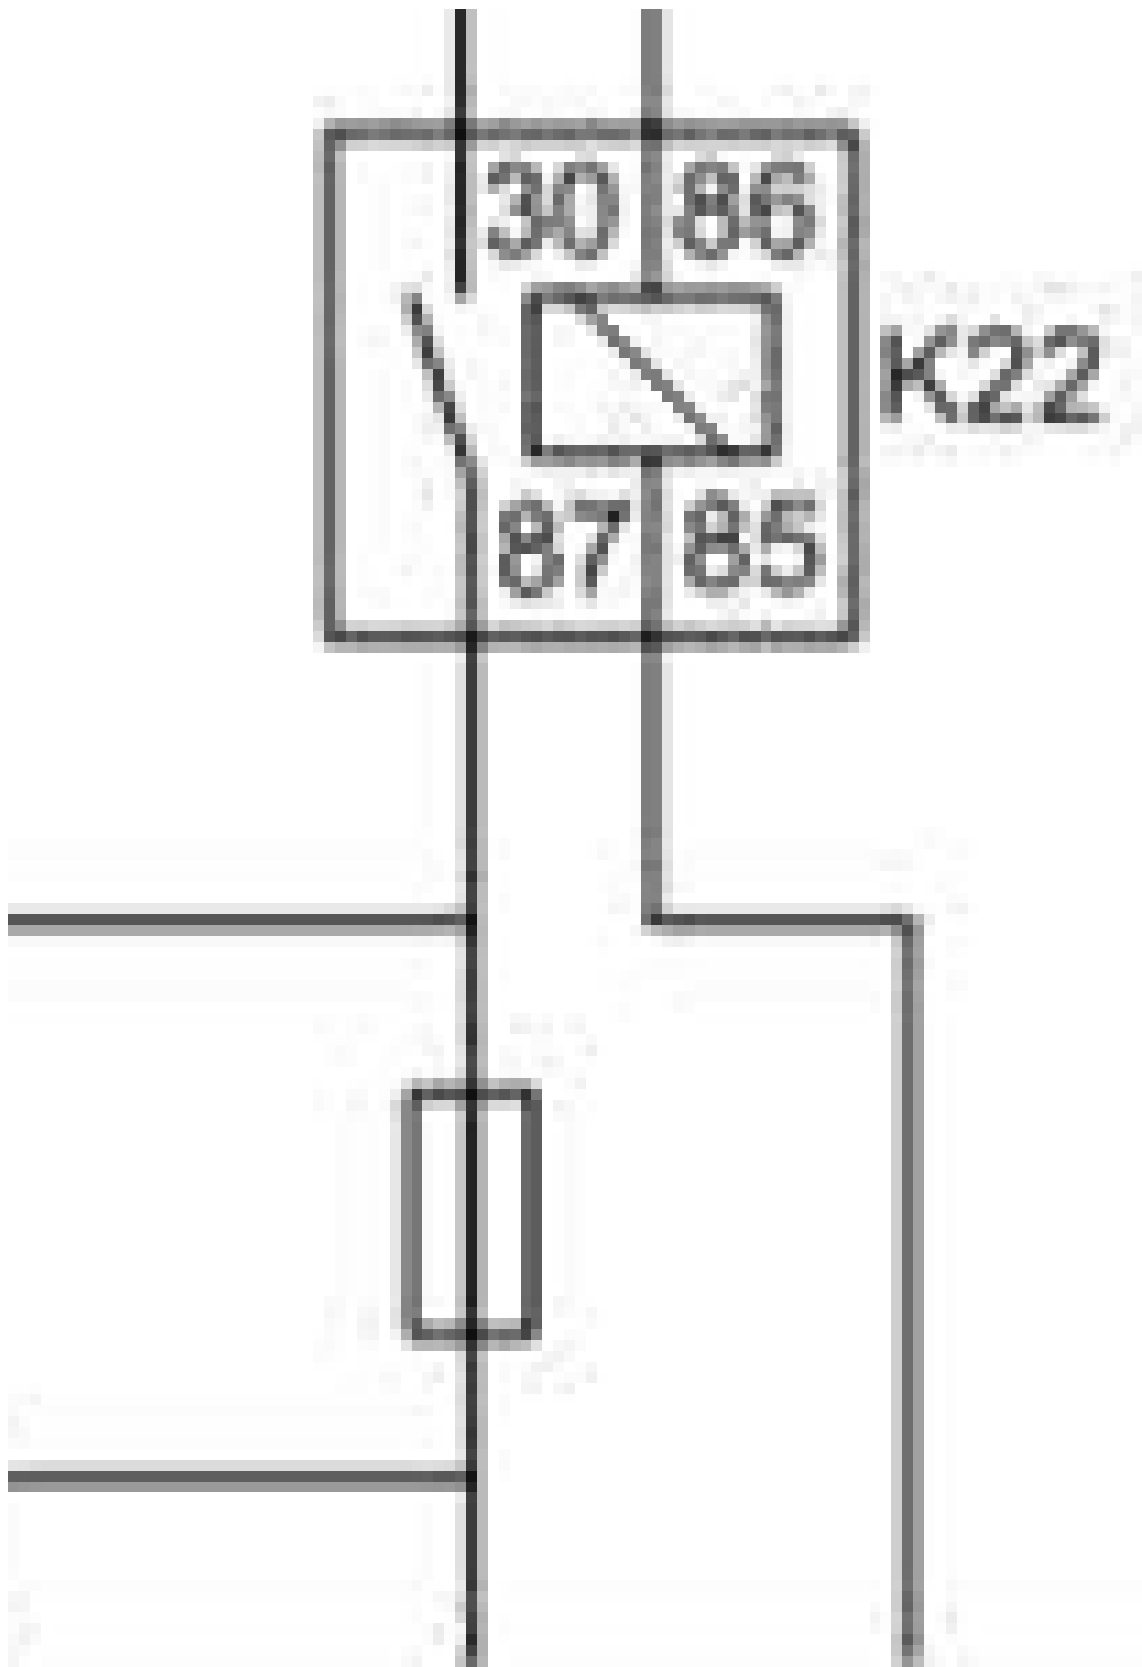
If complaints are made regarding the above-mentioned vehicles that the engine is losing power or going into limp-home mode, a possible cause is a defective 10 A fuse for terminal 87 (see Figure 1) of the control unit.

- The fault codes refer to the following scenarios:
- P1636, `Malfunction of cooling fan control unit`.
- P0100, `Mass air flow sensor defective`.
- P1403, `Exhaust gas recirculation defective`.
- P1470, `Vacuum valve of the pressure control valve function faulty`.
- P1189, `Function of intake manifold runner control system (IMRC) faulty`.

The above-mentioned fault codes could lead to the components listed here (mass air flow sensor, cooling fan control unit, etc.) being misinterpreted as defective because of inadequate voltage supply of the engine control unit.

The 10 A fuse for the control unit is located in the module box in the engine bay (This fuse is not shown in all circuit diagrams). In order to remedy any problem, a faulty fuse should be replaced and any fault codes that have been stored should be deleted.
