Mini F56 - water ingress in the vehicle interior

Data sheet	
Manufacturer	Mini
Vehicle model	F56
Engine	2.0i
Engine code	B48
Year of manufacture	2014
Symptoms	Water ingress in the footwell

Moisture in the vehicle interior caused by condensation draining from the air-conditioning system

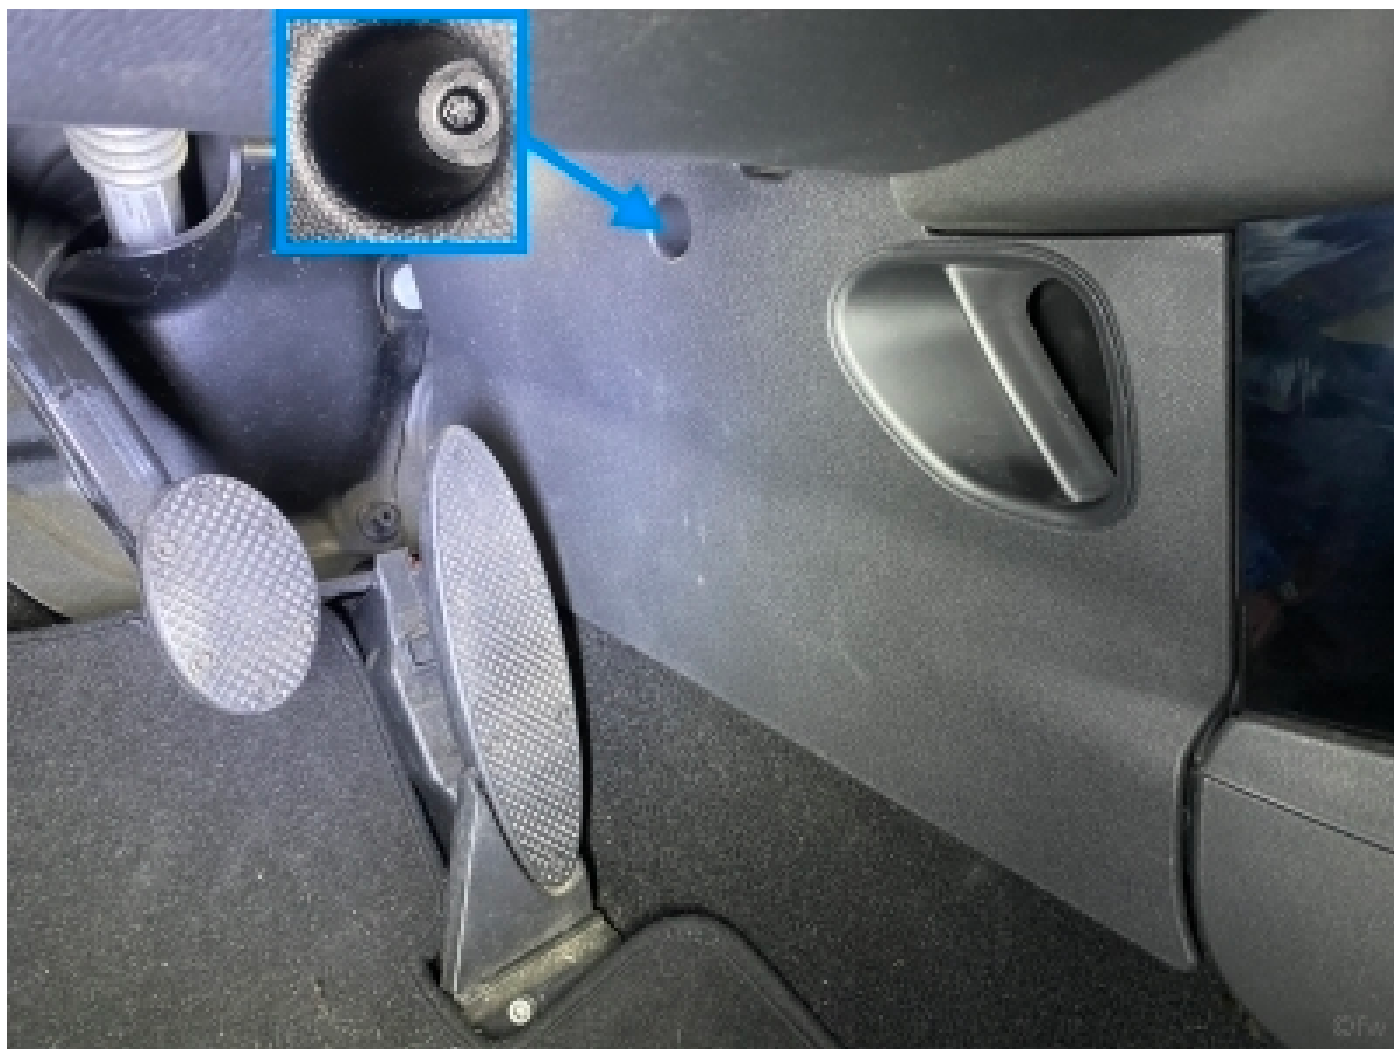
The side panelling (Fig. 1) in the footwell must be removed to carry out the necessary checks. In order to do this, the fastening screw has to be undone and the panelling removed from the brackets. The carpet can be pressed down slightly on the side underneath the air-conditioning unit in order to check it. The rubber seal of the water drain must fit all the way round the air-conditioning unit (Fig. 2) and have no kinks in it.
