Nissan X-Trail (T31) - Leak from the fuel level sensor | HELLA

X-Trail (T31)

Engine: 2.5 i 16V

Leak from the fuel level sensor

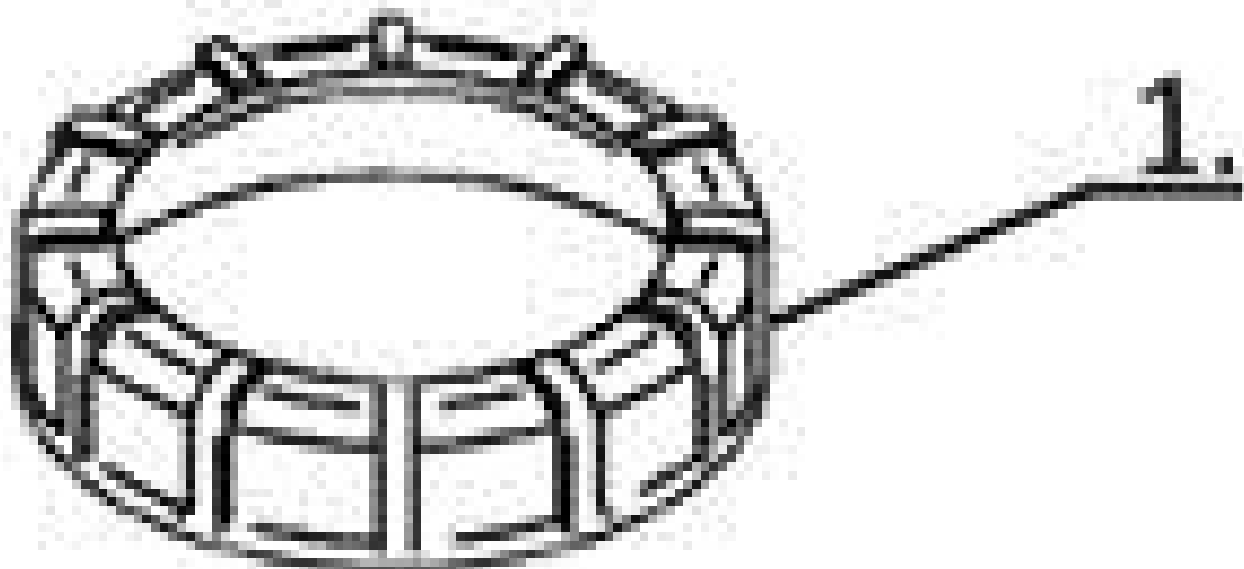
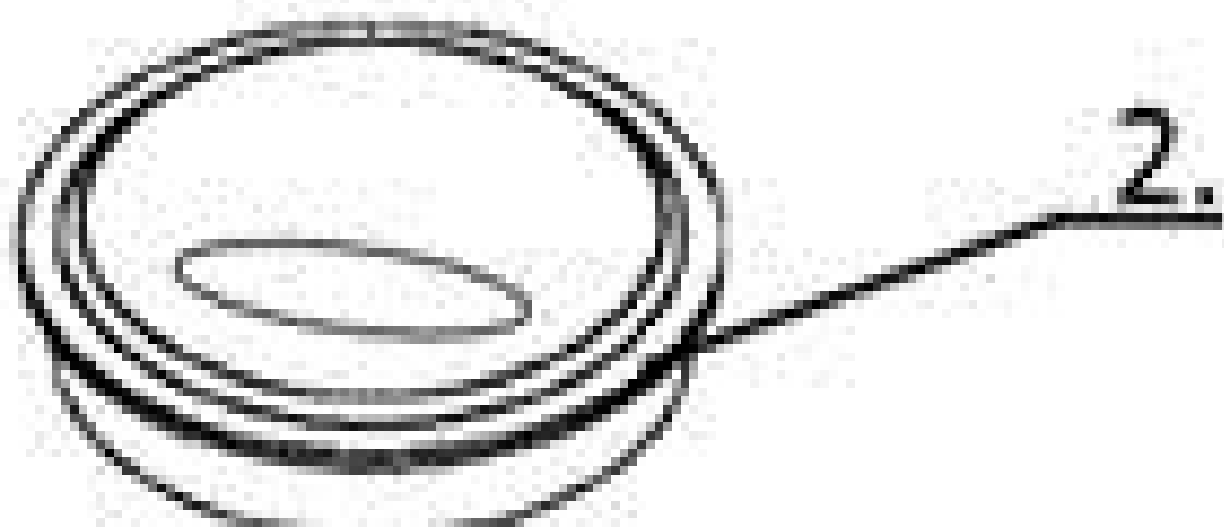
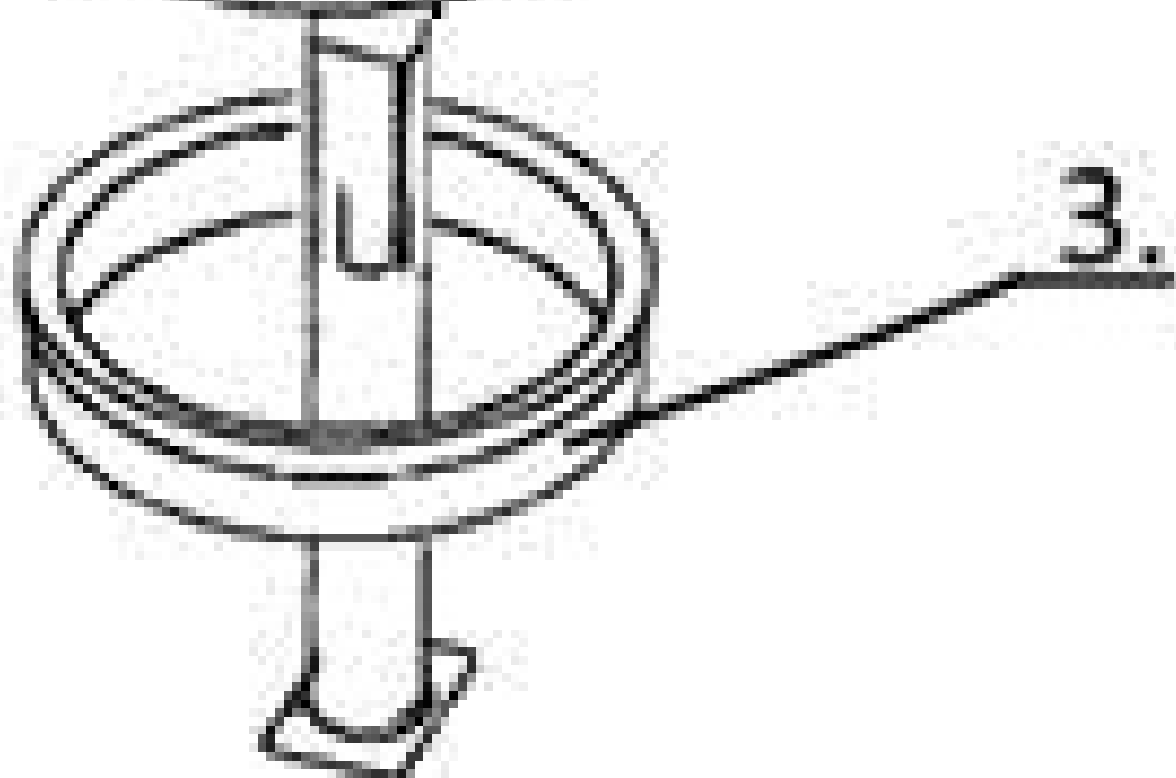
In most cases, the problem mentioned above only occurs when the tank is full.

The cause in such a case is inadequate sealing of the gas tank sensor because of a faulty seal.

Replace the defective gasket (Diagram - position 3) with a new one in accordance with the vehicle manufacturer's specifications.

Access to the mounting opening of the fuel level sensor unit is located below the rear seating area.

- Gasket 1734279900 (Diagram - position 3)

- Circlip 17343JG00A (Diagram - position 1)

- Fuel level sensor unit 25060JG00A (Diagram - position 2)
