Opel Astra-G, Opel Zafira, Vectra-B - Irregular engine running | HELLA

Opel Astra-G, Vectra-B

Opel Zafira

All models with X18XE1 engine

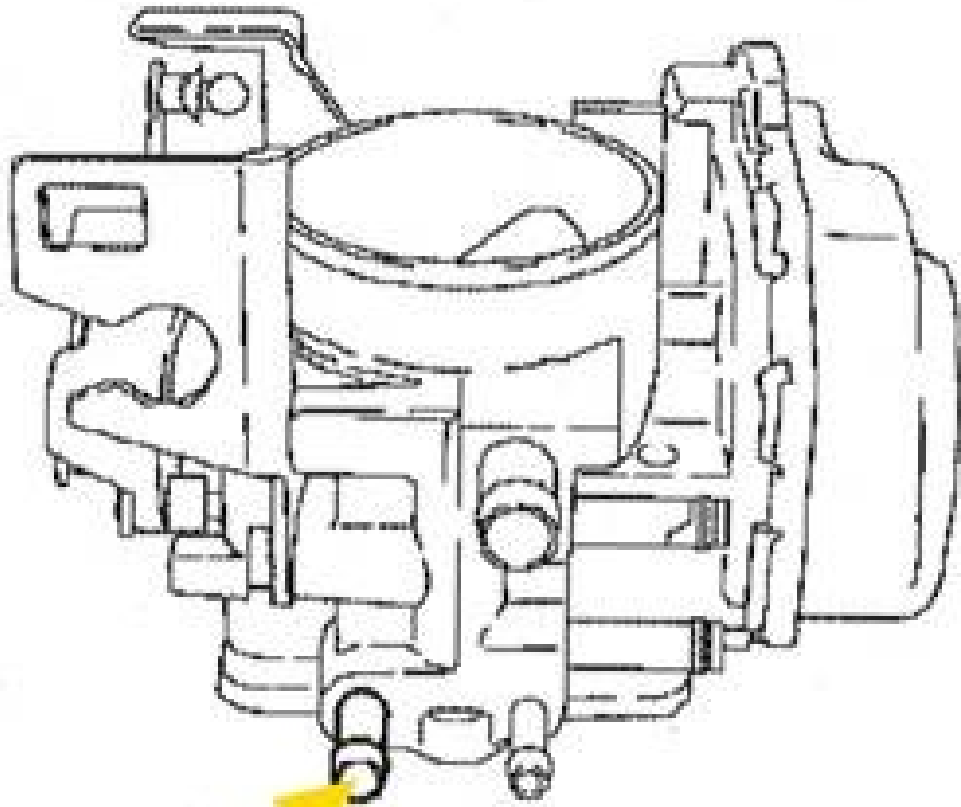
2

If the above-mentioned symptoms occur on these vehicles, this may be caused by a dirty throttle valve. In this case, check the blow-by hole and, if necessary, drill open to 2mm. Afterwards, the ECU must be reprogrammed with a software modified for this purpose. The ECU software can only be updated by an authorised dealer.

- Remove the throttle body
- Secure the throttle body in a vice, protecting the contact faces from damage with a cloth rag.
- Drill blow-by connector (2) open and clean.

Make sure that no chips remain in the throttle body.
