Opel Astra J GTC - Noise in the roof lining area | HELLA

Astra J GTC

Noise in the roof lining area

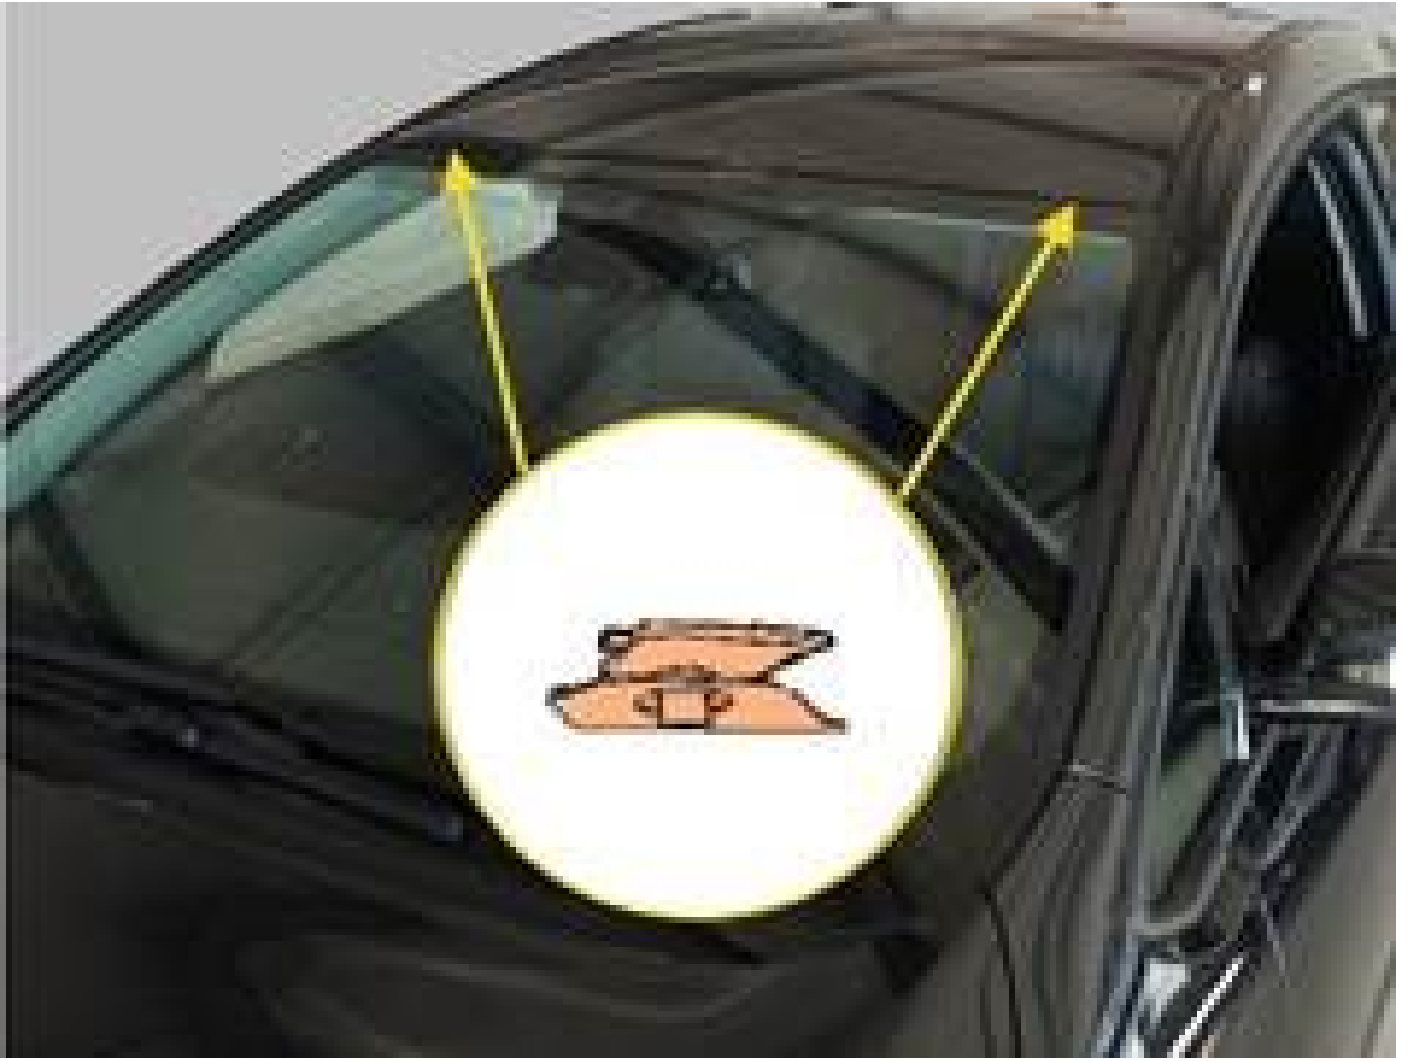
Figure 1

The cause of this noise development could be the clips that were used as a mounting aid for the panorama windshield (figure 1).

The clips may come loose due to heat generation (insolation) for example.
