# Opel Insignia - rasping noise from the engine compartment when load is changed

| Vehicle model | Insignia A |
| Engine code | A16 LET |

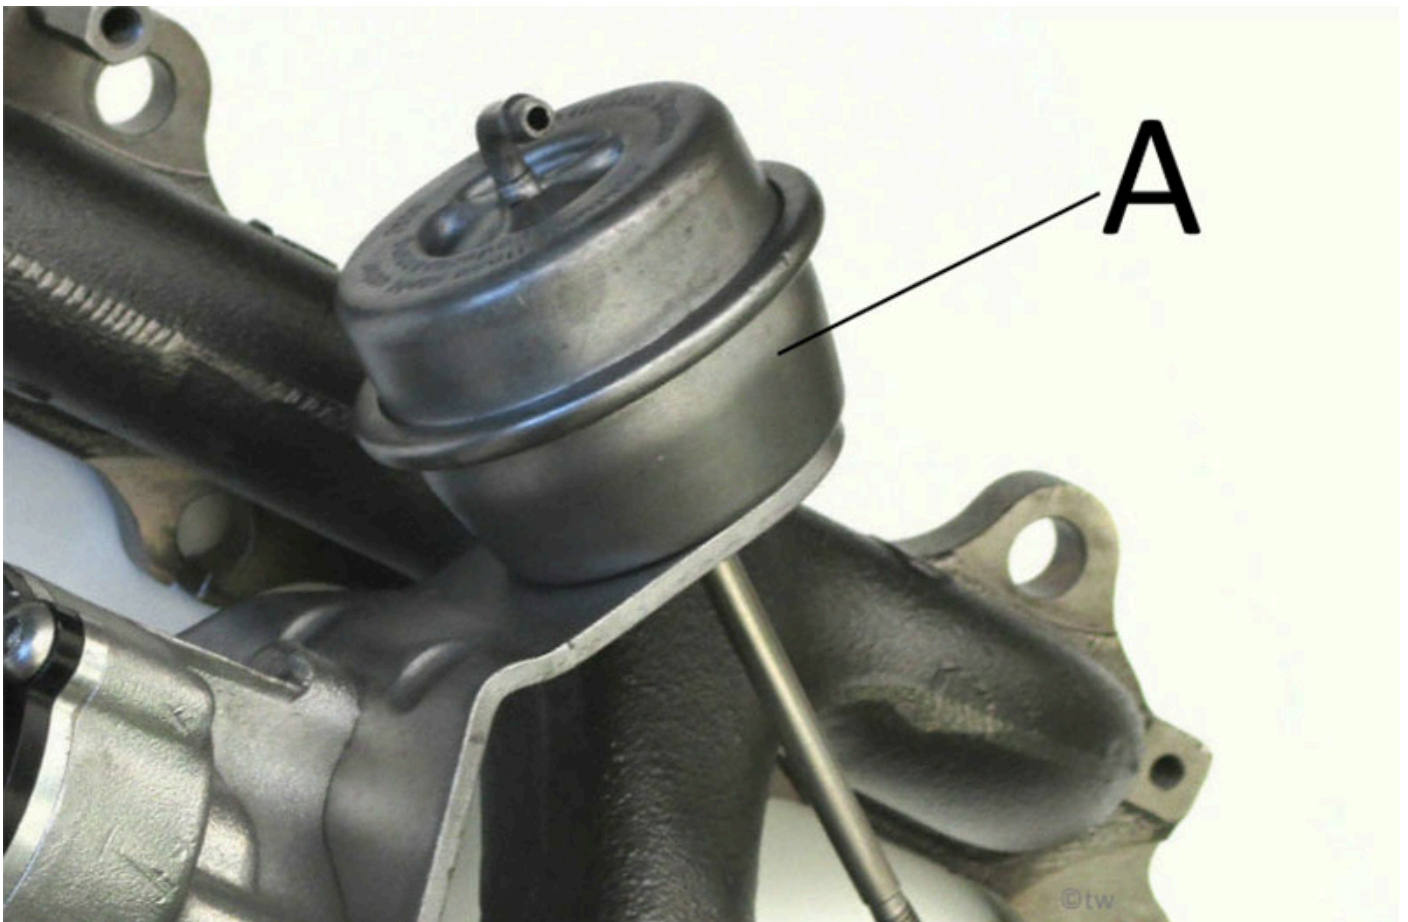
If the above-mentioned defect is detected, it may be related to a defect in the vacuum system responsible for controlling the turbocharger.

The vacuum box on the turbocharger actuator (A) is connected to a vacuum tank via vacuum lines and valves. Leaks caused by ageing or component defects can lead to faulty controlling, which triggers the rasping sound.

In such a case, the vacuum system should be tested with an installed vacuum hand pump.

If the test shows that the vacuum is leaking of its own accord, the defective components are to be replaced.
