Opel Insignia - Engine warning light comes on | HELLA

Opel

Insignia

With engine: 1.6L (LLU) A16LET

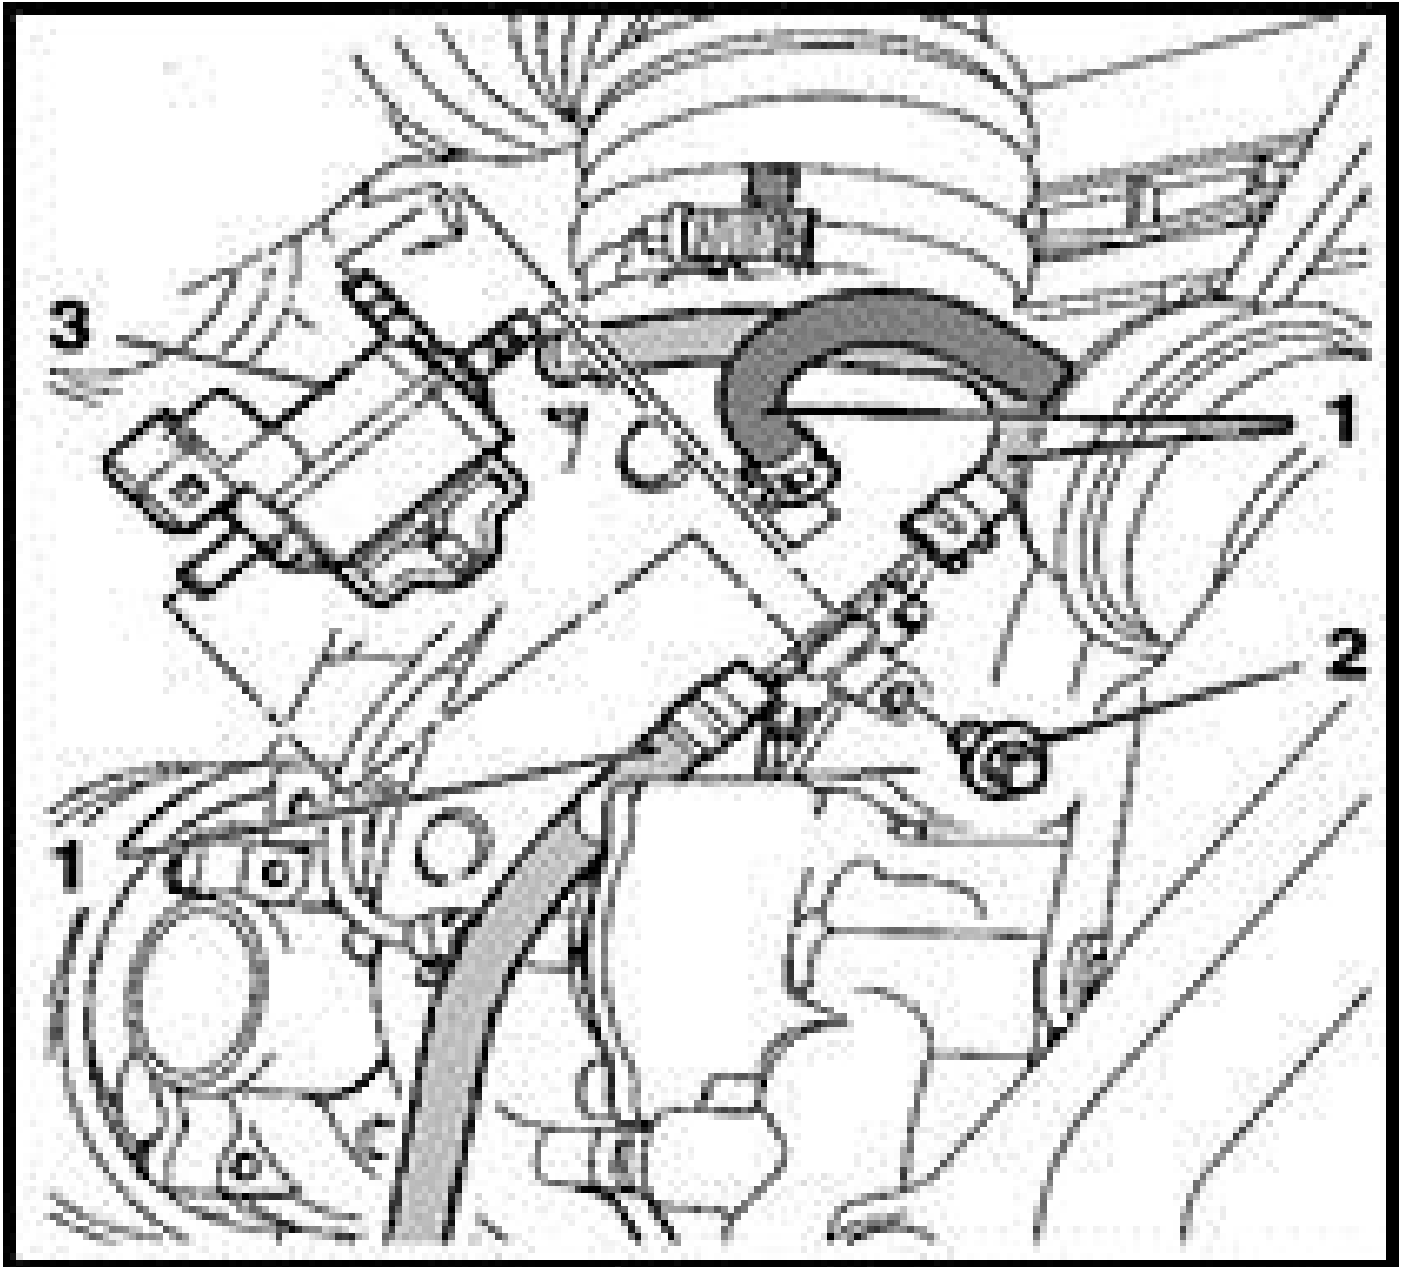
Sticky residue in the solenoid valve's steel nozzle (plug side) can hinder the switching function. The cause of this could stem from the use of a lubricant for making assembly easier during the production or assembly process.

- Ensure the section has been de-energized or disconnect the solenoid valve from the power.

- Disconnect the hoses (Figure, item 1).
- Unscrew the screw (Figure, item 2).
- Replace the turbocharger's shift solenoid valve (Figure, item 3).
- Then reattach the screw and hoses.
- Clear the error codes.
