Opel Insignia - Height adjustment system for seating defective | HELLA

Opel

Insignia

Model year: 2009

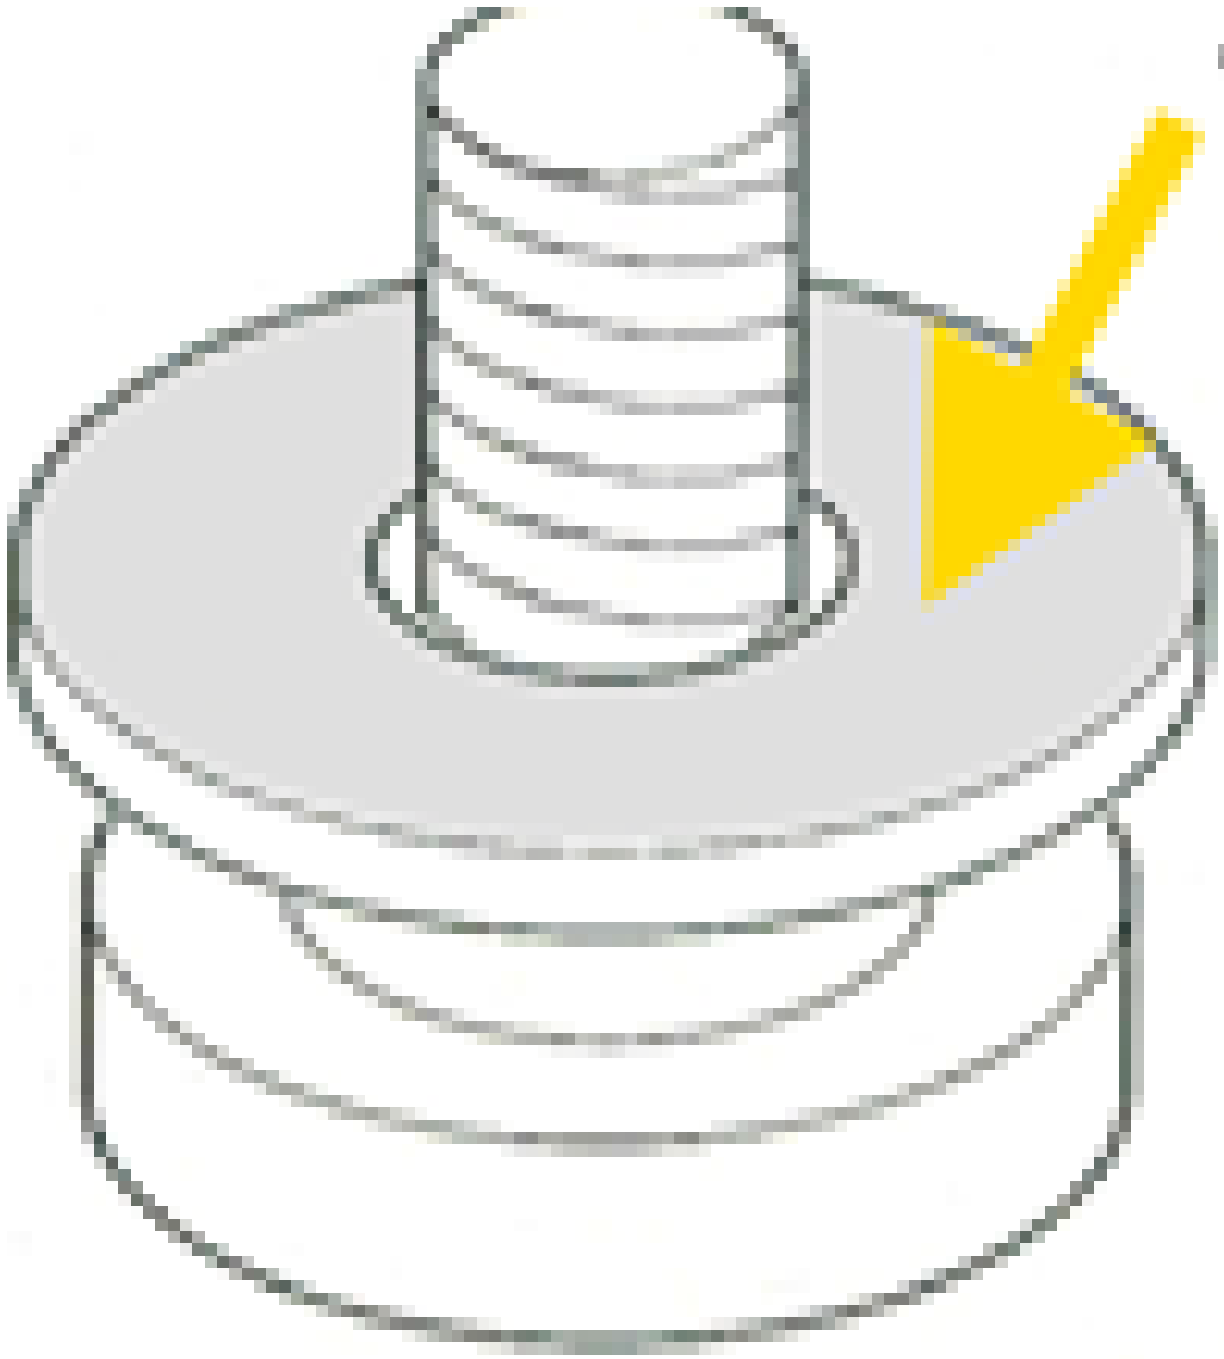
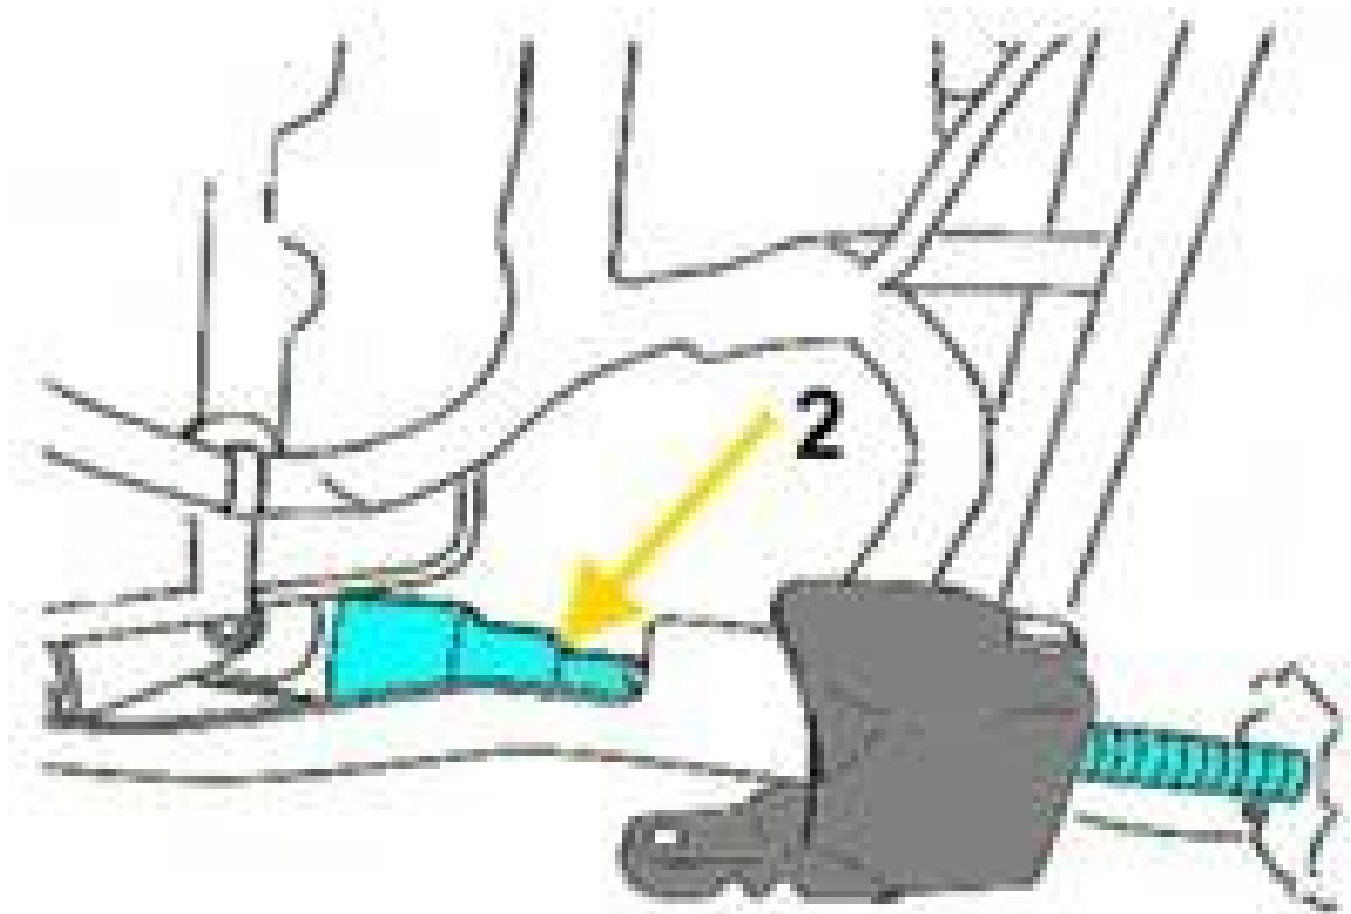
1

If the height adjustment system for the seating in the vehicle mentioned above no longer functions, it can be the fault of a blocked adjustment spindle.

The motor responsible for the adjusting of the seat height can jam between the spindle and the plastic stopper.

The problem can be solved with the help of an additional washer (1).

- Dismantle seat
- Loosen screw (2) and dismount
- Place washer (1) with the measurements 6.4 x 18 x 1.6 in position (OE No. 11035613)
- Lubricate with special grease (OE No. 13329237)
- Replace screw (2) and tighten with 10 Nm torque
- Remount seat
