# **Saab 9-3 - Passenger compartment fan | HELLA**

**9-3 (YS3D)**

## **Passenger compartment fan**

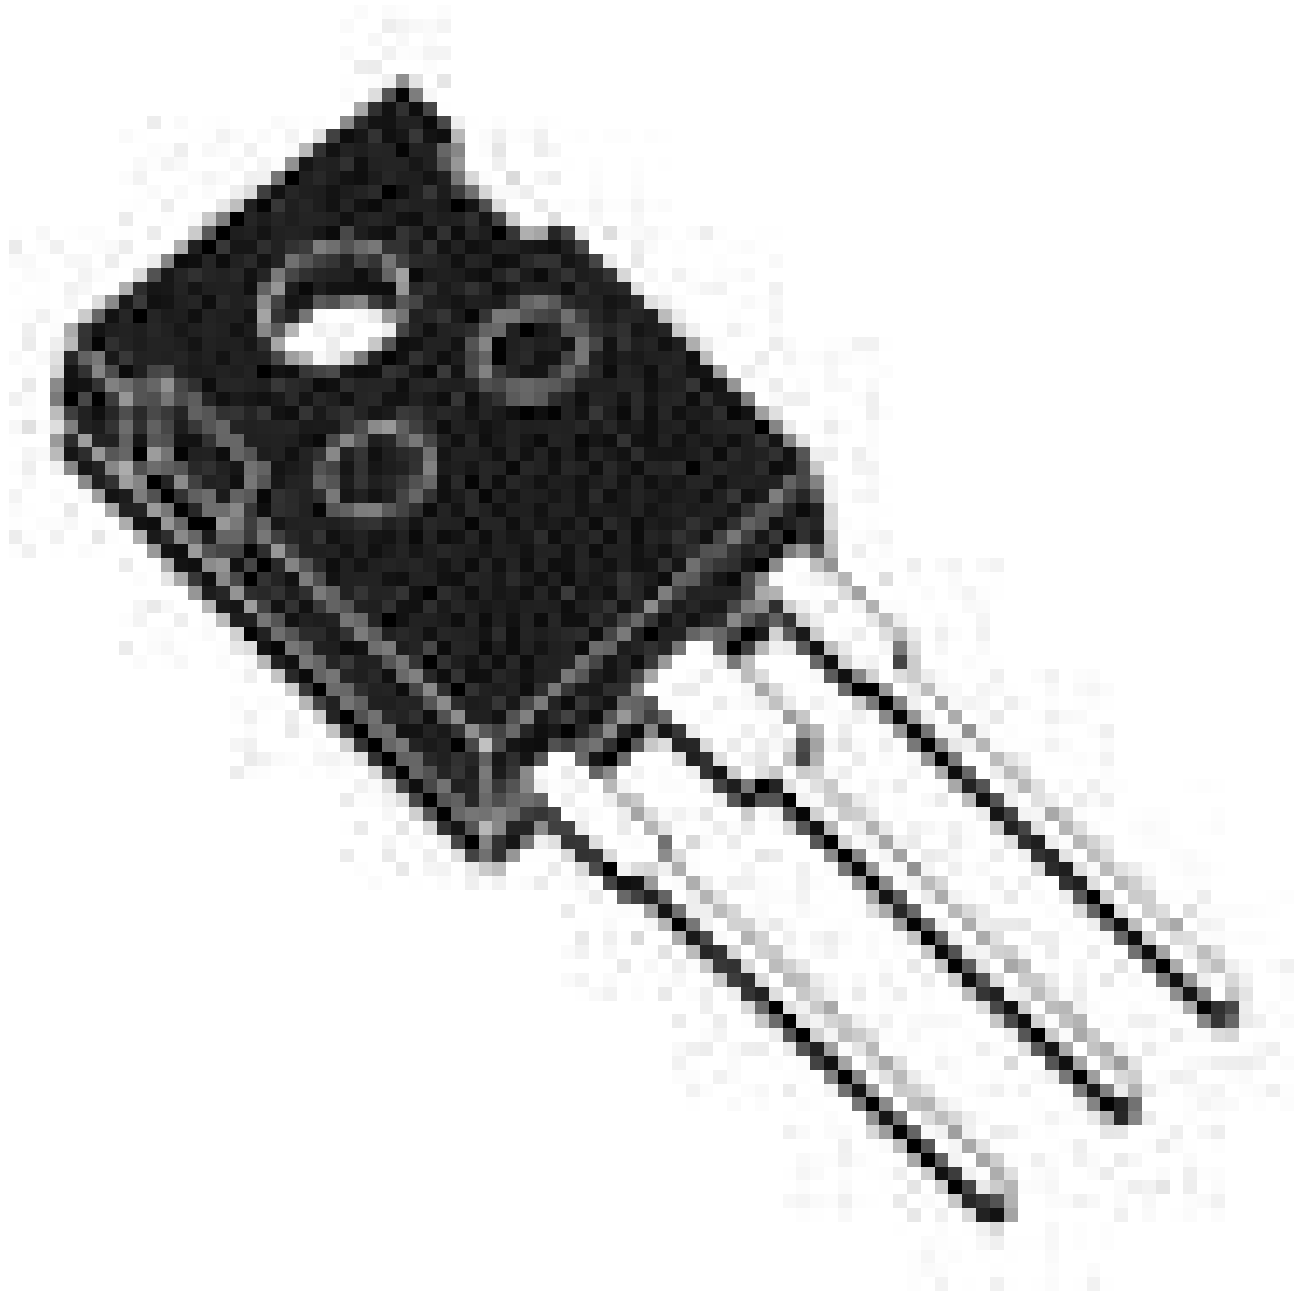
In the above vehicles, a defective fan control unit can result in the passenger compartment fan operating only at the highest speed.

If the fan speed can no longer be controlled by the control unit or the fan operates only at the highest setting, the cause is probably a defect in the electronic fan control unit. In most cases, the transistor (MOSFET) on the circuit board has failed.

In addition to replacing the fan control unit, somewhat skilled technicians could also repair the control unit by replacing the transistor. For this procedure, the following accessories/replacement parts are needed:

- 
- Transistor (Type IRFP064N)
- Soldering iron, ca. 30W
- Desoldering pump
- Solder
- Thermal grease
- Screwdriver, narrow
- Blade
- Harness tape, temperature-resistant
