Saab 900 II - Speed control for heating-system fan | HELLA

900 II

Year of manufacture: 1993 - 1998

Speed control for heating-system fan

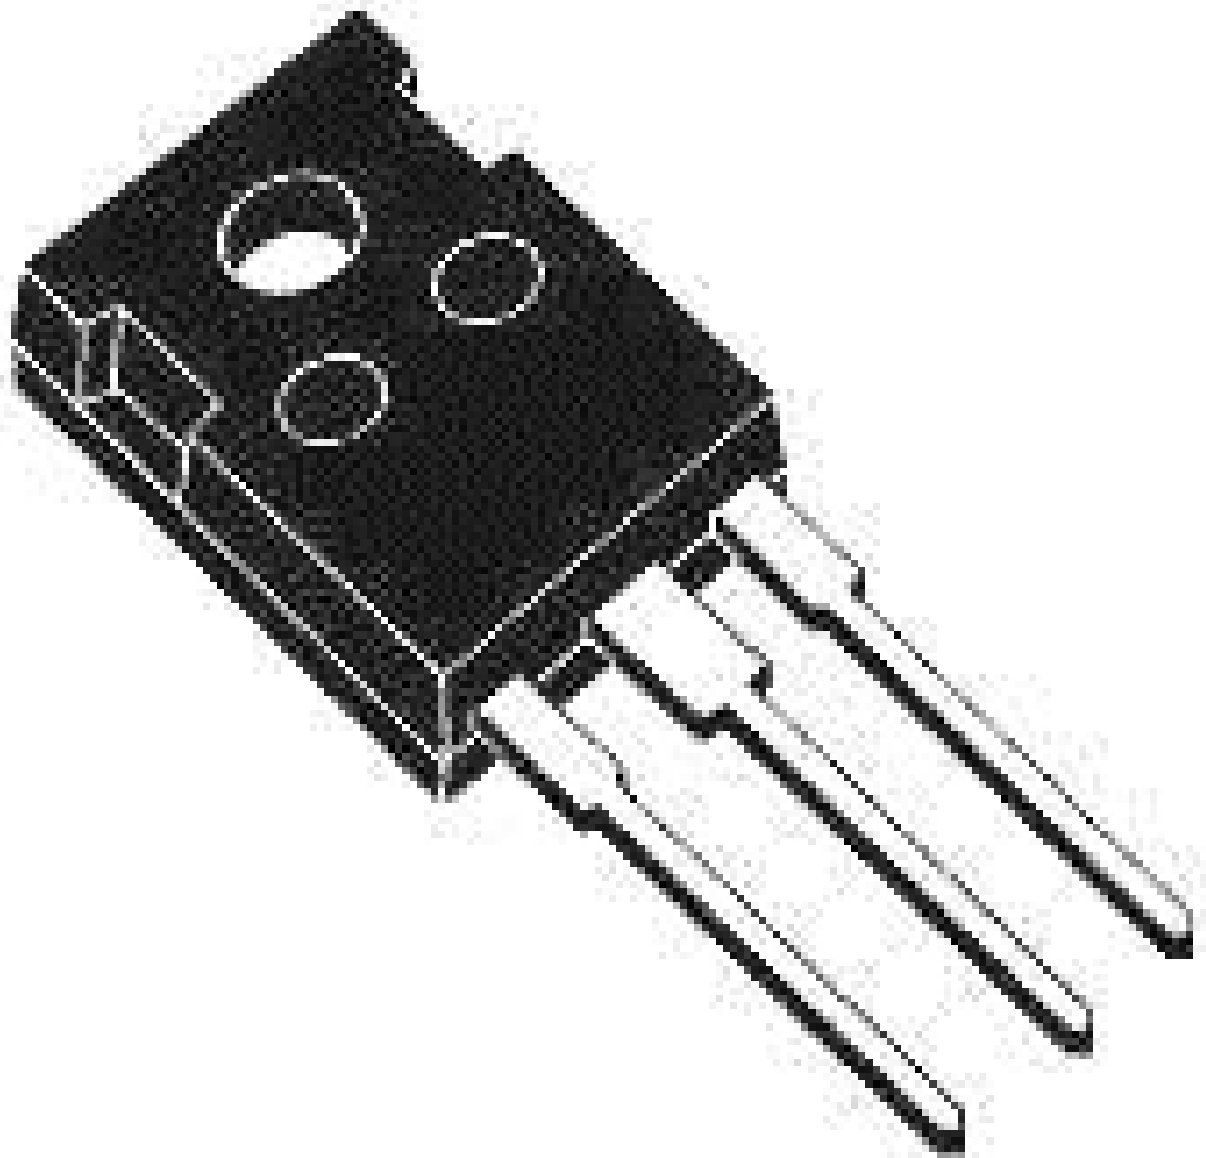
If the fan speed can no longer be controlled by the control unit or the fan operates only at the highest setting, the cause is probably a defect in the electronic fan control unit. In most cases, the transistor (MOSFET) on the circuit board has failed.

Somewhat skilled technicians could also repair the control unit by replacing the transistor.

- Transistor (Type IRFP064N), see drawing
- Soldering iron, ca. 30W
- Desoldering pump
- Solder
- Thermal grease
- Screwdriver, narrow
- Blade
- Harness tape, temperature-resistant
