# Volkswagen Lupo - Excessively high engine temperature | HELLA

## Volkswagen

## Lupo

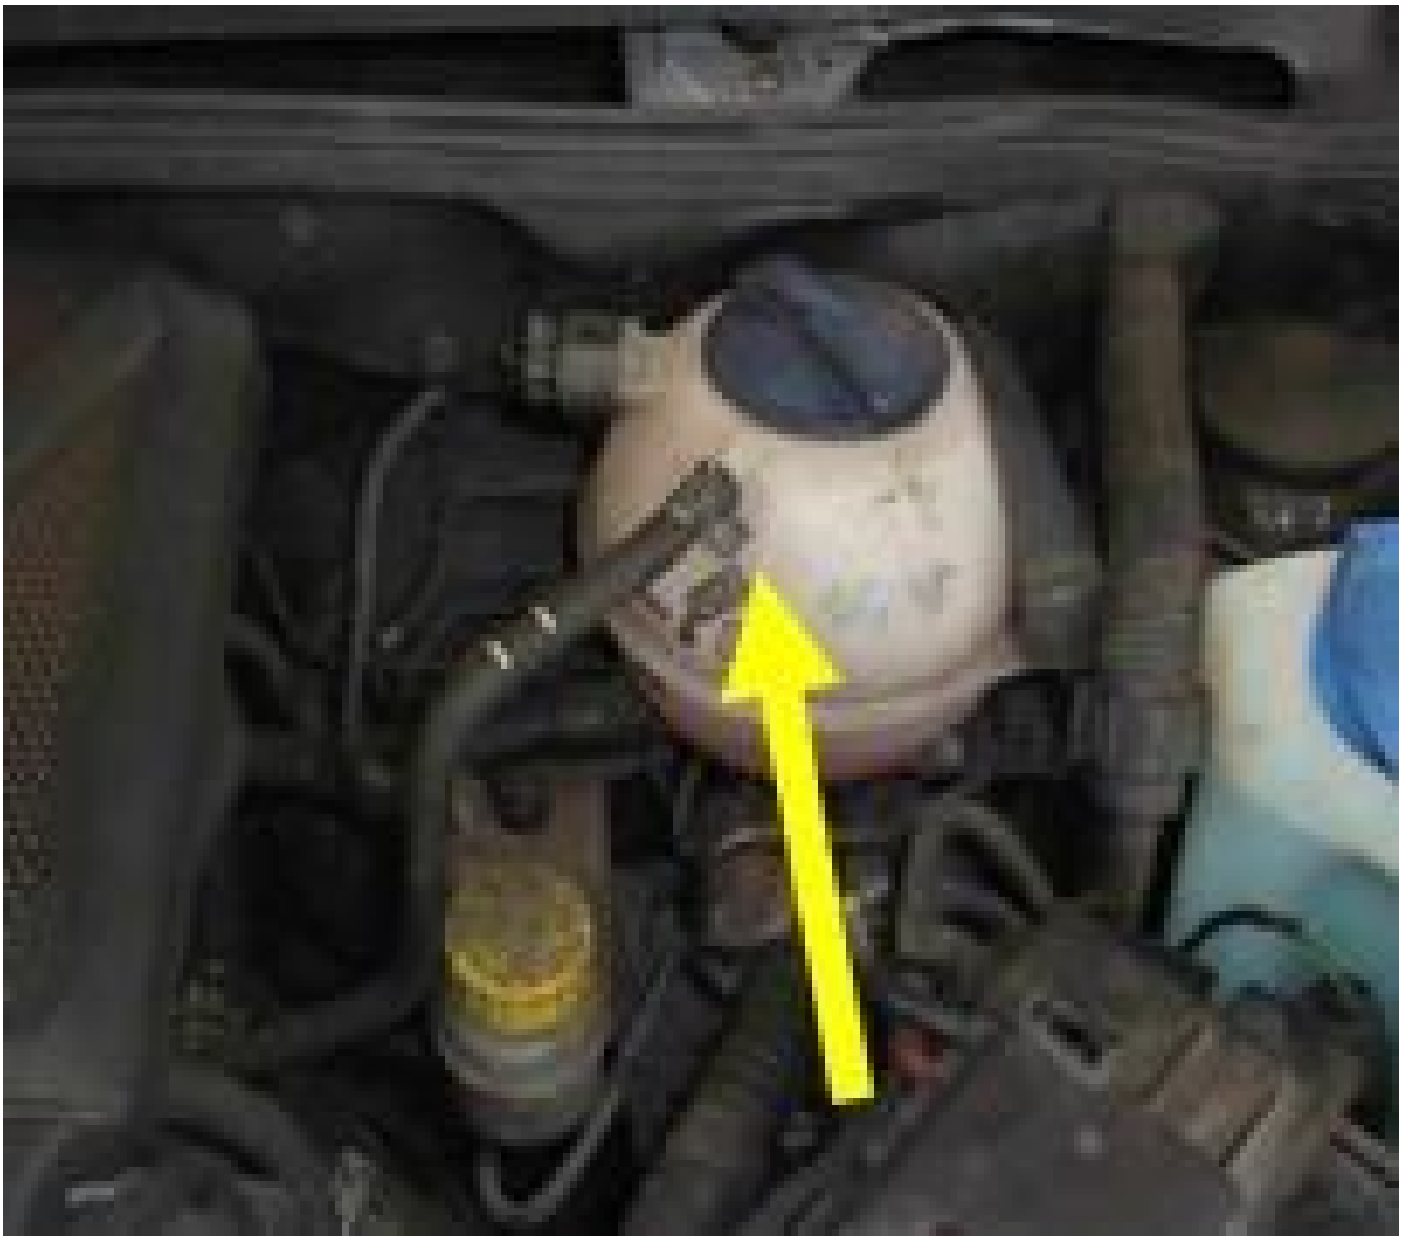
Figure 1.

Also remove the coolant return pipe from the  
coolant expansion vessel (see figure 1.).

If no coolant flow is detected, the water pump is  
to be renewed.

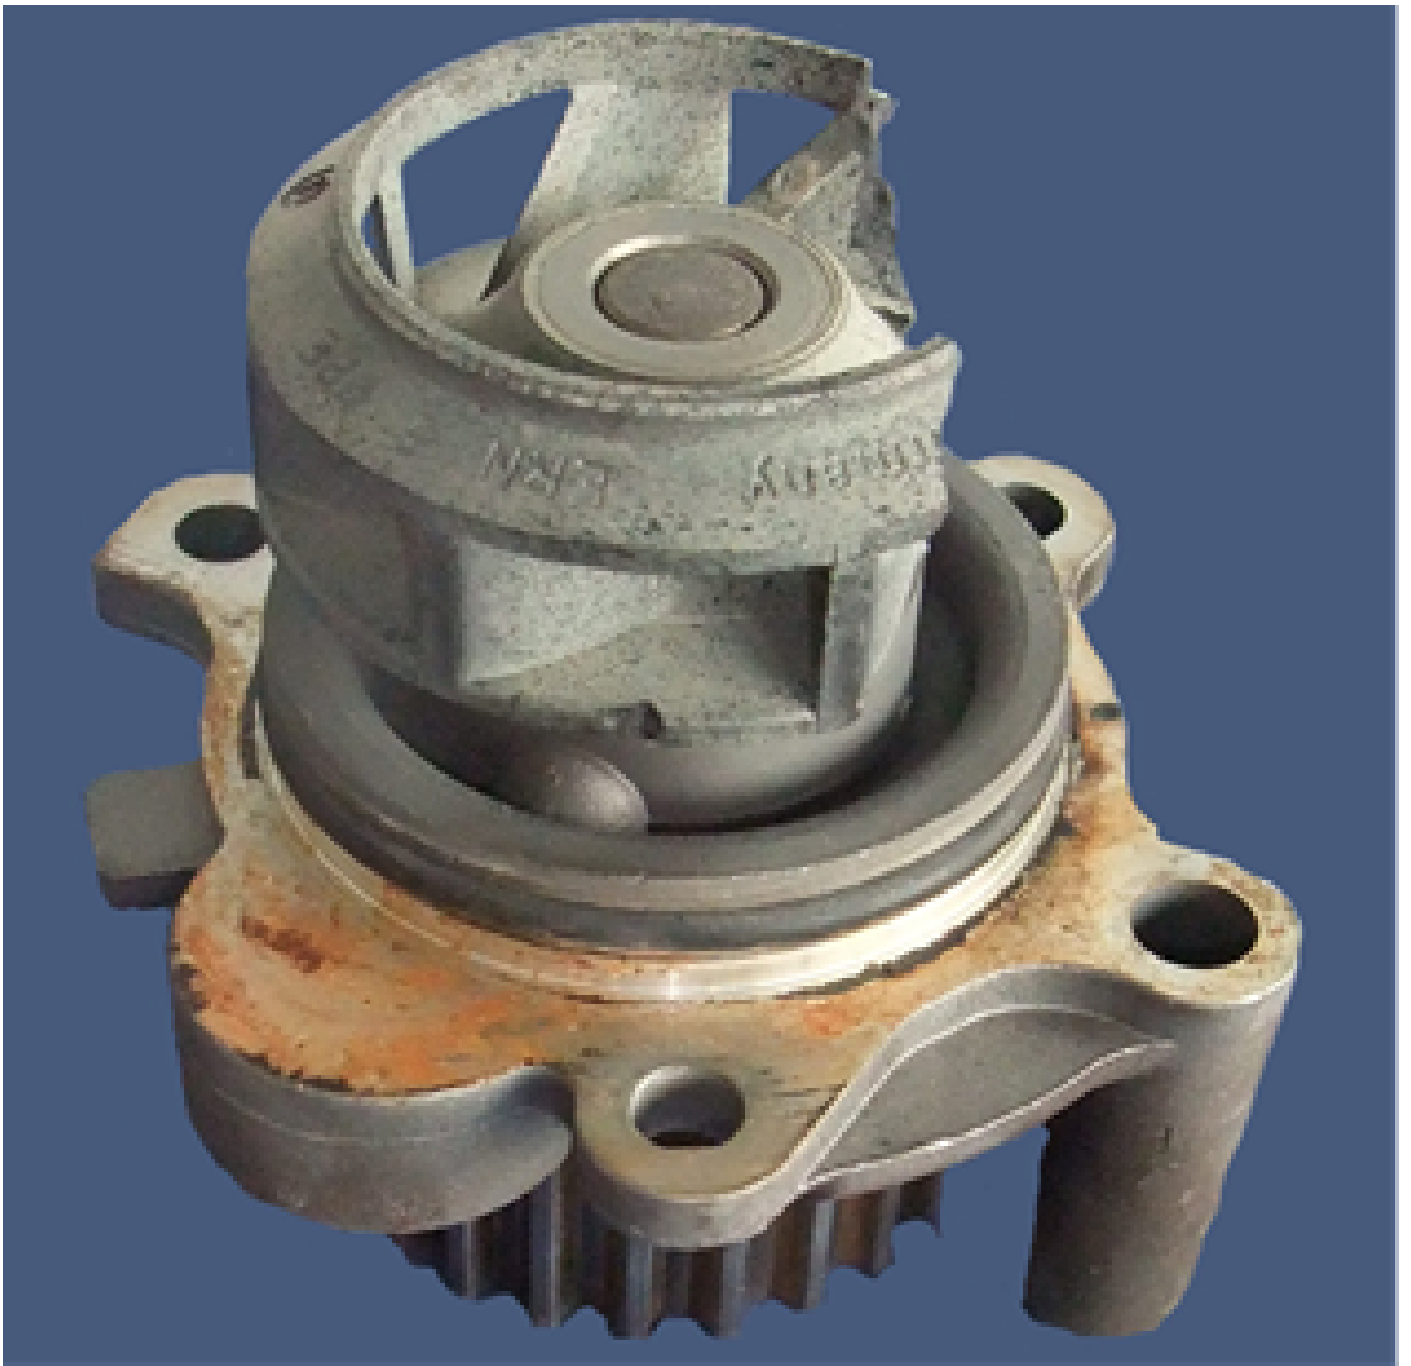
Figure 2.

This problem may be caused by a broken impeller (plastic impeller, see figure 2+3) in the water pump.
