# Volkswagen T6 - hissing noise from engine compartment

Data sheet	
Manufacturer	Volkswagen
Vehicle model	Transporter T6 (SF/SG)
Engine	2.0 TDI (CAAC/CXFA/CXHA)
Year of manufacture	2015 - 2019
Symptoms	Hissing noise from the engine compartment

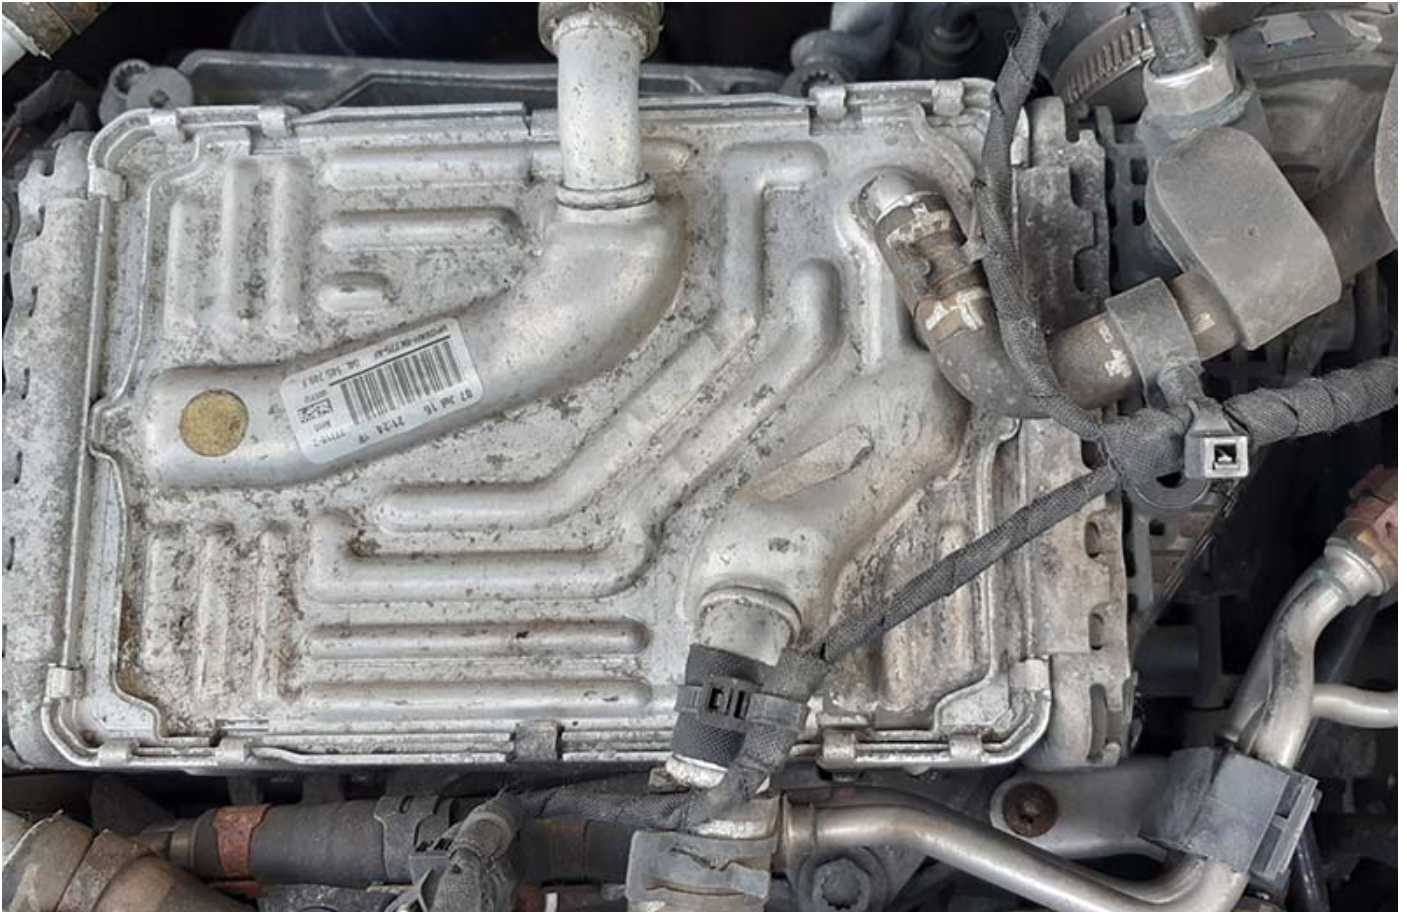
Figure 1: Charge air cooler

Defective or loose hoses or hose connections in the area of the charge air cooler are possible causes ([Fig. 1](#)).

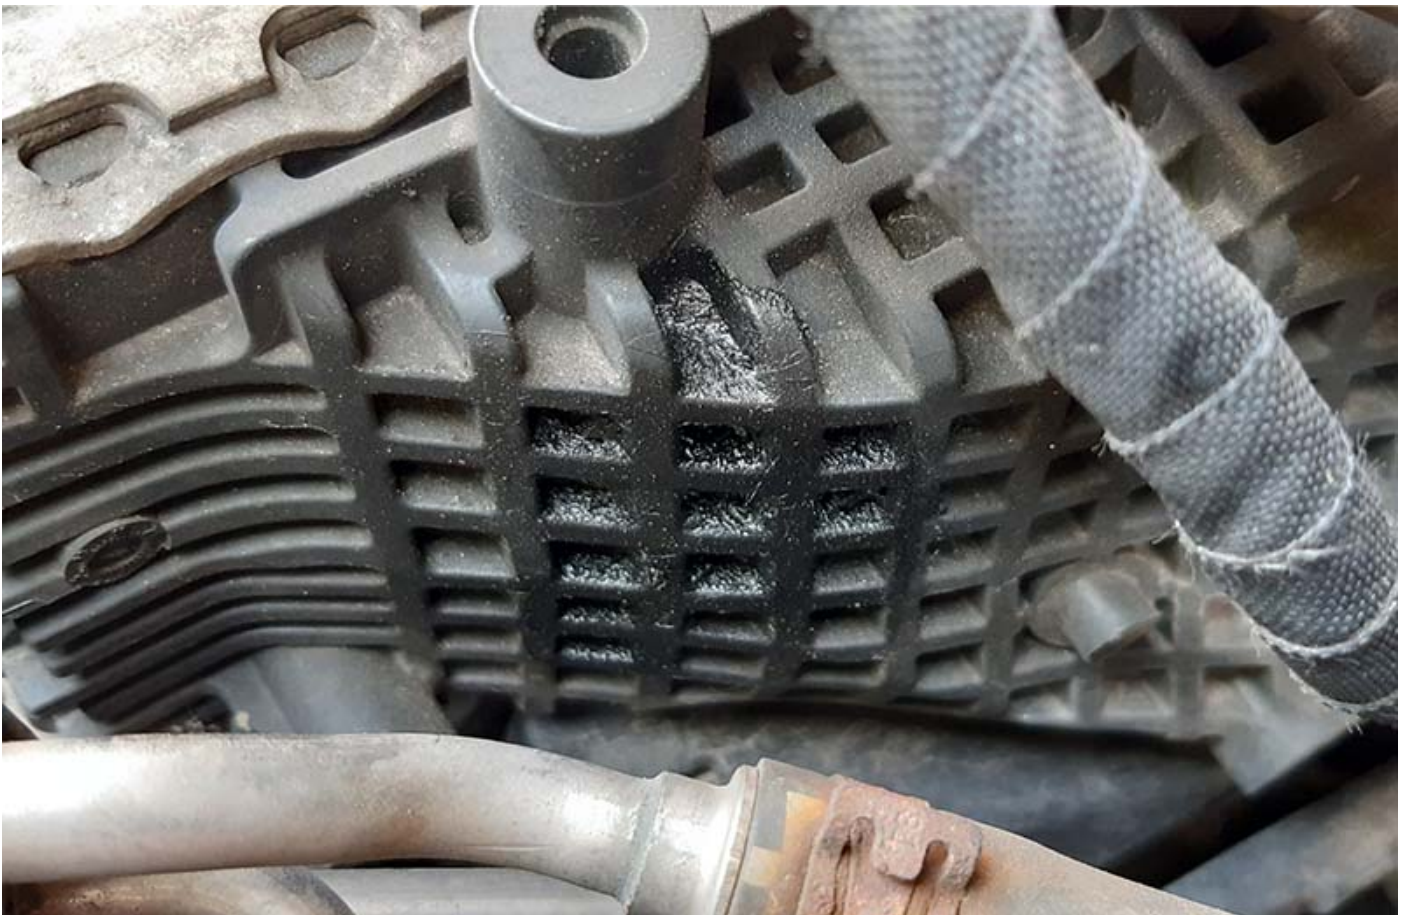
In addition, it is also possible that the charge air cooler itself is damaged. Often a visual inspection reveals the cause. Traces of oil on the surface ([Fig. 2](#)) indicate a crack, which causes the noises mentioned above.

## Figure 2: Oil traces on the charge air cooler

The charge air cooler must be replaced to rectify the problem.
