# Volkswagen Up/Seat Mii - engine start impaired: Error code 4629

Data sheet	
Manufacturer	Seat/Volkswagen
Vehicle model	Mii/Up
Engine	All models
Year of manufacture	2012 - 2019
Symptoms	Engine start impaired

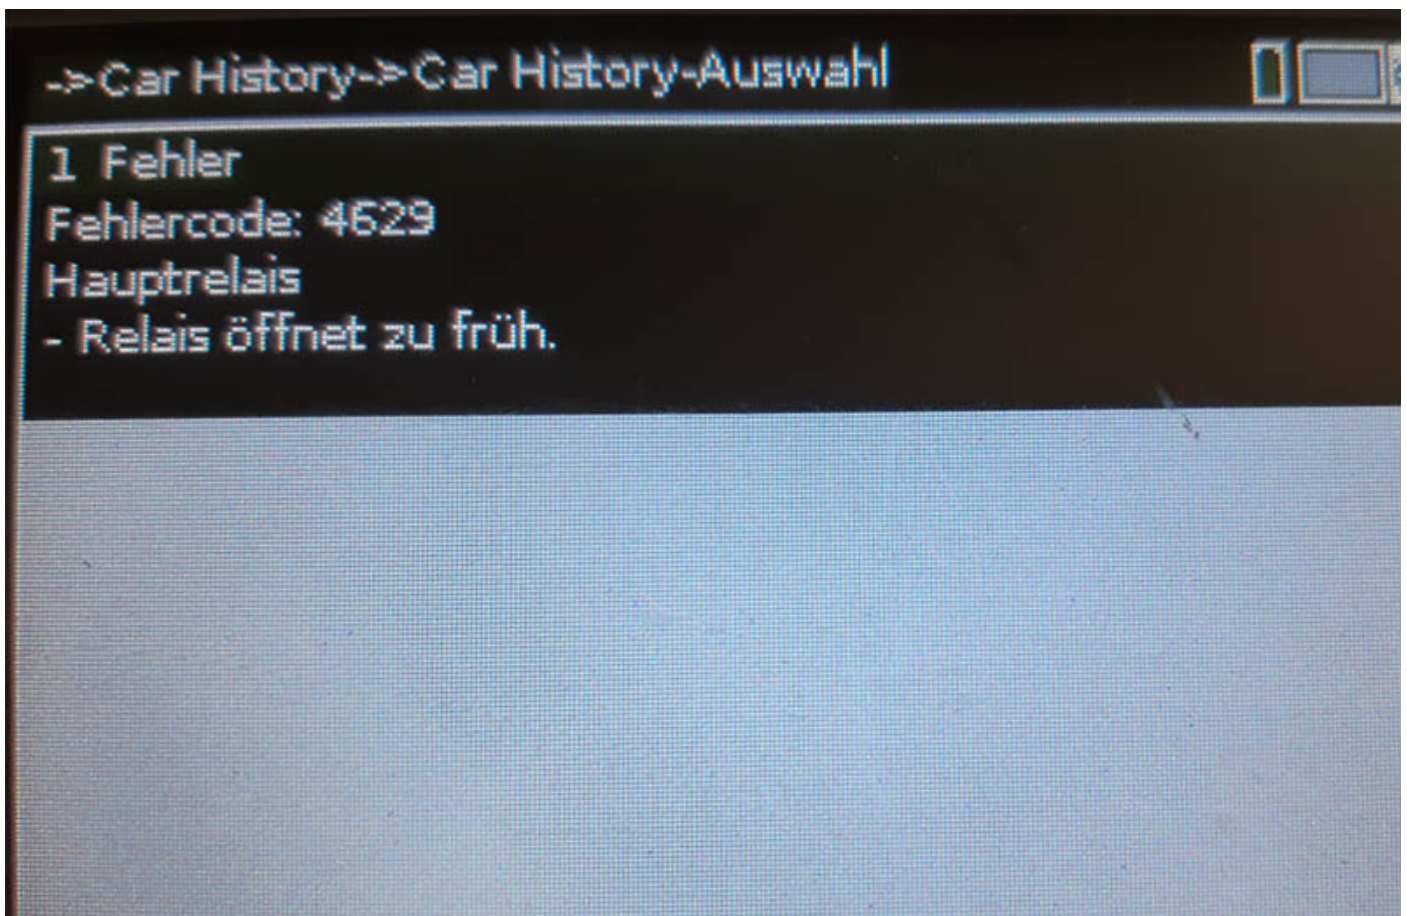
The first step is reading out the error memory. Error code 4629 (main relay opens too early) may be stored. ([Fig. 1](#)) This leads to the assumption that a relay is faulty. The relays can be reached relatively easily after removing the left cover on the dashboard. ([Fig. 2](#)) The position of the main relay(s) should be identified using a relay plan ([Fig. 3](#)). One of the relays controls the fuel pump. If the relay is defective, this would explain why the engine does not start.
