## VW, Audi, Seat, Skoda: insufficient headlamp range and headlamps dazzle

Data sheet	
Manufacturer	VW   Audi   Seat   Skoda
Vehicle model	Various models
Symptom	Insufficient headlamp range, headlamps dazzle

## VW, Audi, Seat, Skoda: insufficient headlamp range or poor illumination of the road after H7 bulb replacement

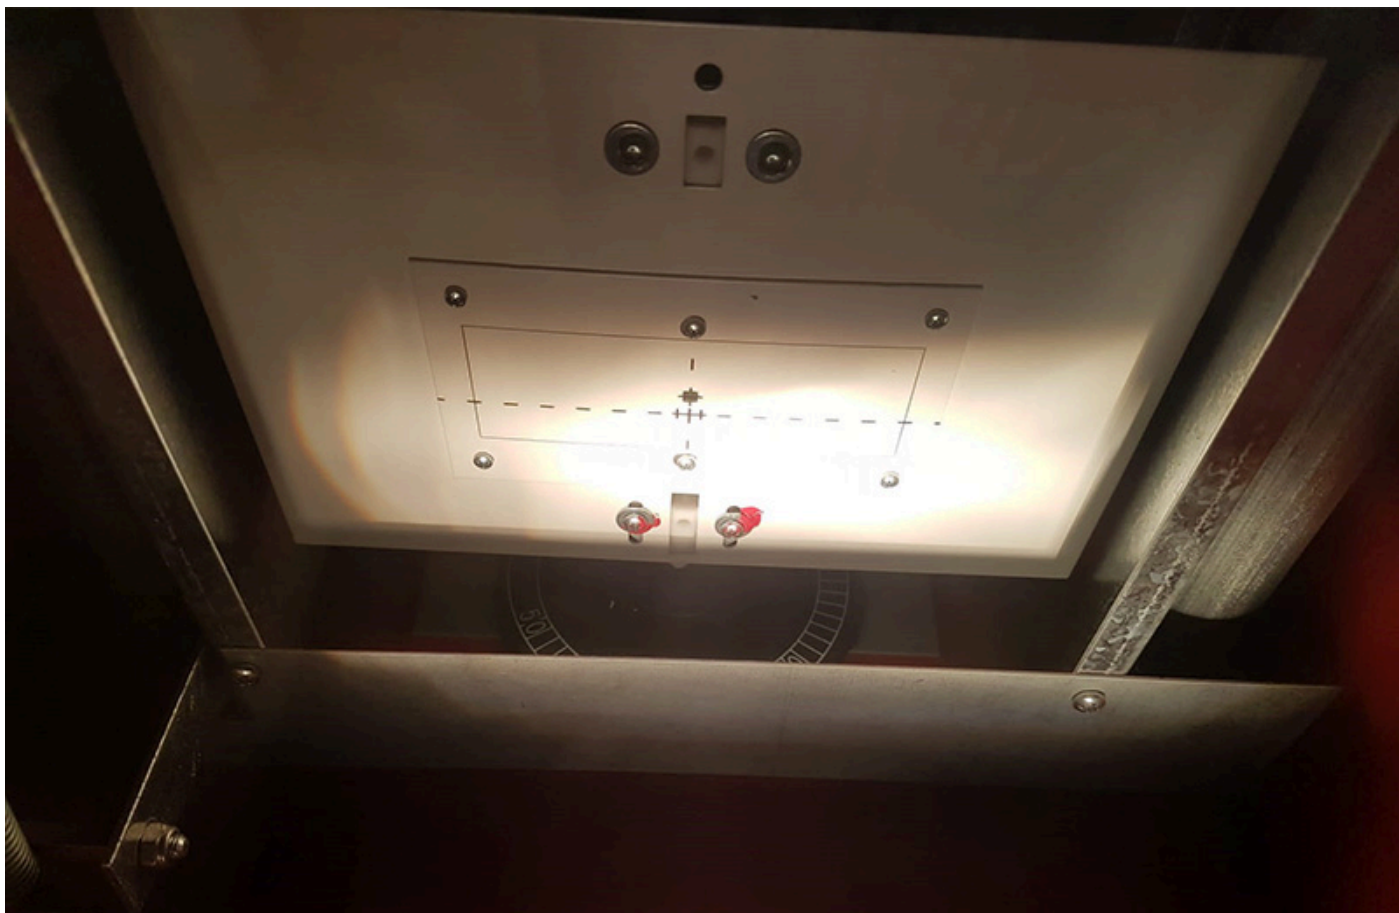
After the main headlamp bulbs have been changed on the vehicles mentioned above, there may be insufficient illumination of the road or oncoming traffic may be dazzled. This is especially true when using H7 bulbs. There are two reasons for this. Either the headlamp's bulb socket allows different mounting positions or the bulb has not been correctly inserted (twisted) during mounting. This leads to uncontrolled scattering of the light ([Fig. 1](#)).

Figure 1: uncontrolled scattering of light

Therefore, checking that the bulb is installed correctly is strongly recommended after every bulb replacement. The light pattern can be checked using a headlamp tester. [Figure 2](#) shows that the installation has been done correctly. Here, the light/dark boundary and also the asymmetric angle are clearly visible.

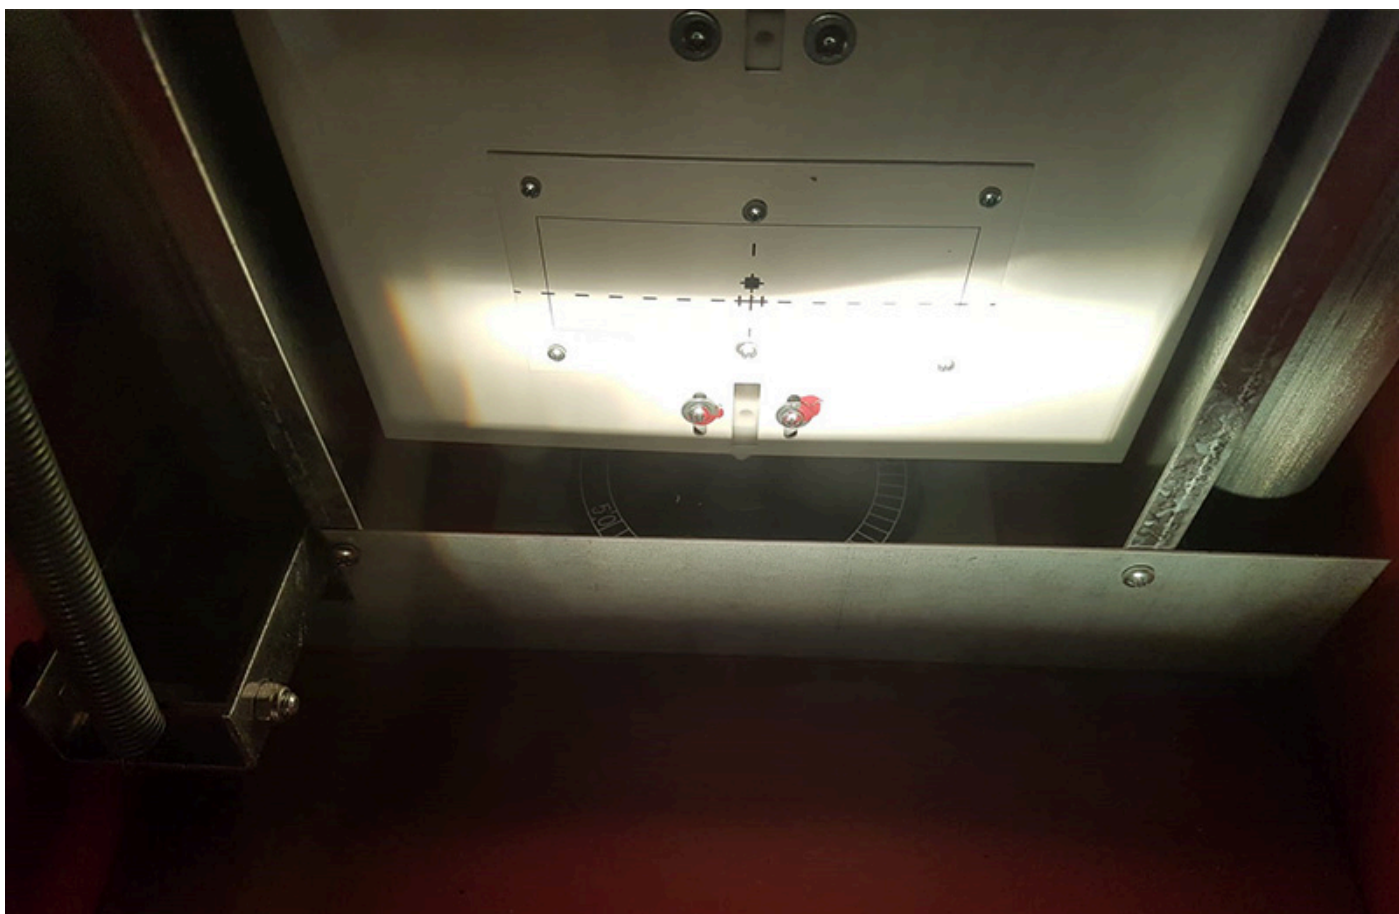
## Figure 2: Light/dark boundary and asymmetric angle clearly visible
