VW Golf VII - loss of coolant

Data sheet

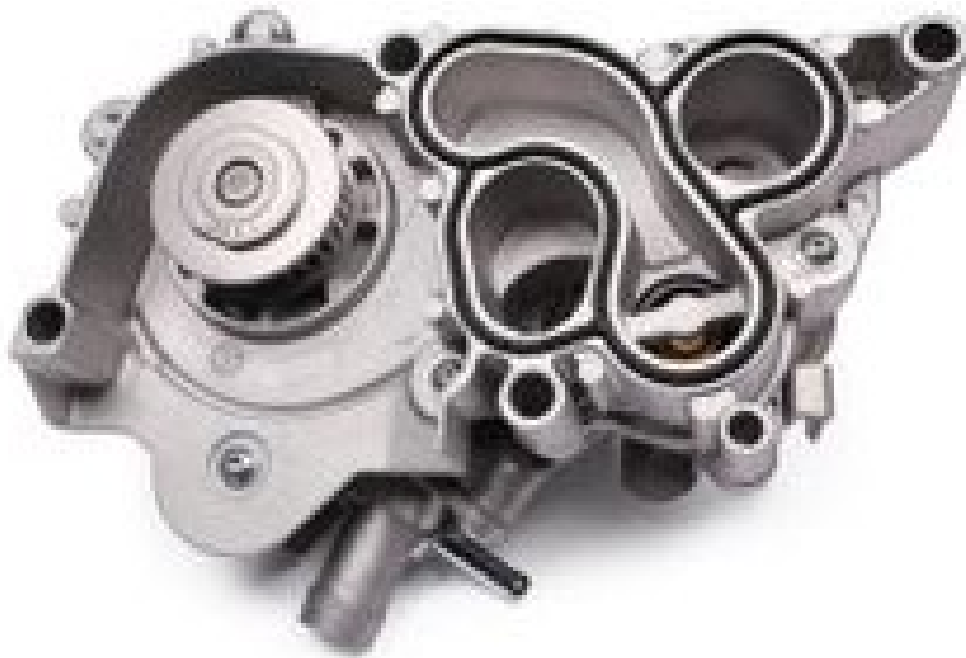
Loss of coolant

If a loss of coolant is detected in the vehicles mentioned above, the cooling system should be pressurised in accordance with the vehicle manufacturer's specifications and all components checked for damage/leakages. Paying particular attention to the coolant pump is advisable. Often the cause of coolant loss is a defective seal. To eliminate the problem, the seal and, if necessary, the entire coolant pump must be replaced. The cooling system must then be refilled and vented in accordance with the manufacturer's specifications. Ensure that the correct coolant additive is used and the correct mixing ratio is observed.
