VW Golf V - Poor engine starting performance | HELLA

Golf V

1.9D TDI PD

Engine code: BKC

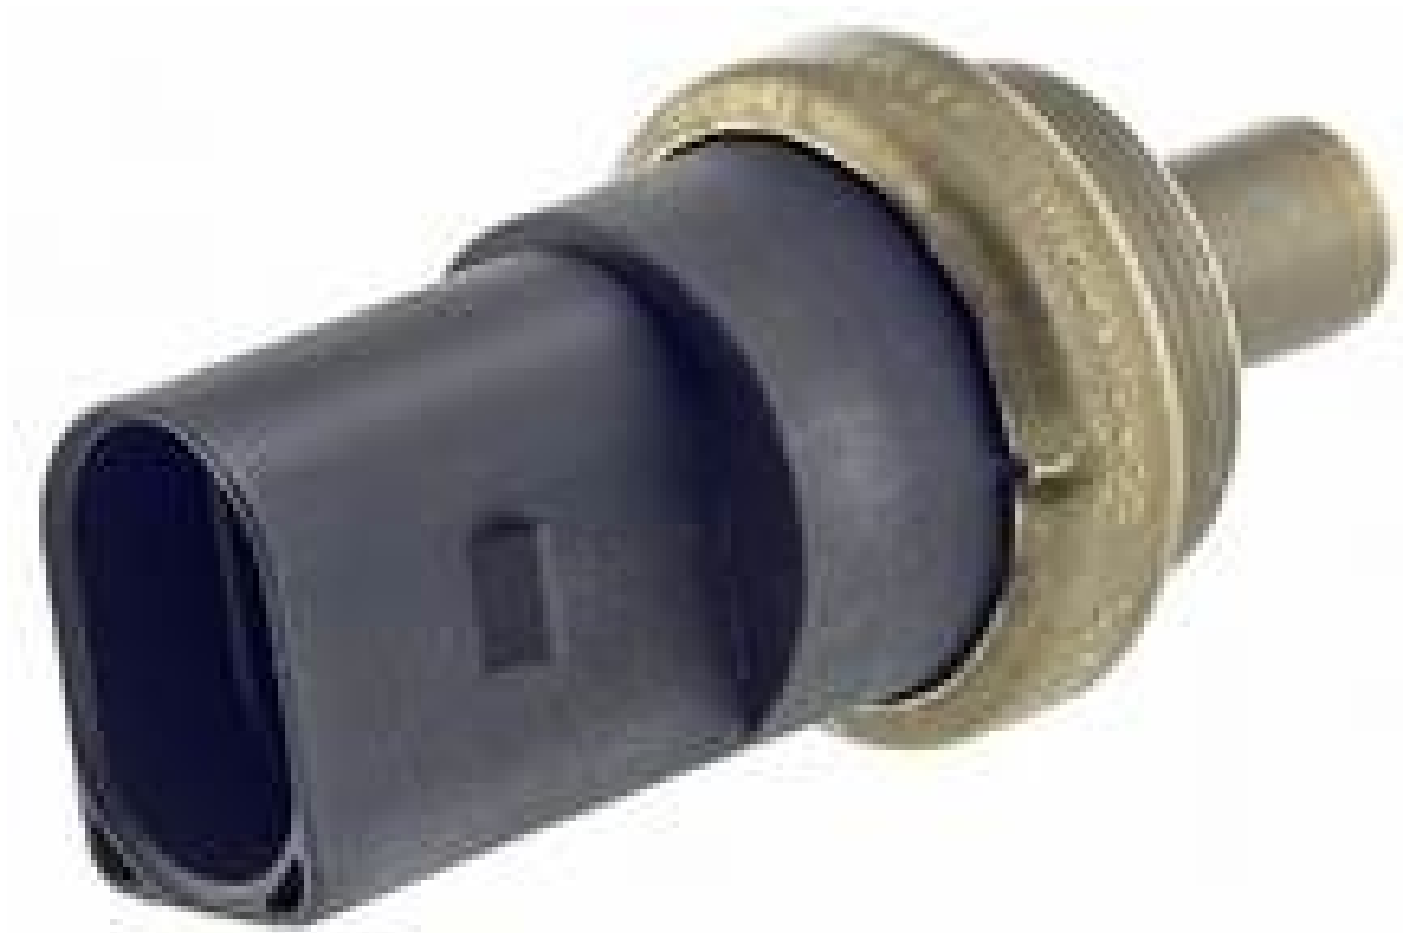
Figure 1.

Poor engine starting performance.

Engine is operating in emergency mode.

If the fault pattern listed above is reported, the cause may be a defective coolant temperature sensor. In addition, error codes (triggered by implausible sensor values) may be stored in the engine control unit.

In addition, with the potentially misleading turbocharger pressure error code (P1556), excessive engine knocking while idling could be indicative of a faulty sensor.

- Check that coolant temperature sensor is functioning properly. As guidelines, the specified resistance value should be $\approx 2080 \Omega$ at 25°C and $\approx 289 \Omega$ at 85°C respectively.

Replace the sensor if necessary (see Figure 1.).

Hella coolant temperature sensor: 6PT009309-331
