# VW Sharan (7M6 / 7M9) - Engine warning light illuminates | HELLA

Sharan (7M6 / 7M9)

Engine: AUY 1.9 TDI

## Engine warning light illuminates

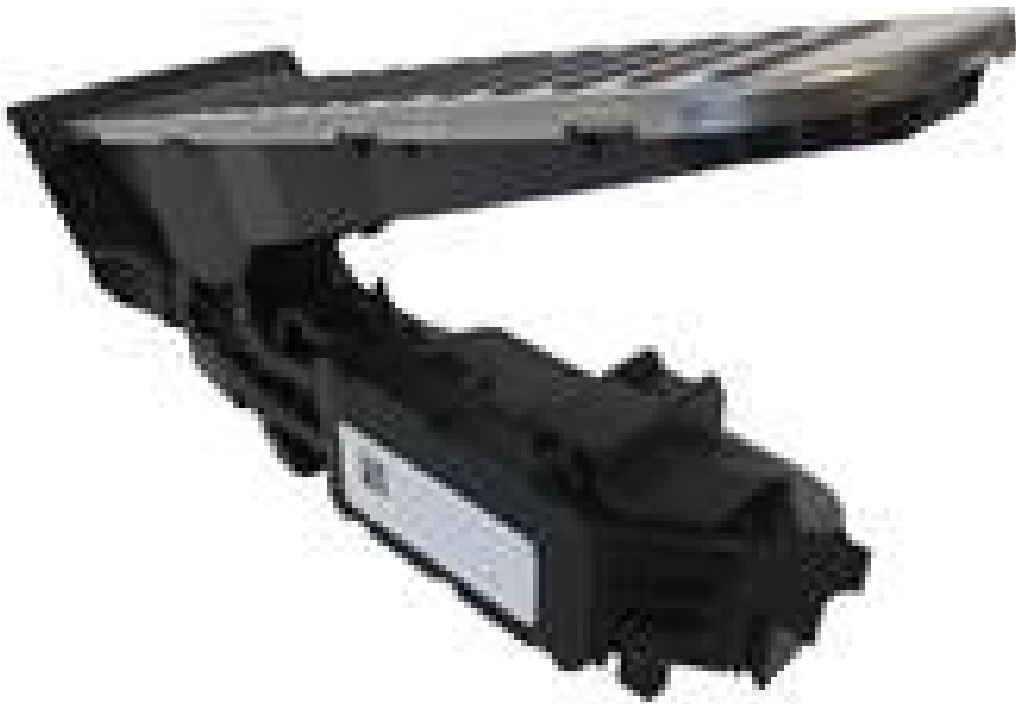
Figure 1

The error codes listed above all refer to an issue in the area of the accelerator pedal sensor (figure 1).

- Check that the accelerator pedal sensor is functioning correctly

(carry out a noise or potentiometer test using an oscilloscope) and replace if necessary.

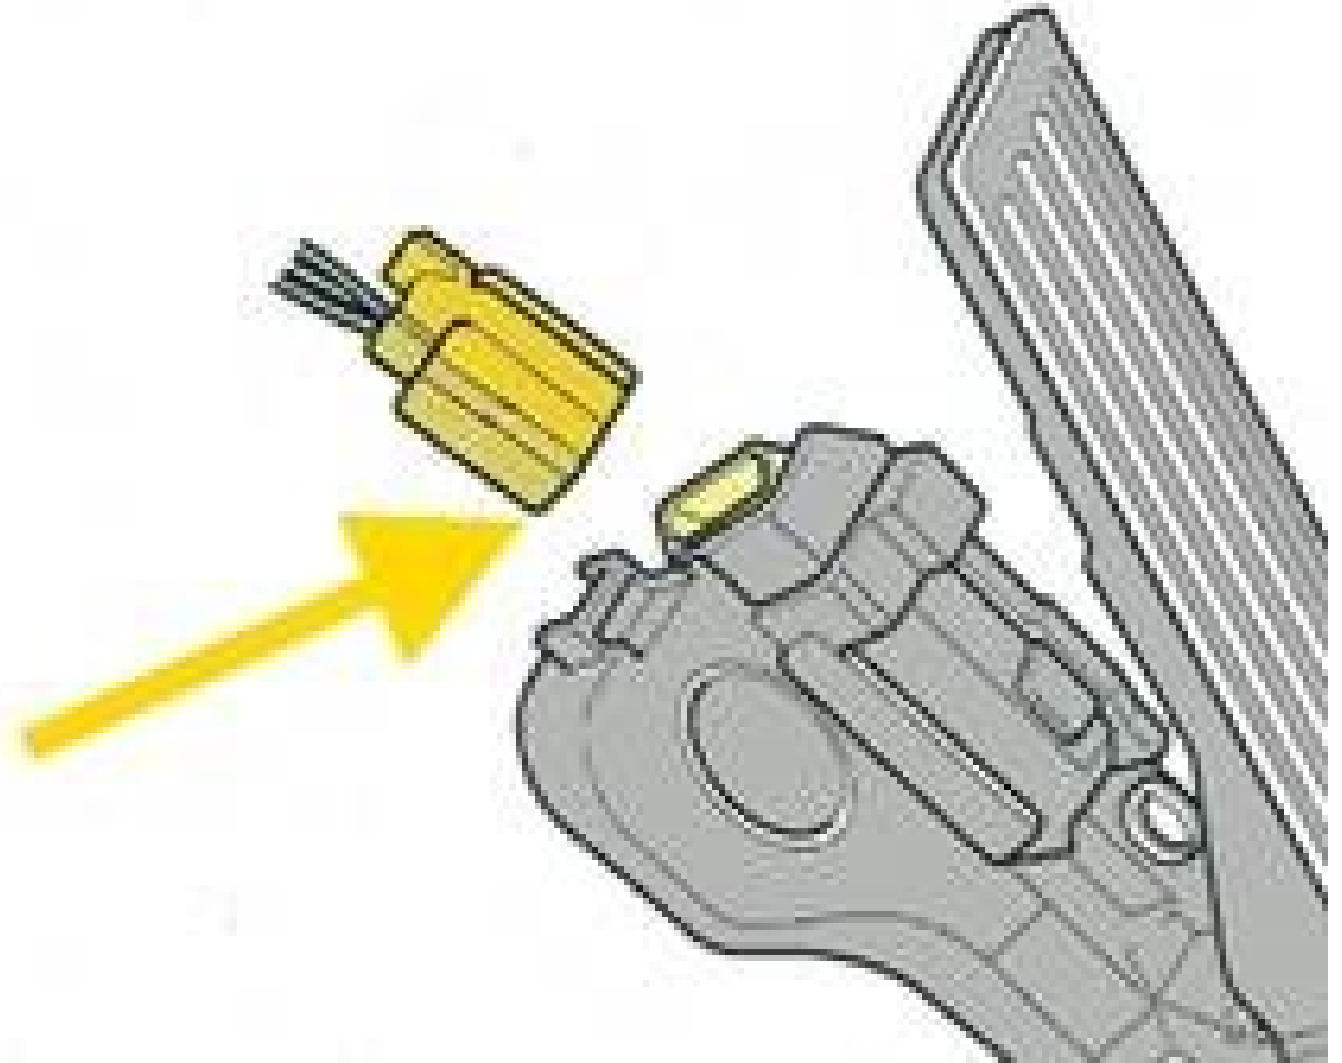
Figure 2

In this case, insufficient contact in the connection between the accelerator pedal sensor and the connector (figure 2) is responsible for the above-mentioned problem.

- Check the plug-type connection for damaged or corroded connector pins (figure 2, figure 3) and replace if necessary
