VW Touran - fault code 148C/148B and water ingress in the A-pillar area

Data sheet	
Manufacturer	Volkswagen
Vehicle model	Touran with panoramic sunroof
Engine	2.0 TDI
Year of manufacture	2016
Symptoms	Engine control light comes on; water ingress in the area of the A-pillar
Error code	148C / 148B
Recommended HGS tool	mega macs X

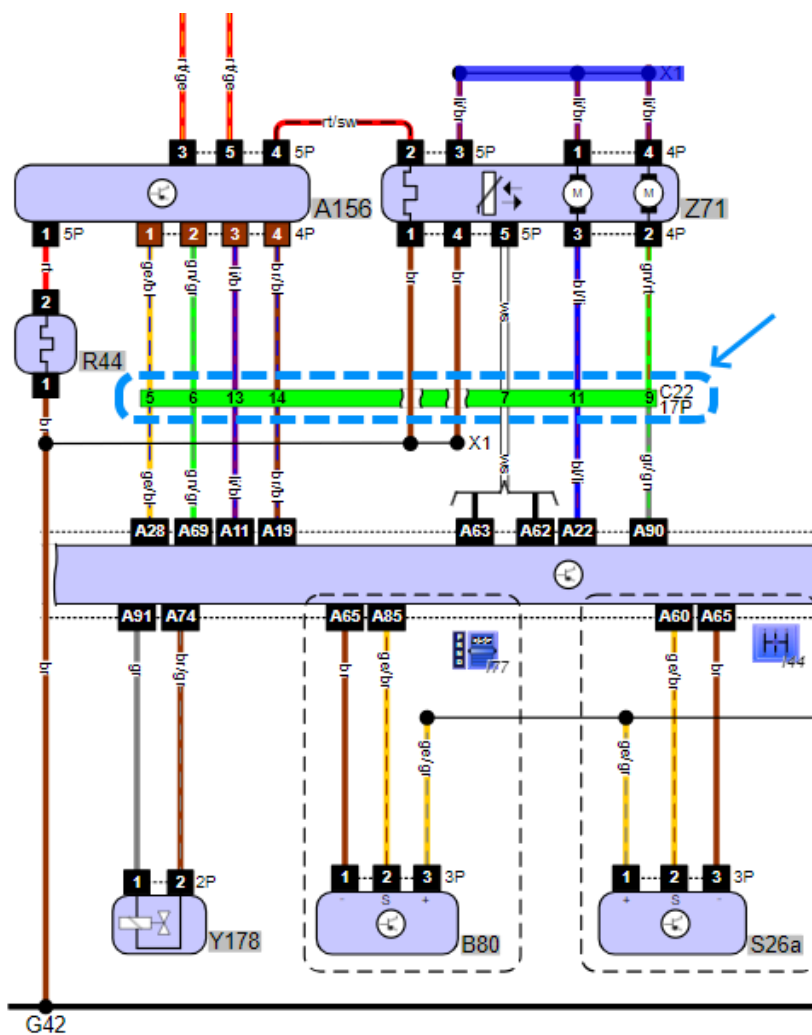
The engine control light in the above vehicle type may illuminate although there is no noticeable loss of power. If the above fault occurs and fault codes 148B and 148C (faulty auxiliary heating output stage) are stored in the fault memory, the connecting plugs in the footwell should be checked. They connect the electrical cables of the auxiliary heating, among other things, and are located behind the footwell panelling of the A-pillar on the driver's or passenger's side, depending on the equipment variant.

If moisture or corrosion is detected on the pins of these plug connections, special attention should be paid to the water drains of the panoramic sunroof.

These can become clogged with dirt. The water builds up, flows over the roof cassette into the passenger compartment of the vehicle and enters the plug connections, among other things. To

check this, open the glass roof and pour water directly into the drains. If water builds up in the sunroof cassette and does not drain away immediately, the drains should be cleaned. This can be done, for example, with a cleaning brush that is specially designed for cleaning the water drains.

Once the sunroof drains have been completely cleaned, the damaged pins of the plug connections should also be repaired in order to re-establish a perfect electrical connection.

Once the cause of the fault has been rectified, delete the error memory then carry out a test drive.
