VW Transporter T6 - coolant loss

Data sheet

Manufacturer	Volkswagen
Vehicle model	Transporter T6
Engine	2.0 TDI
Year of manufacture	2015 - 2019
Symptoms	Loss of coolant

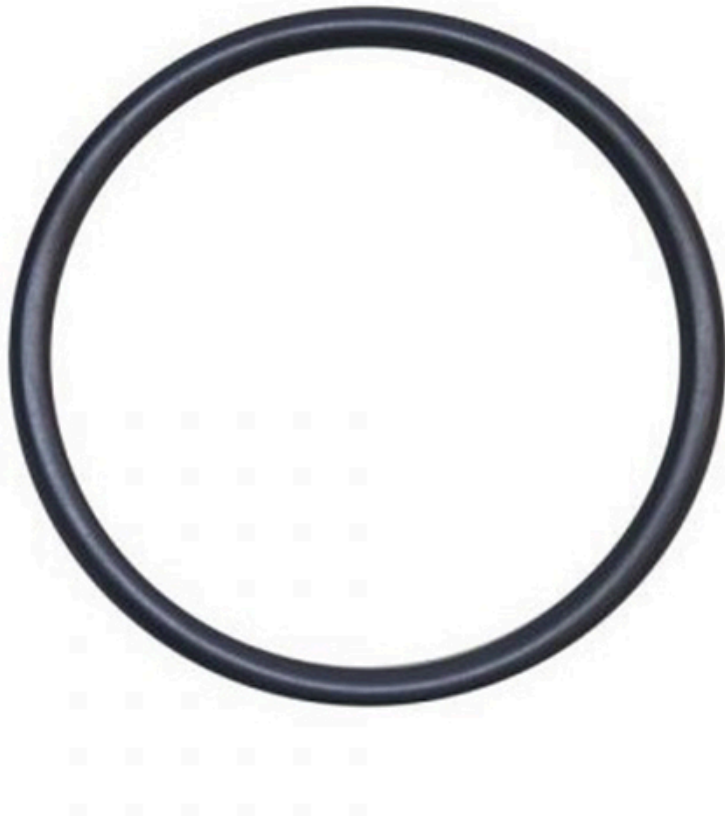
When identifying the leak, pay special attention to the thermostat housing. Coolant loss here may be caused by a faulty O-ring. When replacing the O-ring, make sure that the contact surfaces on the thermostat housing and engine block are sufficiently cleaned.

Simultaneously also replace the thermostat when replacing the O-ring (06B121119B)
