VW Transporter T6 - coolant loss

Data sheet	
Manufacturer	Volkswagen
Vehicle model	Transporter T6
Engine	2.0 TDI
Year of manufacture	2015 - 2019
Symptoms	Loss of coolant

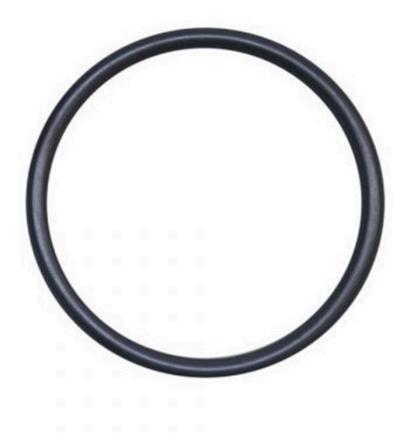
When identifying the leak, pay special attention to the thermostat housing. Coolant loss here may be caused by a faulty O-ring. When replacing the O-ring, make sure that the contact surfaces on the thermostat housing and engine block are sufficiently cleaned.

Simultaneously also replace the thermostat when replacing the O-ring (06B1211119B)
