VW Up / Seat Mii / Skoda Citigo - poor engine performance

Data sheet	
Manufacturer	VW Seat Skoda
Vehicle model	Up Mii Citigo
Engine	1.0 MPI
Engine code	CHYA
Year of manufacture	2011 - 2016
Symptoms	Engine performance poor
Error codes	P0010 P0016 P0088 P0341

Poor engine performance: Error codes P0010, P0016, P0088, P0341 stored in the control unit

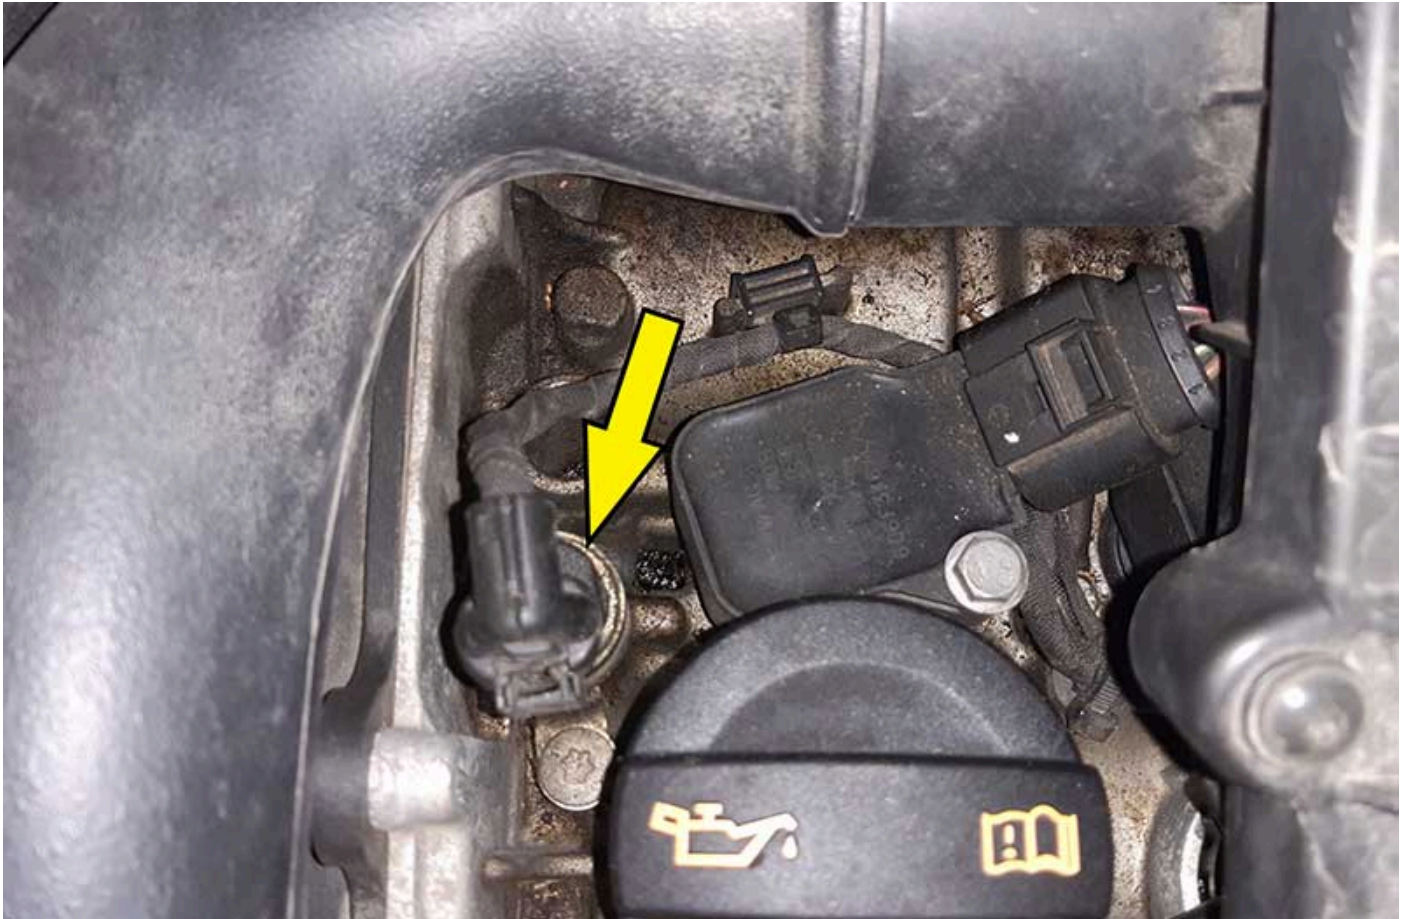
In addition to the classic sources of faults when it comes to the timing belt drive, particular attention should be paid to the oil pressure valve of the variable camshaft control (see picture). Blockages or coking of the oil bores can lead to the above-mentioned symptoms. These usually contribute to faulty camshaft adjustment.

In order to remedy this, the oil pressure valve of the camshaft control can be cleaned. In some cases, an immediate replacement is the best option. It is advisable to also inspect the area of the oil bore in the cylinder head and to check for contamination.

With the help of a diagnostic device (e.g. Hella Gutmann mega macs X), the error memory should then be deleted. Finally, a test drive has to be carried out.
