# Audi A6 - Interior blower not working | HELLA

**A6 (4F2/C6)**

**Interior blower not working**

**Error in data bus communication**

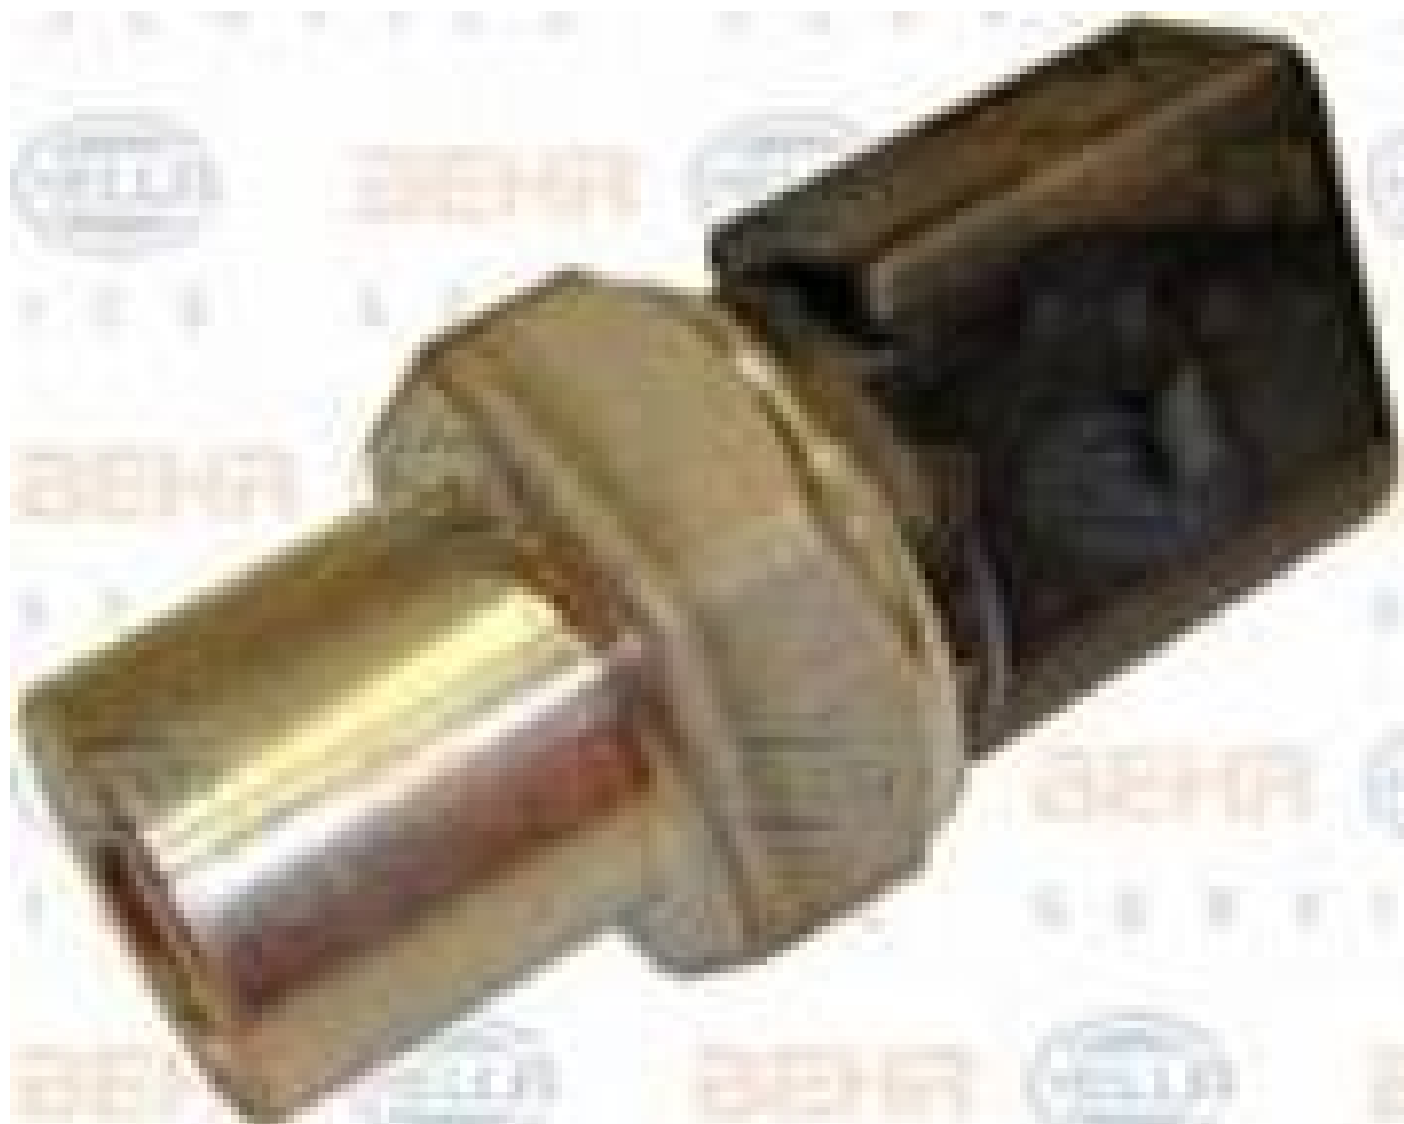
If the interior blower fails on the vehicles mentioned above, the cause may be a faulty pressure sensor in the air-conditioning system.

The blower output stage and the pressure sensor (see figure) use a shared signal line to communicate with the control units (Climatronic). If the sensor fails, communication is disrupted and the blower is no longer activated. The error code 2071 is then stored in the error memory.

If the blower fails, diagnostics should be carried out as follows:

- Check fuses
- Read out the error memory
- Check the parameter for the pressure sensor via the measured value blocks (the parameter should be around 5 bar when the air-conditioning system is filled and switched off)
- Check the control of the sensor and fan as necessary
