BMW E60 - Headlamp fogging | HELLA

Headlamp fogging

Water enters the headlamp

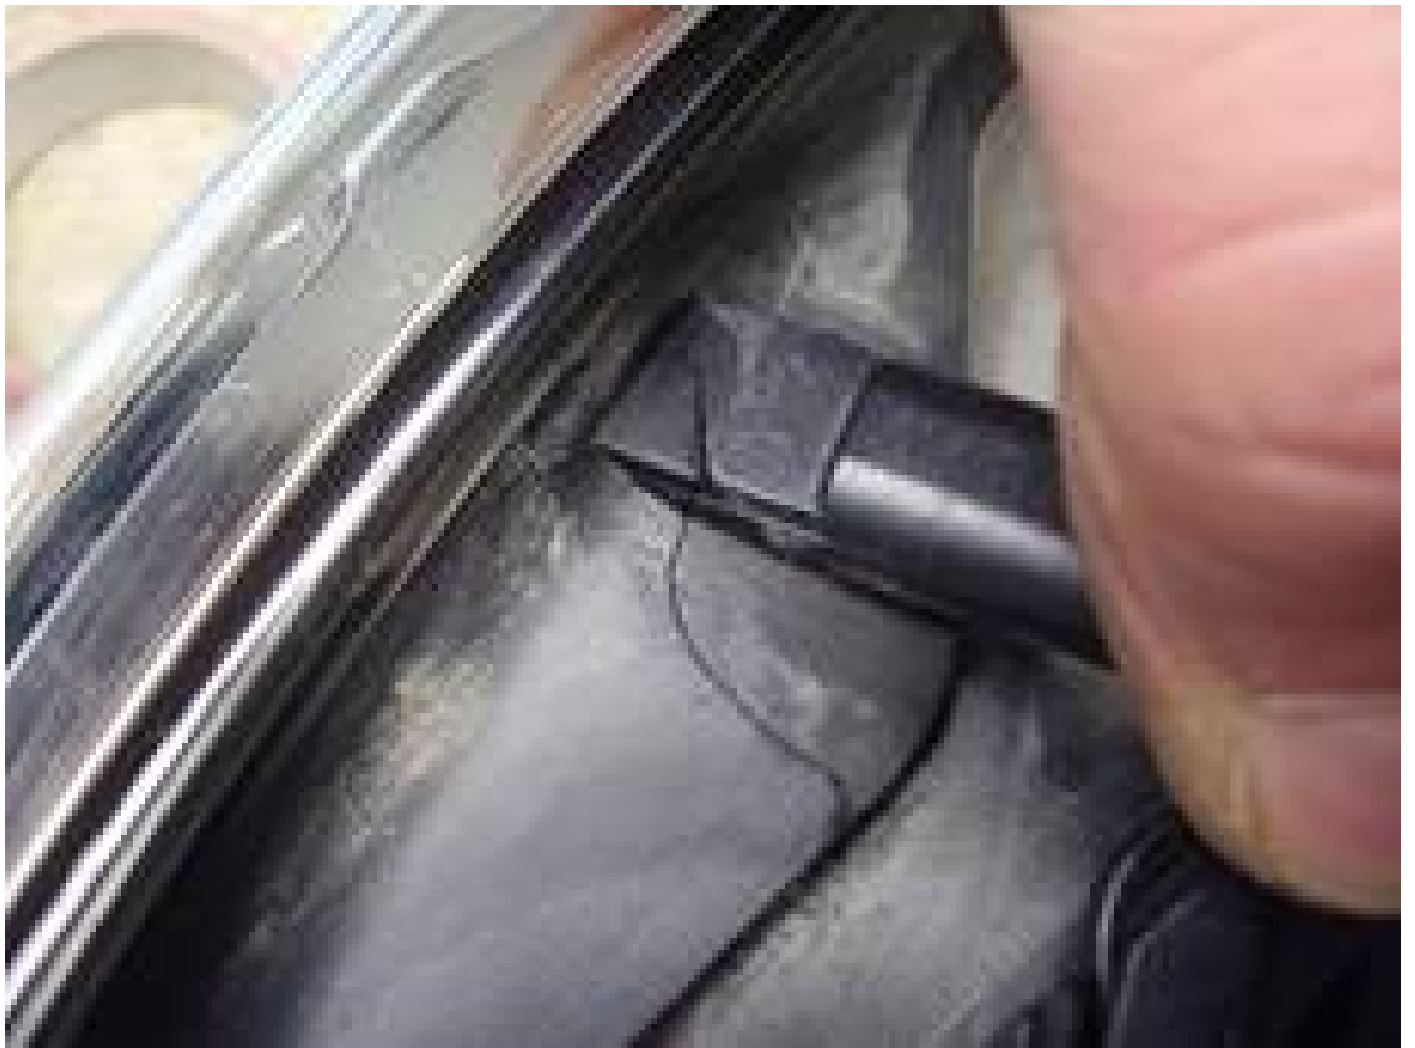
Figure 1

If heavy fogging or, in some cases, increased water ingress is observed inside the headlamp, this may be caused by a crack in the housing of the SML (side marker lamp) (Fig. 1).

The housing of the SML is damaged.

Cracks may have formed by adverse mechanical stress, for example, if pressure forces occur in this area due to objects or tools: (closing the bonnet without removing tools / objects before).

- Incorrect adjustment of the bonnet.
