## Citroen Berlingo - Failure of the low beam | HELLA

**Berlingo**

Failure of the low beam

**Model years 2002-2008**

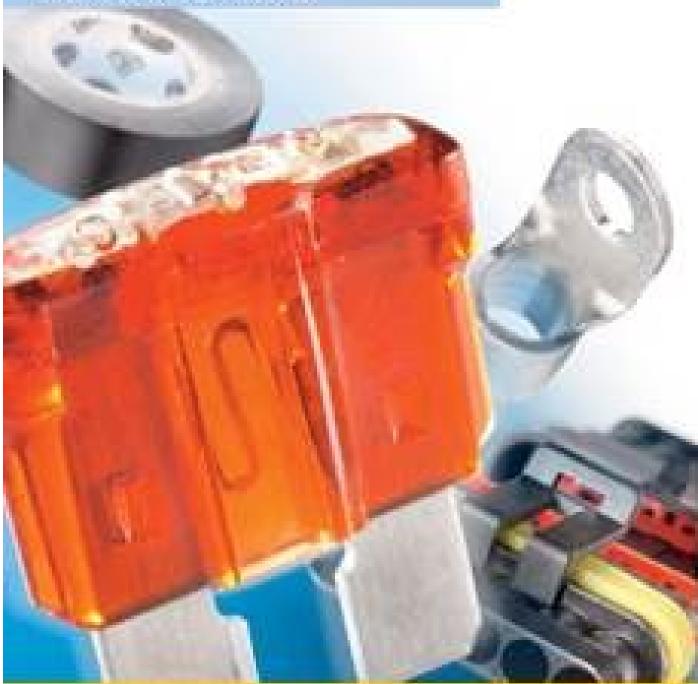
If a customer complains about the above problem, this could be caused by a frayed cable harness. Additionally there may be electrical failures/malfunctions. The cable harness runs from the fuse box in the engine compartment (front left) through a passage opening in the wheel arch to the headlamps. Since the cable is not protected at this opening, it may become frayed here due to vibration. This then leads to the above-mentioned problems. In this case, the damaged areas on the cable must be repaired. Then protect the cable harness in the area of the passage hole with a corrugated pipe in order to avoid repeated chafing. Below is a summary of corrugated pipes. For details on installation material, refer to Hella Bulletin with order .

4.4 Corrugated pipes	Mominal ID	hmer dismeter	Outer dismeter	Material	Contents (pcs)	Park number	VPE (pcs)
Slotted corrugates pipes	7,5	6,7	10	PP	50	▶ 8JR 177 882-002	50
	10	9,9	13	PP	50	▶ 8JR 177 882-012	50
	13	12,7	15,8	PP	50	▶ 8JR 177 882-022	50
	17	16,6	21,2	PP	50	▶ 8JR 177 882-032	50
	22	21,3	25,4	PP	50	▶ 8JR 177 882-042	50
	26	25,8	31,2	PP	50	▶ 8JR 177 882-052	50
	37	36	42,4	PP	25	▶ 8JR 177 882-062	25
