Citroen C3 Pluriel (HB) - Water entering rear combination lamp | HELLA

Water entering rear combination lamp

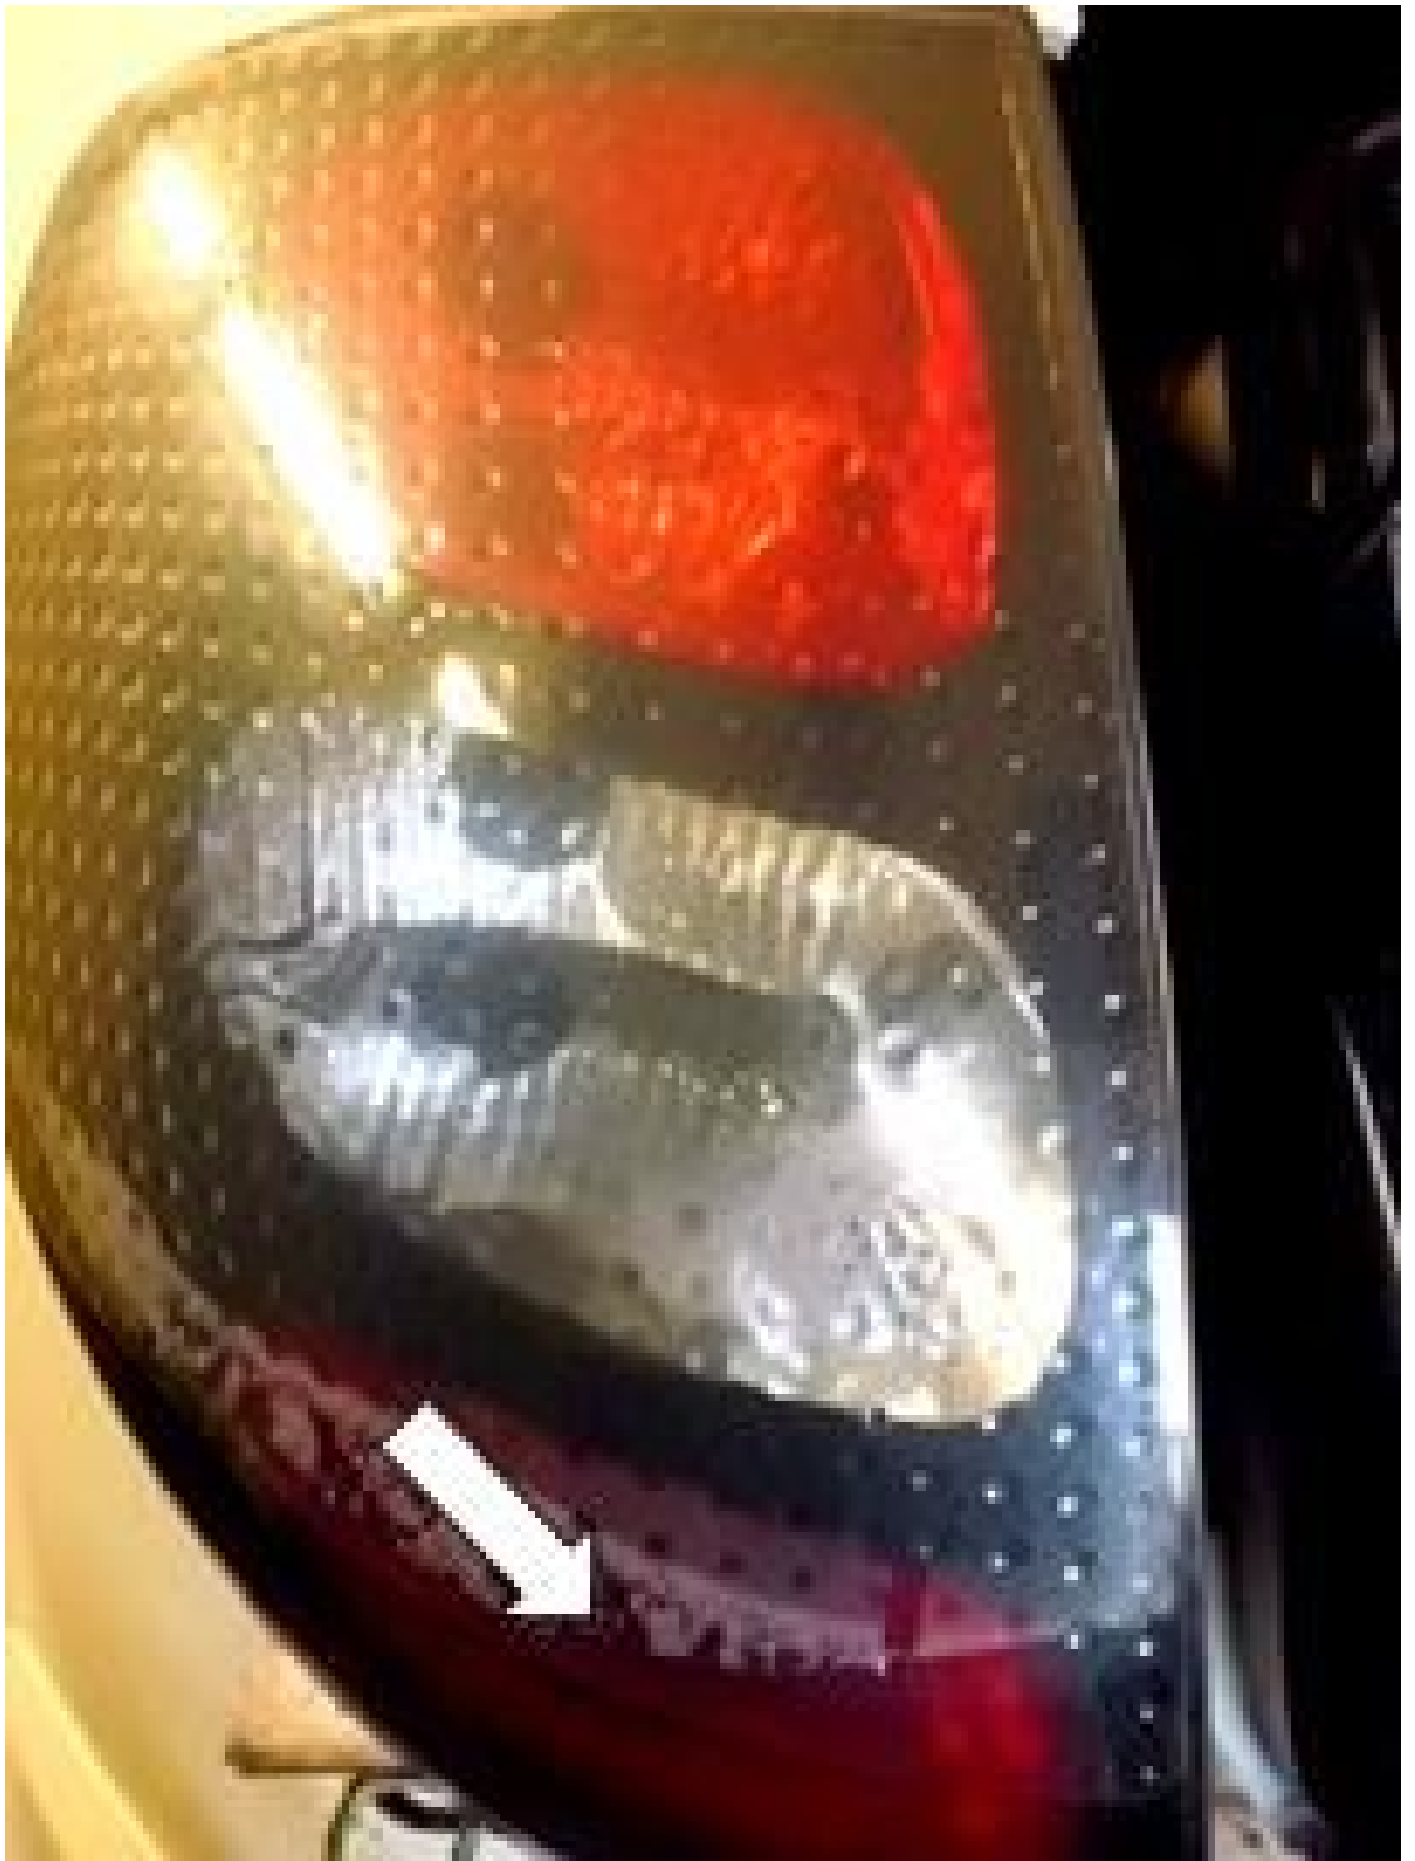
On the vehicles mentioned above, there is a risk of the rear combination lamp functions failing due to water ingress (Figure 1).

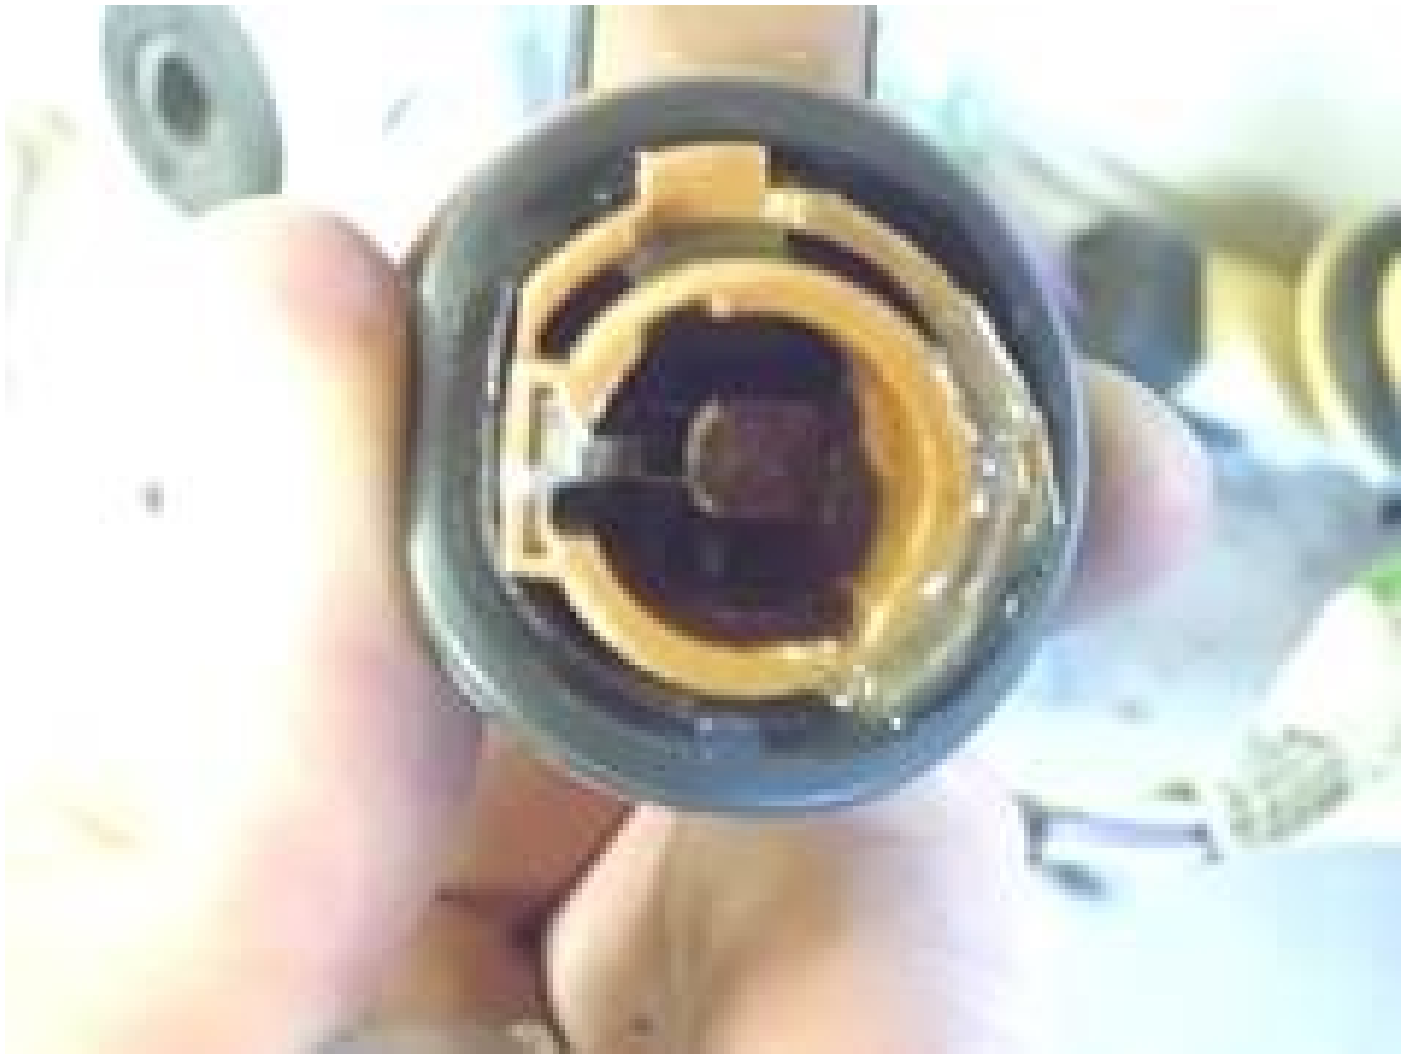
Figure 4

Then unclip the lamp at the side (Figure 3), remove and unscrew the bulb holders. Look out for contamination and corrosion (Figure 4).
