Citroen Dispatch / Jumpy - Illumination of the engine control light and sporadic problems on engine start | HELLA

Citroen

Dispatch / Jumpy

Models I/II from 20 March 2006

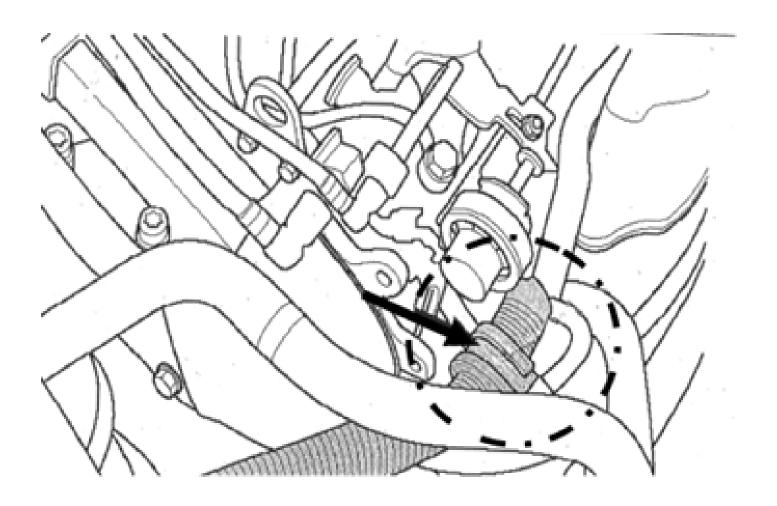
On the above mentioned vehicles sporadic problems may occur on engine start or the engine may die. In addition the engine control light may illuminate. This problem may be caused by a damaged wiring harness above the power steering pump (see figure). The fault on the wiring harness may be caused by "chaffing" on the cable harness guide. To rectify this problem, the wiring harness should be checked. Repair / renew damaged areas and fasten correctly (incl. protector).
