# Jaguar XF, XJ, XK - Insufficient cooling | HELLA

## Insufficient cooling from air-conditioning system

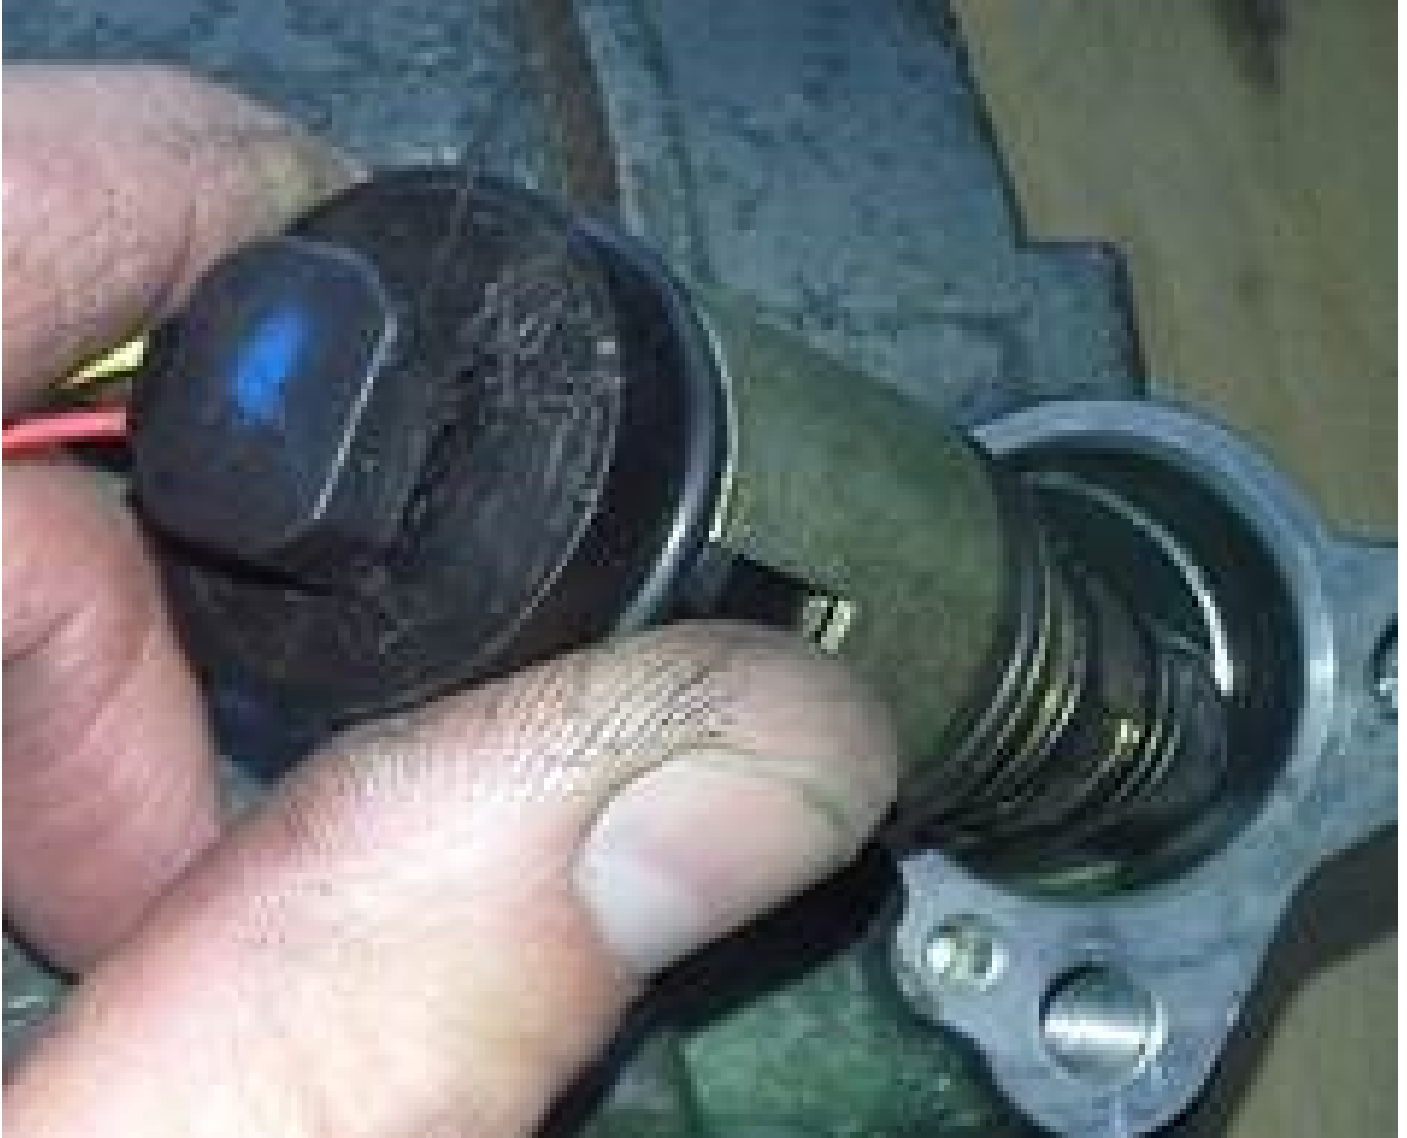
If the customer complains that the cooling power of the air-conditioning system in one of the aforementioned vehicles is insufficient, this may be due to a faulty pressure control valve in the compressor.

A faulty pressure control valve can often be identified by unusual high and low pressure: high pressure too low; low pressure too high.

The figure shows an example of an electronically actuated pressure control valve

To replace the compressor pressure control valve, proceed as follows:

- Drain off refrigerant
- Remove compressor (usually required)
- Clean area around control valve
- Remove circlip from valve
- Carefully remove control valve
- Check the area of the compressor into which the new valve is going to be inserted for damage and soiling
- Moisten the seal rings on the new valve with compressor oil, and insert the new control valve
- Fit circlip

- Fit compressor
- Carry out leak test
- Fill air-conditioning system and perform a functional test
