## Mazda CX5 - error code P0471 and poor starting and acceleration behaviour

Data sheet	
Manufacturer	Mazda
Vehicle model	CX5 GH/KE with automatic transmission
Engine	2.2 16V CDI Skyactiv-D
Engine code	SH-Y4
Year of manufacture	2013-2017
Symptoms	Poor starting and acceleration behaviour Vehicle goes into emergency mode Error code: P0471

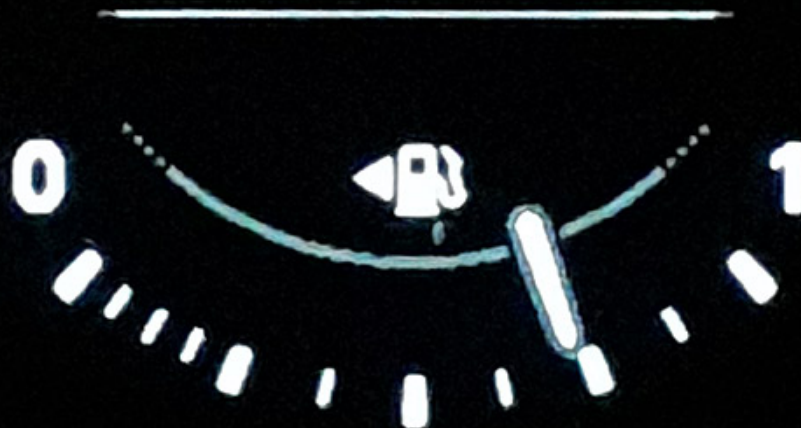
## Warning on the instrument cluster

If the error message "SCBS / City emergency stop assistant forward gear malfunction" is displayed on the instrument cluster on the vehicle models mentioned above, one cause for this may be a defective boost pressure sensor. The faulty signal can cause error entries in different control units. In addition, the warning lamps for tyre pressure control, parking brake, I-Stop system and ABS may light up simultaneously. The error can be reset briefly by switching the ignition off and on, but usually reappears after a short driving time.

**SCBS  
Vorwärtsgang  
Fehlfunktion**

- P0471 Exhaust pressure sensor 1 (boost pressure sensor) – function faulty  
<shy /> Repair advice<shy /> Continuing to drive with this defect can damage the engine. In addition, the deficiency causes hard shifting behaviour in vehicles with automatic transmission.<shy /> The vehicle manufacturer replaced the exhaust pressure sensor with a new modified component.<shy /> Within the scope of the repair, it must therefore be ensured that the old defective sensor is replaced by a new modified sensor (repair kit).<shy /> After the repair, the relevant error memory entries in the relevant control units must be deleted.<shy />
