Mazda CX5 (KE) - Fault code P0299 boost pressure too low

Data sheet	
Manufacturer	Mazda
Vehicle model	CX5 (KE)
Engine	2.2 CDI Skyactiv-D
Year of manufacture	2011 - 2017
Symptoms	P0299 - Boost pressure too low Poor acceleration behaviour Vehicle activates limp-home mode
Info	This defect may also occur in other models from this manufacturer with the same type of engine.

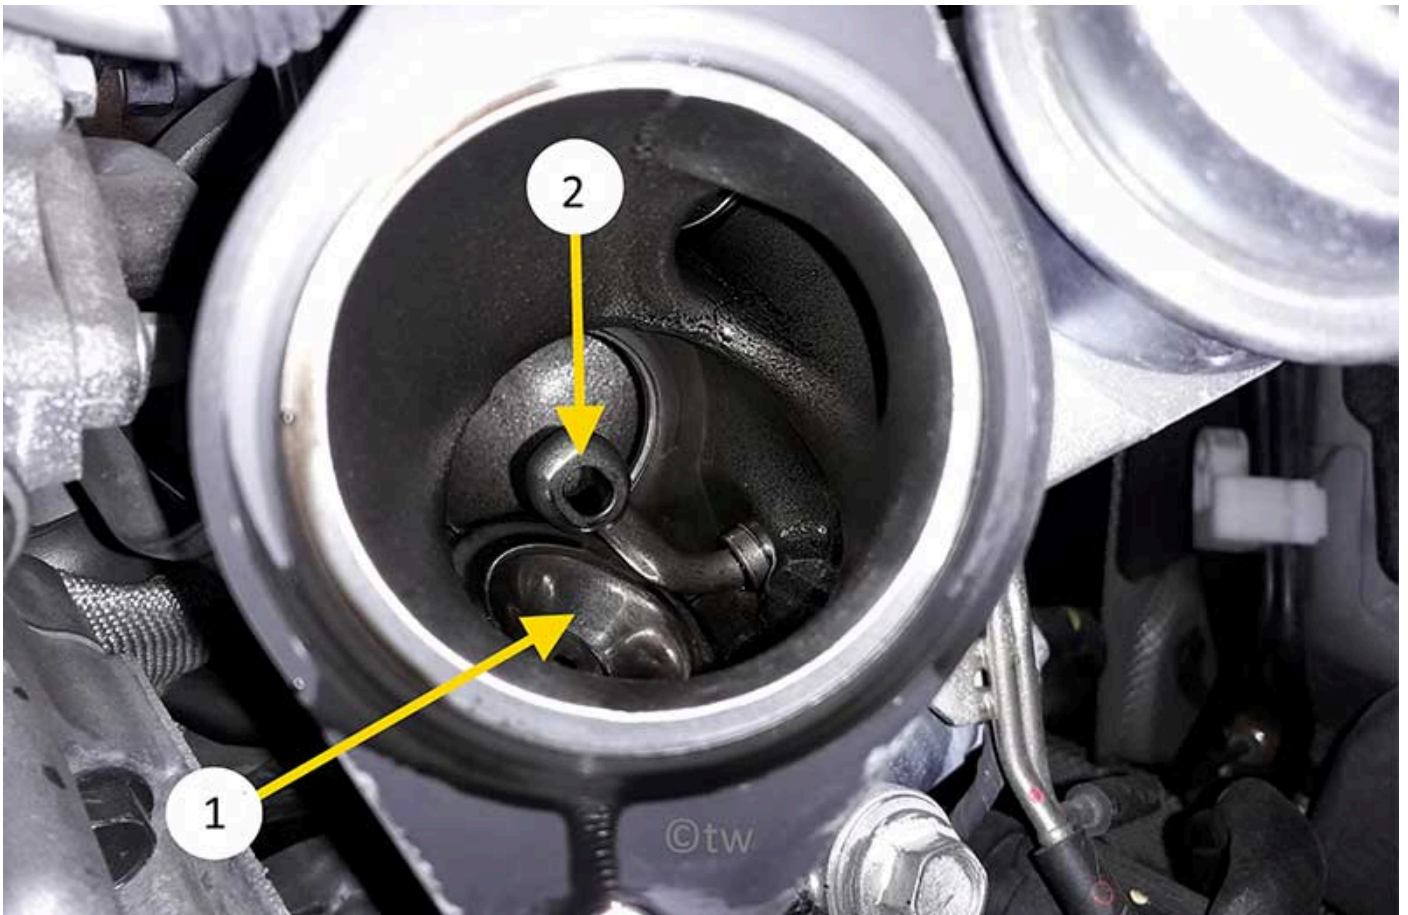
If the fault mentioned above is detected, it may also be related to a defective bypass flap on the small turbocharger. A mechanical defect ensures that the flap does not close properly and thus cannot build up sufficient boost pressure. In this case, the charge air hoses on the turbocharger should be removed and the flap control visually inspected. In our case study, the flap (1) had already completely detached from the lever (2). (Picture)

In a repair case, the complete turbocharger unit must be removed and replaced. The vehicle manufacturer does not offer the option of repairing the bypass flap's operating device.

Please follow the repair instructions from the vehicle manufacturer in this regard.
