Mercedes C-Class - ESP/ABS pilot lamp lights up | HELLA

Mercedes

C-Klasse (W 203)

ESP/ABS pilot lamp lights up

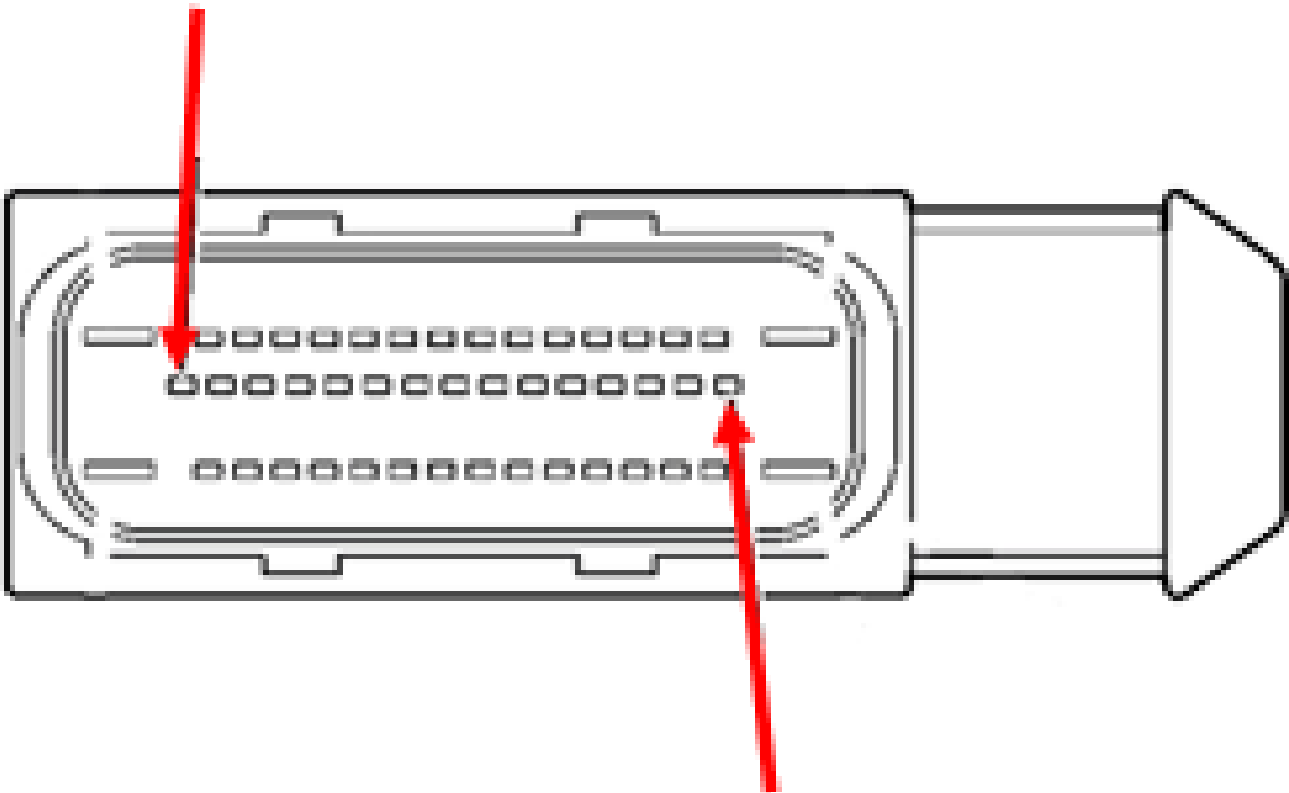
If a customer complains about the above error, this could be caused by a corroded plug connection. Error codes C1140 (steering wheel angle sensor, incorrect signal) and C1145 (ABS wheel speed sensor VR, interruption) may occur.

1. Check connector pins 18, 19 and 20 (all three on the brake pressure sensor) of the plug connection on the ABS/ESP control unit (see Fig.); clean and dry if necessary. The control unit is located in the left side of the engine compartment in the control unit box behind the spring dome.
2. If damage is already severe, use the repair kit to replace the pins.
3. Treat the plug connection with electronic spray or grease before contacting.
4. Check the wiring harness of the brake pressure sensor for continuity. Max. resistance is 0.5 Ohm.
