# Mercedes E-Class W211 - noise from the front suspension area

E-Class W211

Noise generation on uneven road surfaces

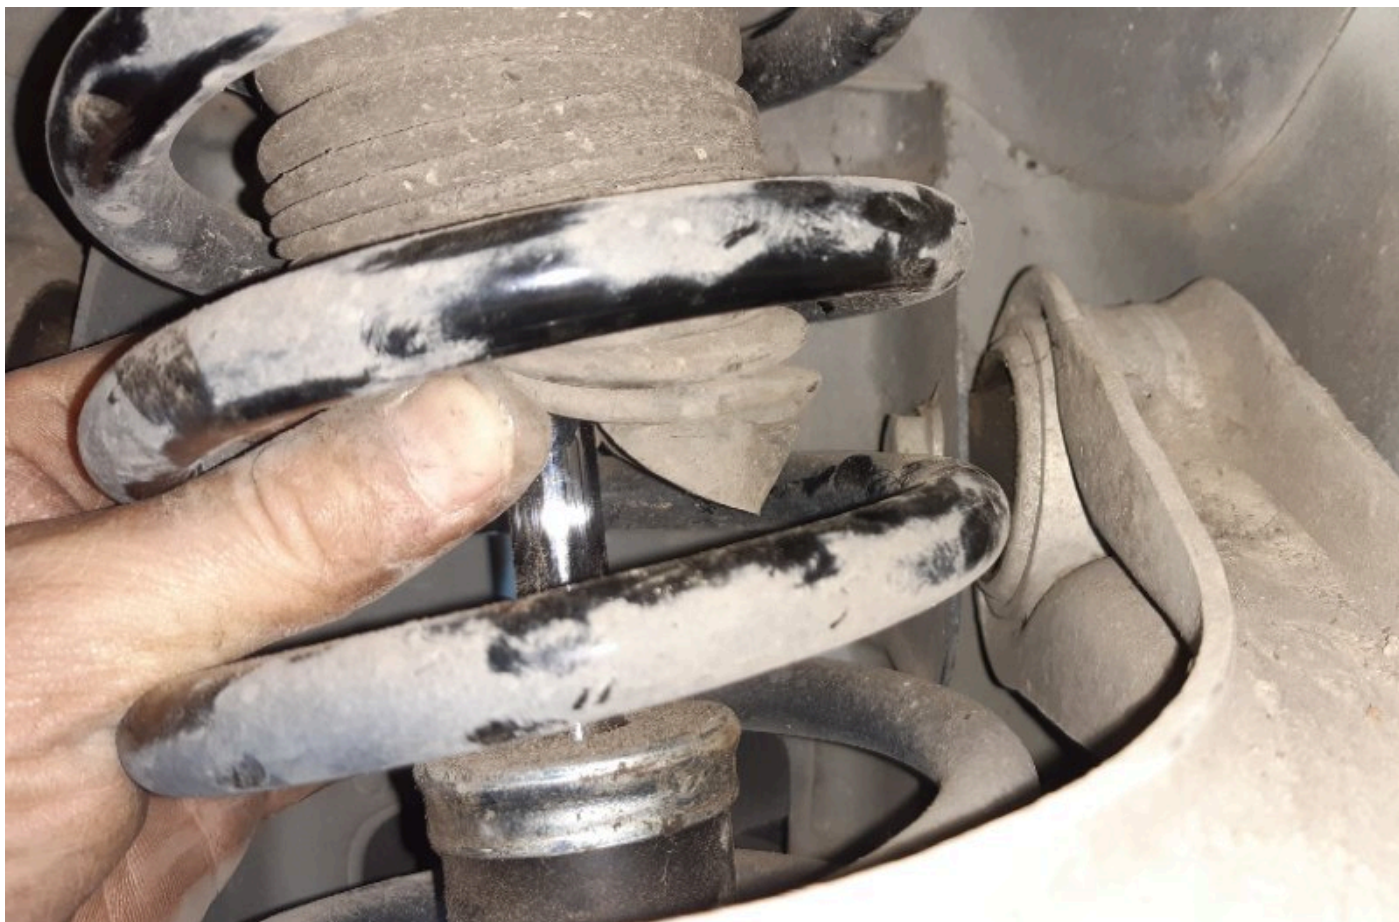
On the vehicles mentioned above, unspecific, squeaking or creaking noises can occur from the area of the front wheel suspension. These are particularly noticeable when driving on uneven road surfaces. Excessive friction between the shock absorber piston rod and the bump stop is a possible cause. This can be remedied as follows:

- Lift the shock absorber's dust boot so that the piston rod is visible
- Apply lubricant (A001989845110) to the piston rod
- Return the dust boot to its original position
- Carry out a test drive
