Mini F56 - signal horn not functioning

Data sheet	
Manufacturer	Mini
Vehicle model	F56 Cooper S
Engine	2.0 i
Year of manufacture	2013
Symptoms	Signal horn does not respond
Recommended tool	mega macs X

Malfunction of the signal horn caused by faulty connecting cables in the steering wheel

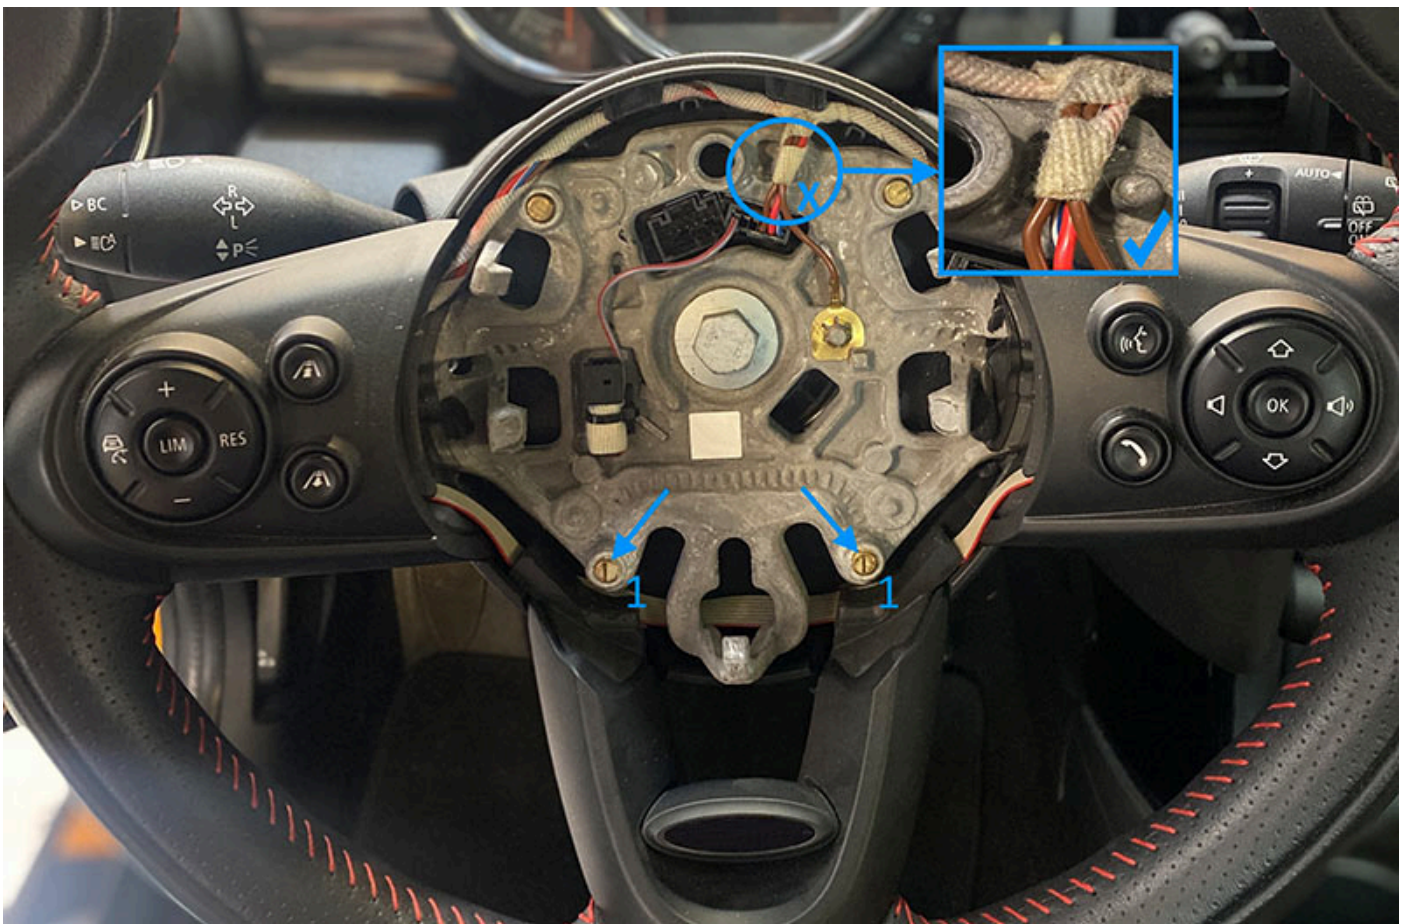
Incorrect routing of the connecting cables in the steering wheel or an unfavourable material pairing on the signal horn contacts between the steering wheel and the airbag unit may be responsible for this defect. Both problems can also occur simultaneously. An error memory entry that indicates a defect is not stored.

If the connecting cable is not laid correctly (see illustration), this has to be rectified. If the cable is visibly damaged, it must be replaced. If contamination is detected on the contact surfaces, a steering wheel with optimised contacts must be installed in accordance with the manufacturer's specifications. The problem has been identified by the vehicle manufacturer and rectified by means of a service solution using modified components.
