Mini F56 - water ingress in the vehicle interior

Data sheet	
Manufacturer	Mini
Vehicle model	F56
Engine	2.0i
Engine code	B48
Year of manufacture	2014
Symptoms	Water ingress in the footwell

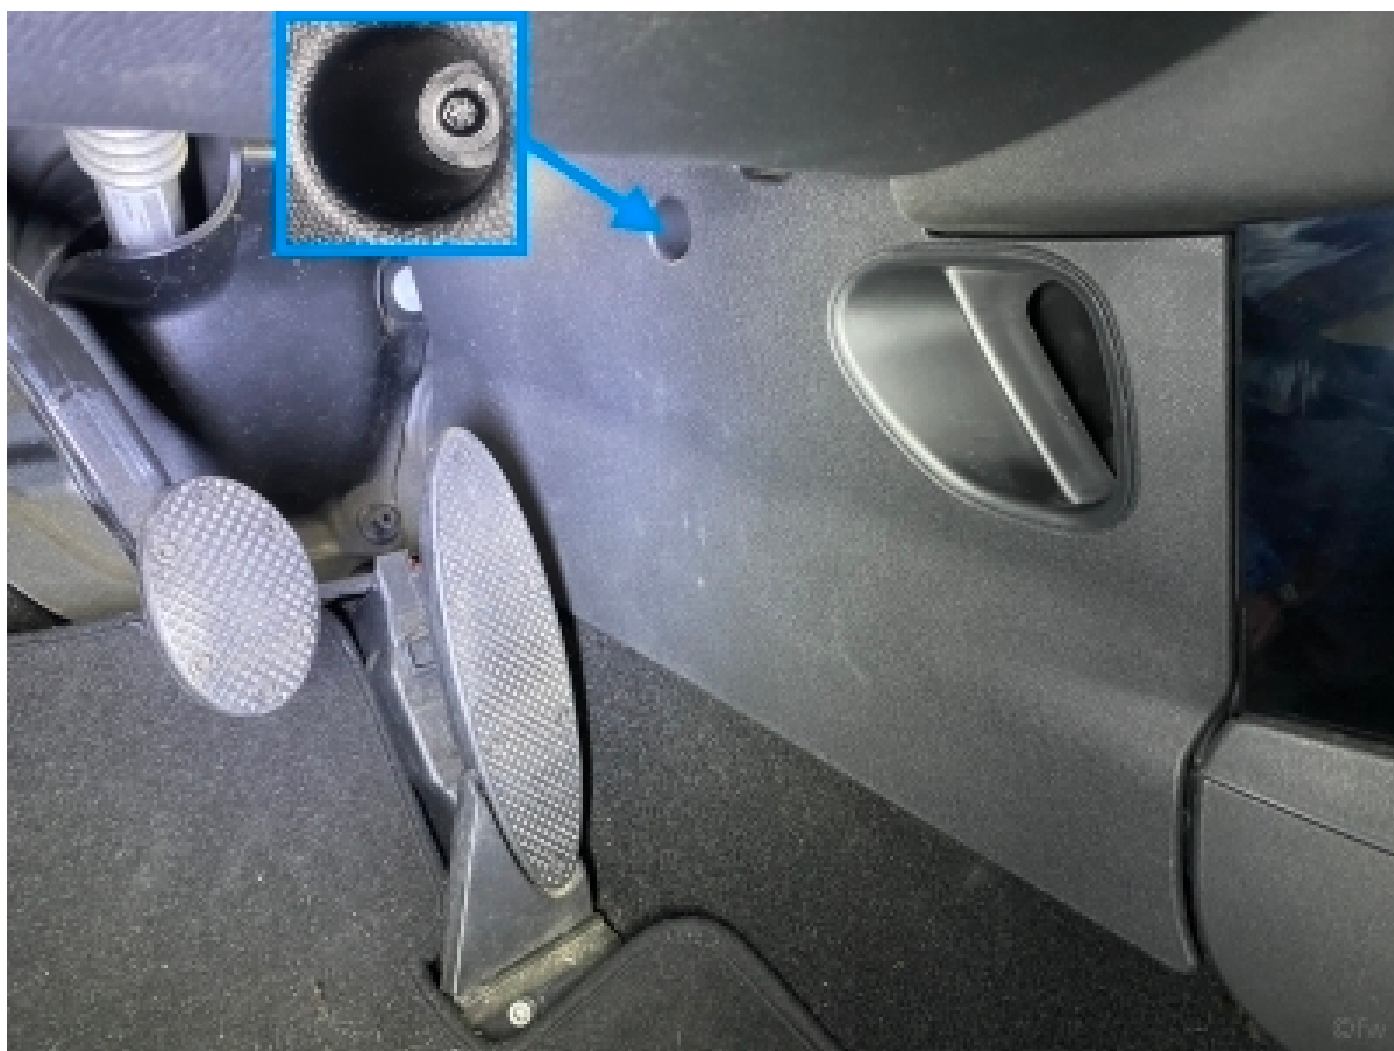
The side panelling (Fig. 1) in the footwell must be removed to carry out the necessary checks. In order to do this, the fastening screw has to be undone and the panelling removed from the brackets. The carpet can be pressed down slightly on the side underneath the air-conditioning unit in order to check it. The rubber seal of the water drain must fit all the way round the air-conditioning unit (Fig. 2) and have no kinks in it.

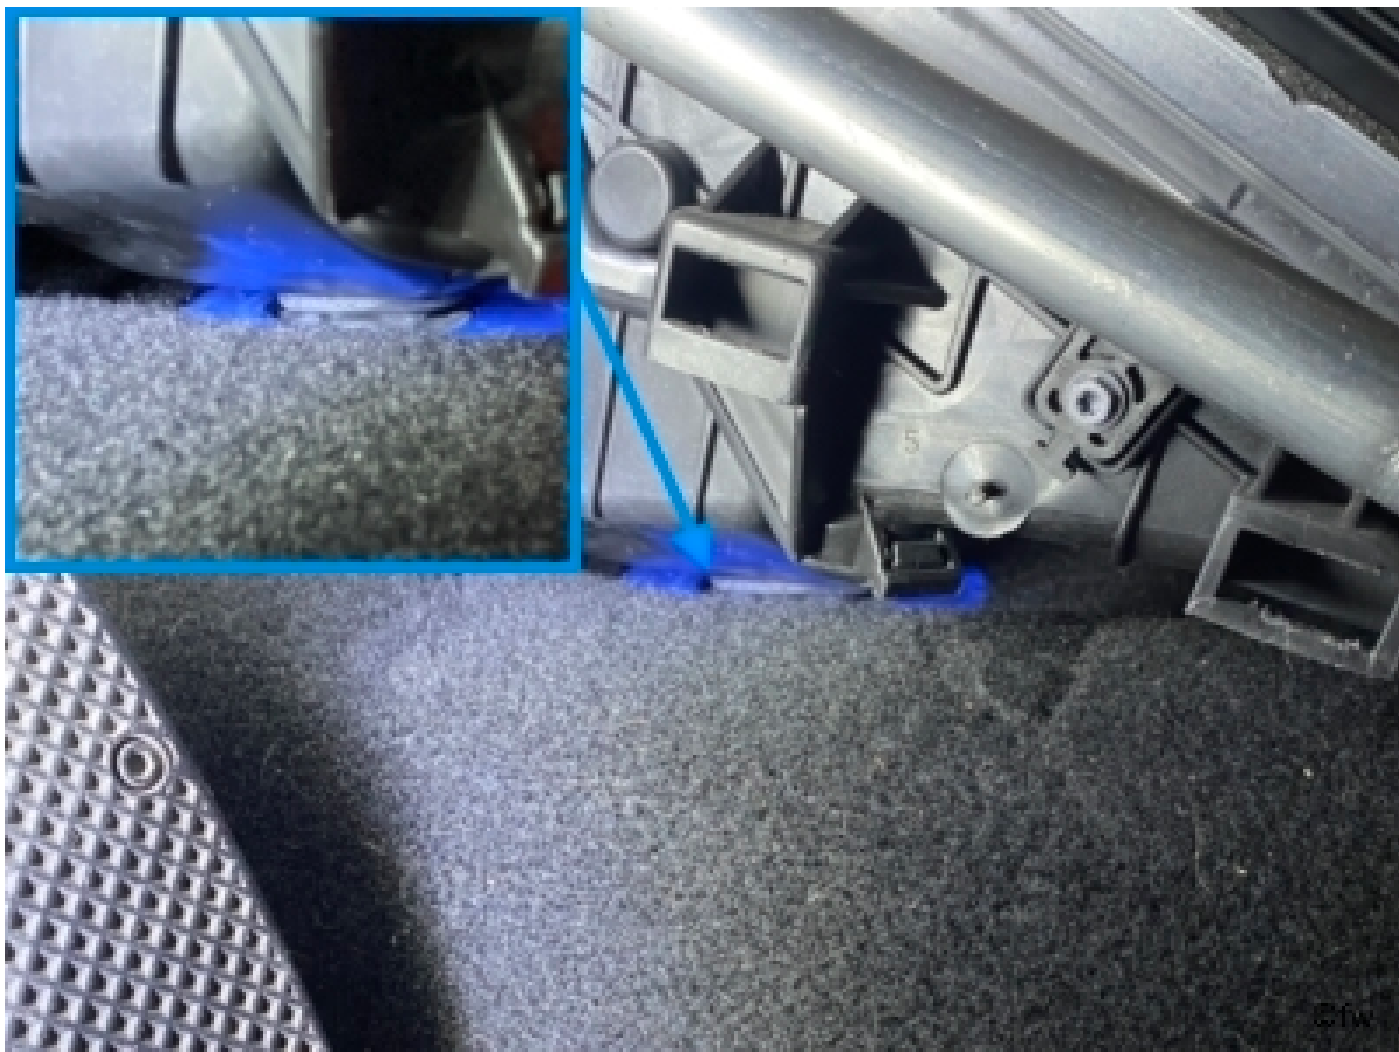
Deformation of the rubber seal means that condensation can no longer drain off properly. The water collects and is not drained off as intended, but enters the vehicle interior as a result of the deformed seal. The interior carpet absorbs the water, which can lead to unpleasant odours and, under certain circumstances, mould growth.

An endoscope is recommended for easier inspection. In the event of a fault, traces of water are usually visible on the side of the drain, indicating that the seal does not fit properly.

One test option is to set the air-conditioning system at maximum cooling capacity. In warm ambient temperatures, this causes condensation. In the event of a fault, this condensation would then run visibly past the seal and into the vehicle interior. If kinks or traces of water are visible, the condensation drain must be replaced. If mould is visible on the interior carpet, this should also be replaced.
