Nissan X-Trail (T31) - Leak from the fuel level sensor | HELLA

X-Trail (T31)

Engine: 2.5 i 16V

Leak from the fuel level sensor

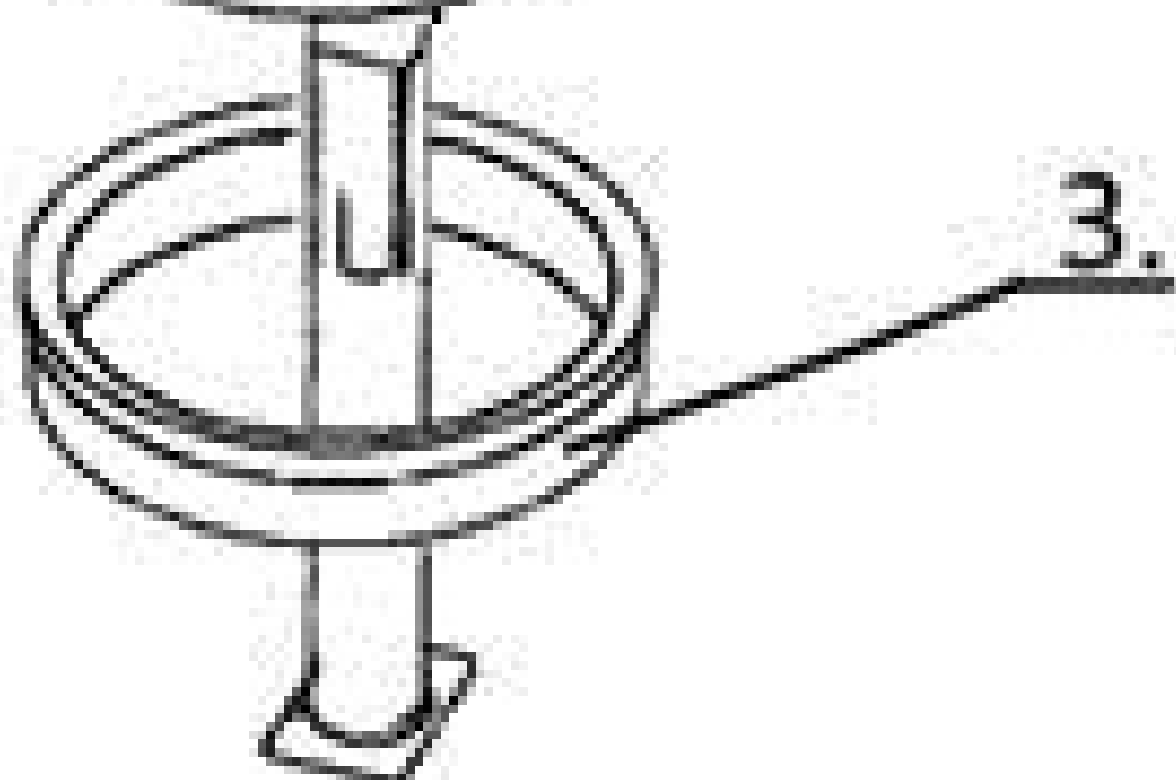
In most cases, the problem mentioned above only occurs when the tank is full.

The cause in such a case is inadequate sealing of the gas tank sensor because of a faulty seal.

Replace the defective gasket (Diagram - position 3) with a new one in accordance with the vehicle manufacturer's specifications.

Access to the mounting opening of the fuel level sensor unit is located below the rear seating area.

- Gasket 1734279900 (Diagram - position 3)

- Circlip 17343JG00A (Diagram - position 1)

- Fuel level sensor unit 25060JG00A (Diagram - position 2)
