# Opel Astra-G, Opel Zafira, Vectra-B - Irregular engine running | HELLA

## Opel Astra-G, Vectra-B

## All models with X18XE1 engine

Vehicle occasionally stalls; impaired idle speed control

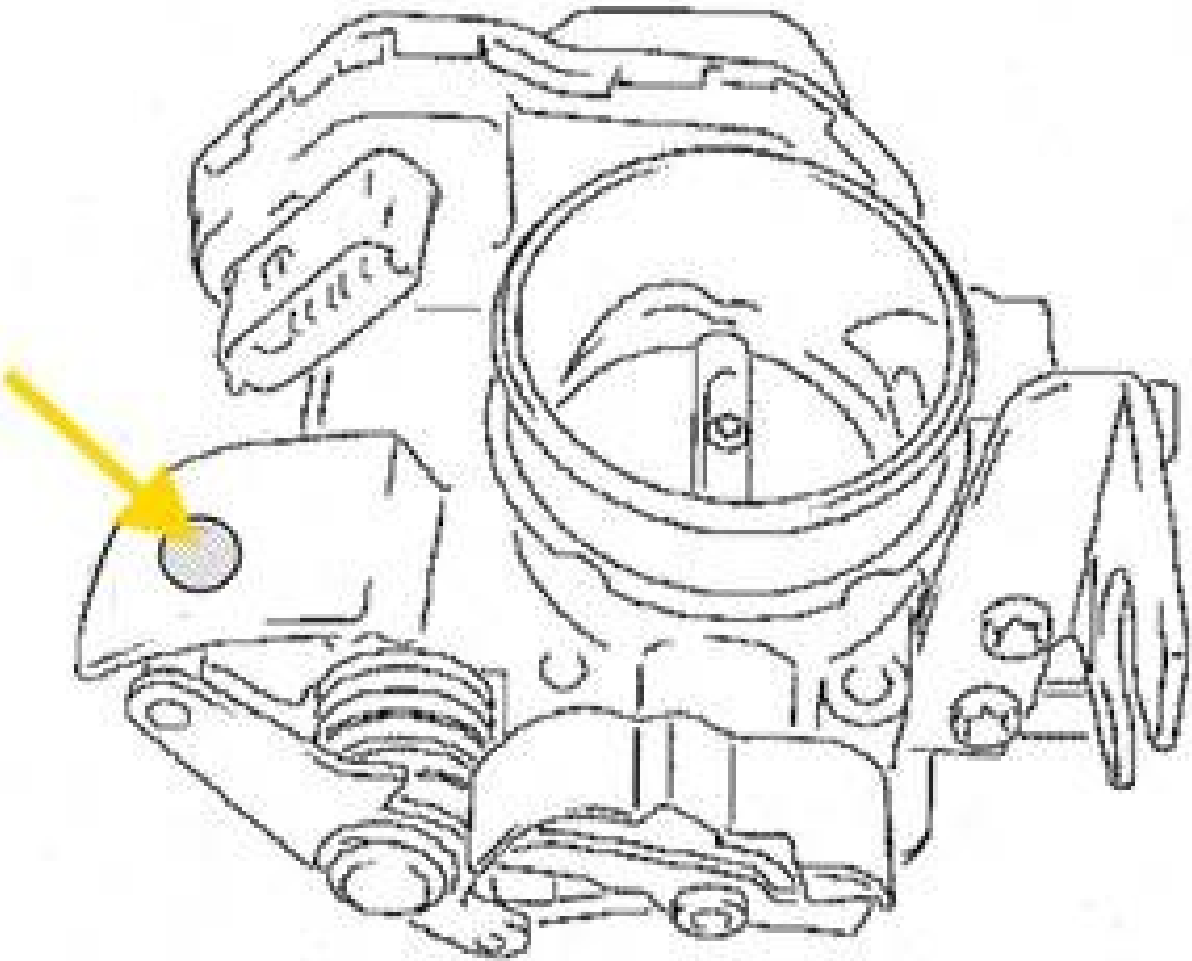
1

If the above-mentioned symptoms occur on these vehicles, this may be caused by a dirty throttle valve. In this case, check the blow-by hole and, if necessary, drill open to 2mm. Afterwards, the ECU must be reprogrammed with a software modified for this purpose. The ECU software can only be updated by an authorised dealer.

Note: If a white dot (1) is already on the throttle body, this measure has already been done.

- Install the throttle body
- Mark throttle body with white dot at position (1)
- Program engine control unit
- Teach throttle adaptation using diagnostic tool. Be sure to follow the instructions from the car manufacturer.
