# Opel Astra H - Noise from the engine compartment | HELLA

**Astra H**

**Model years: 2004 -**

## **Noise from the engine compartment**

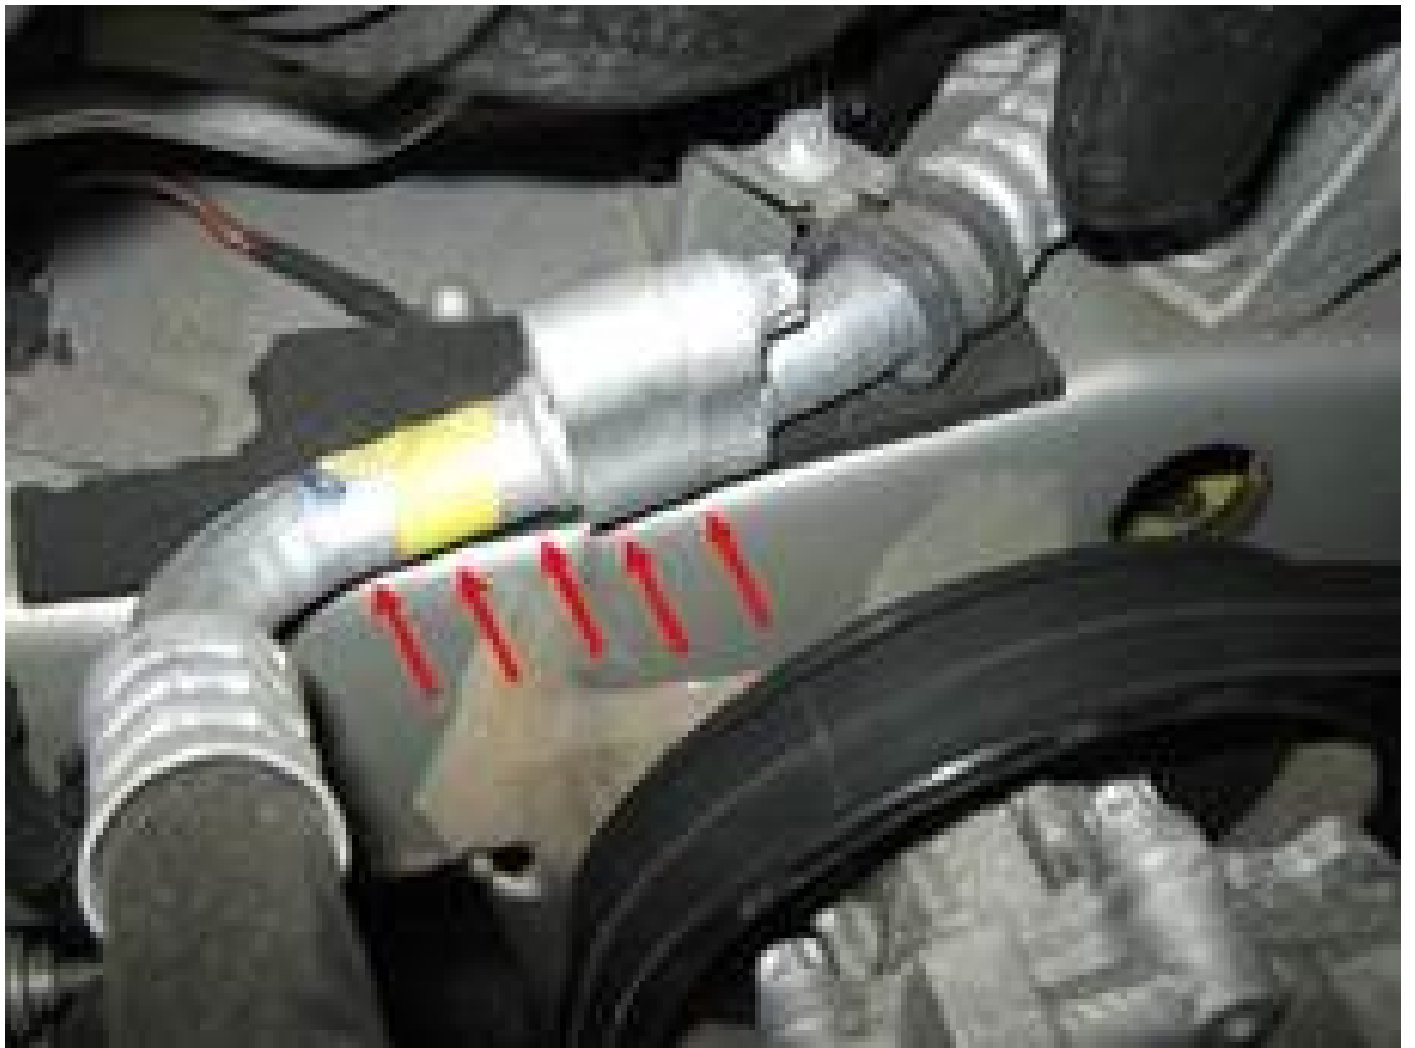
Noise may be coming from the engine compartment in the above vehicles when the engine is running at operating temperature. This occurs in particular during acceleration of the vehicle and an engine speed between 2000 and 3000 rpm.

The cause may be a missing or misplaced damper strip between the frame rail and the refrigerant line (see image).

Make sure that the damping strip is present and correctly installed. If necessary, attach a new damping strip. When doing so, make sure that the refrigerant line does not come into contact with the frame rail.

Otherwise, the flow noise of the refrigerant may be transmitted through the body into the vehicle interior. It is important to ensure that the damping strip extends approx. 5mm beyond the edge of the frame rail.

Note: A suitable damping strip is Hella part no. 9MJ 351 018-011
