Opel Astra K - Noises in vehicle interior / passenger compartment

Data sheet	
Manufacturer	Opel
Vehicle model	Astra K
Engine	All with 1.3 / 1.6 diesel engines
Year of construction	2015 – 2018
Symptoms	Noise occurs at an engine speed of between 1500 rpm - 2500 rpm in the front area of the vehicle when the air-conditioning system is running.

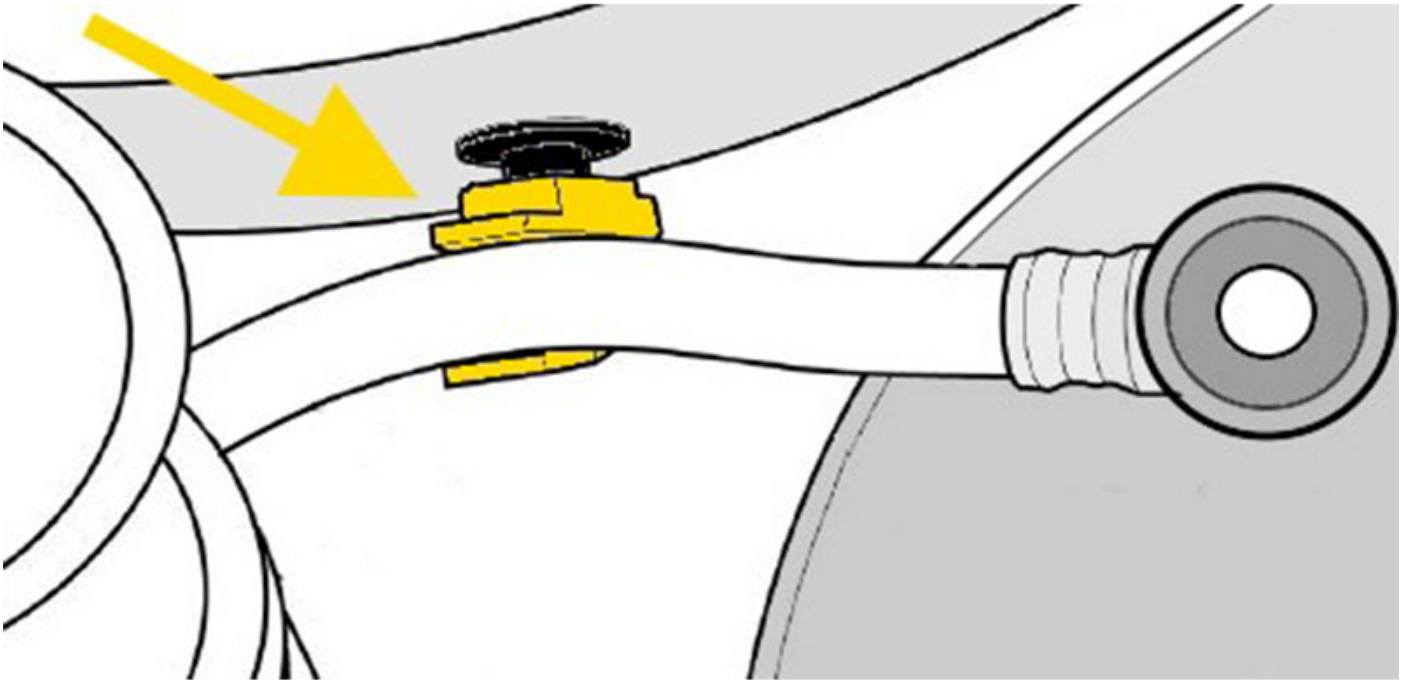
The cause of the noise is inadequate fastening of the brake booster vacuum line resulting from a faulty retaining clip (see picture).

Inadequate fastening of the brake booster vacuum line caused by a faulty retaining clip.

Remedy: Replace the old retaining clip with a new (modified) one. OE part number: 2073033
