Opel Corsa E - straight-line driving impaired: Vehicle pulls to one side

| Manufacturer | Opel |
| Vehicle model | Corsa E |

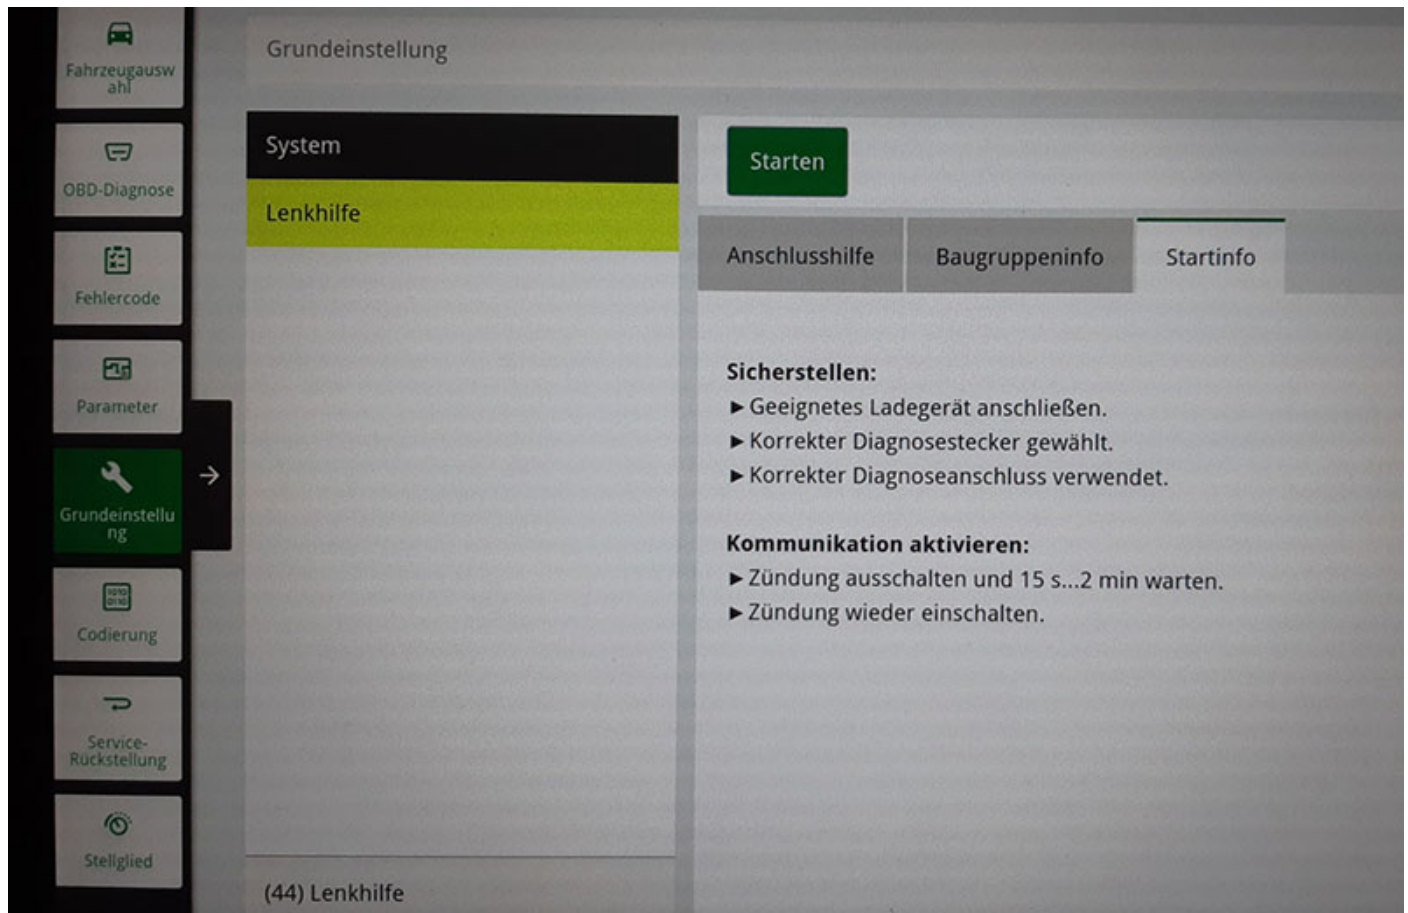
On the vehicles mentioned above, the vehicle may pull to one side even though the steering wheel is in the straight-ahead position.

To remedy this, the steering angle sensor can be recalibrated using a diagnostic device. Experience shows that the vehicle then runs straight again.
