Opel Insignia - Height adjustment system for seating defective | HELLA

Opel

Insignia

Model year: 2009

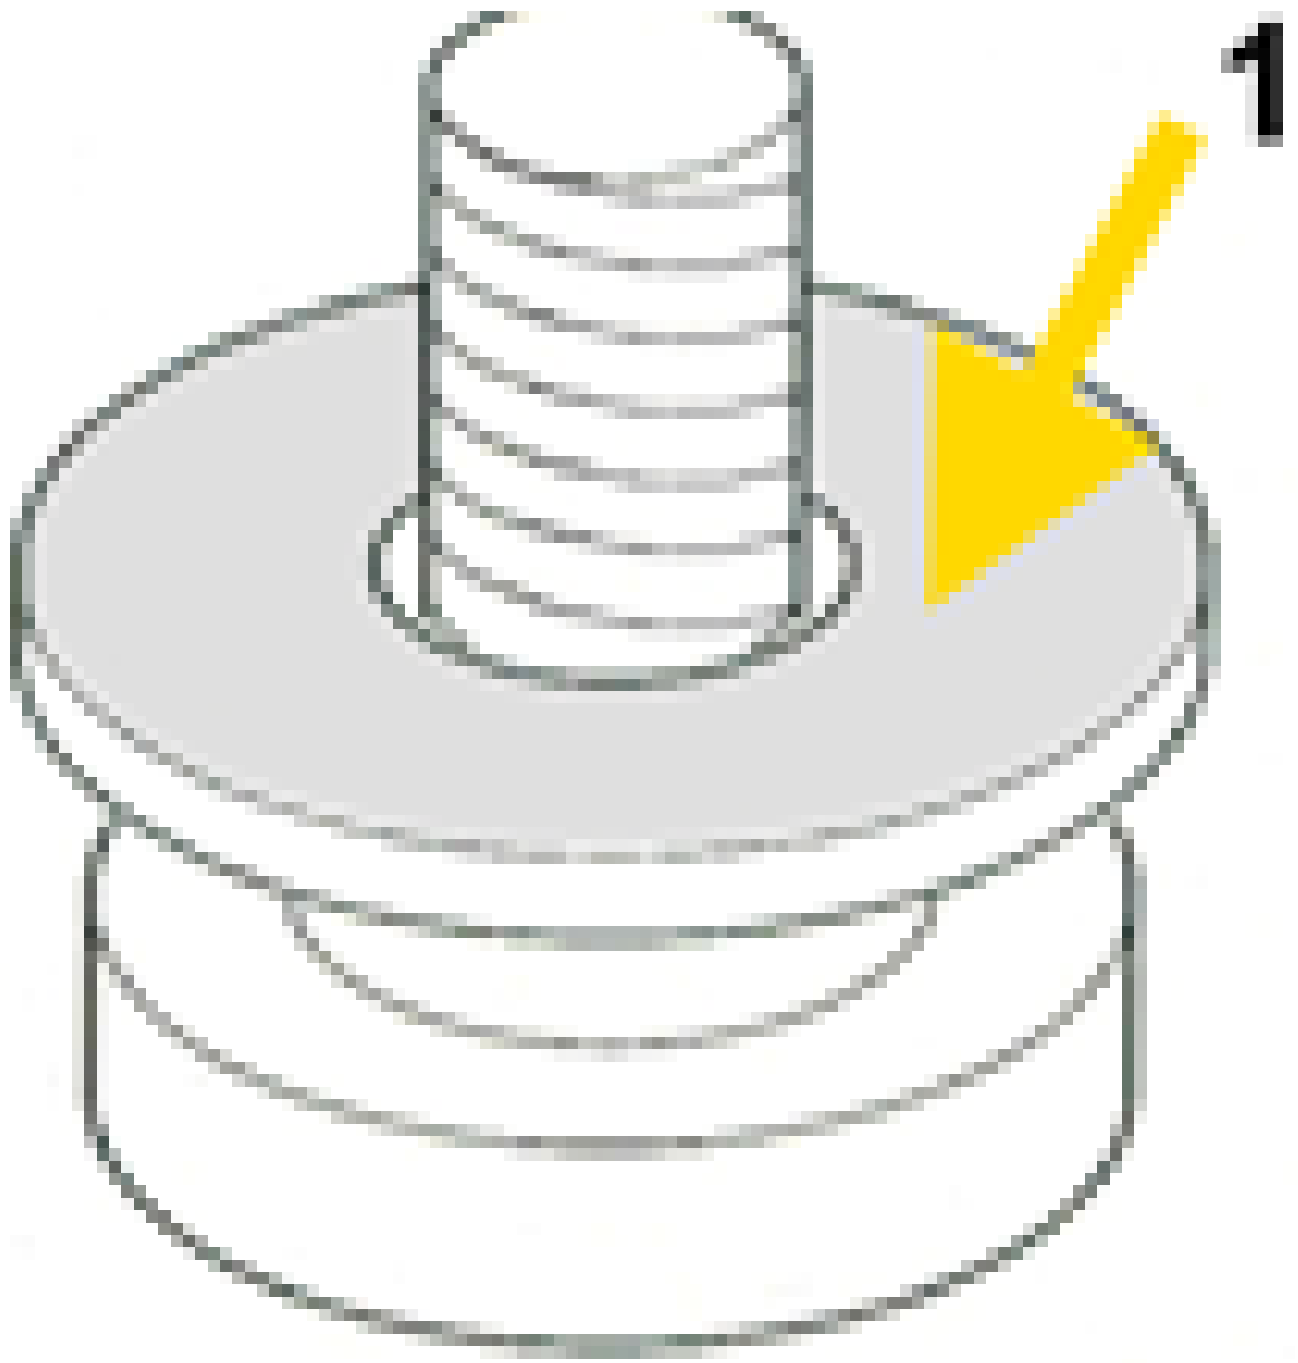
If the height adjustment system for the seating in the vehicle mentioned above no longer functions, it can be the fault of a blocked adjustment spindle.

The motor responsible for the adjusting of the seat height can jam between the spindle and the plastic stopper.

The problem can be solved with the help of an additional washer (1).

- Dismantle seat
- Loosen screw (2) and dismount
- Place washer (1) with the measurements 6.4 x 18 x 1.6 in position (OE No. 11035613)
- Lubricate with special grease (OE No. 13329237)
- Replace screw (2) and tighten with 10 Nm torque
- Remount seat
