# Opel Astra K - power steering failure

Astra K

1.4 16V Turbo (B14XFT)

Power steering failure

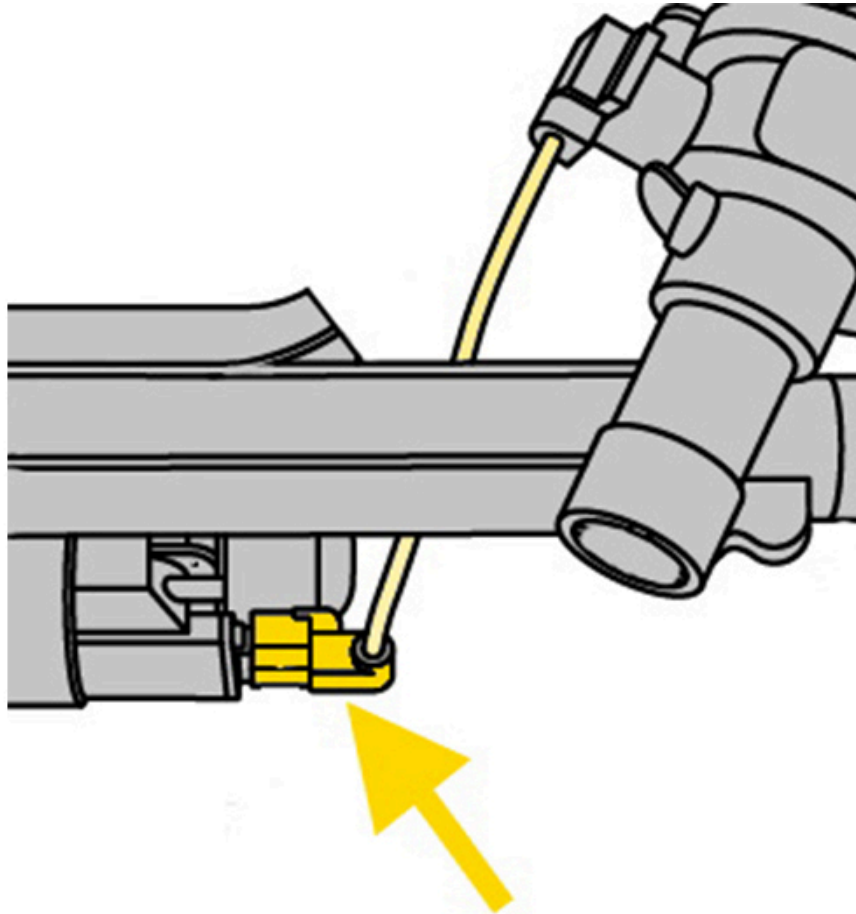
The following problem is observed in the vehicles mentioned above: Vehicle steering sluggish.

The reason for this is an insufficient plug connection between the steering angle sensor and the wiring harness (see figure).

First disconnect the plug connection and check for dirt and damage; if necessary, clean and repair it according to the manufacturer's instructions. Then reconnect the connectors, making sure that the plug connection is correctly seated.

Subsequently run a fault code query and go for a test drive to check the measure.
