Renault Espace-IV - Grinding noises when brake not pressed | HELLA

Renault Espace-IV

Model year 2002-2014

Disk brake, rear axle

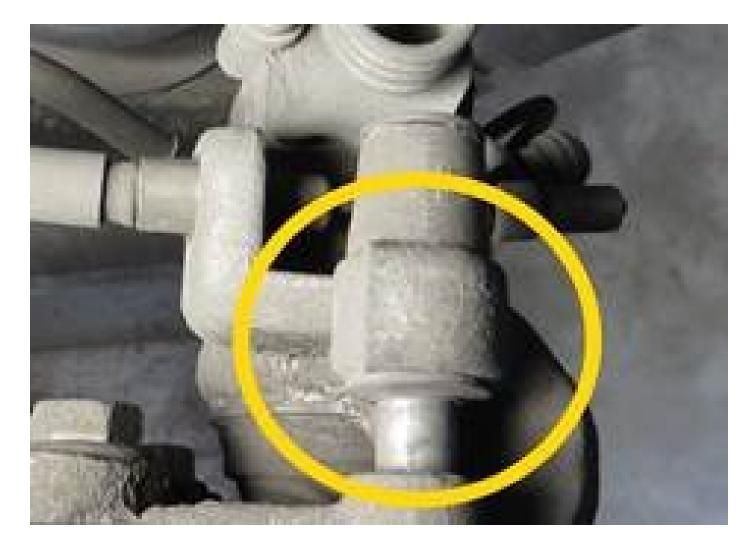
Grinding noises when brake not pressed

Brake pad worn on one side

Heavy wear on brake disc

If this defect is found in the vehicle models mentioned above, this may be due to a brake caliper guide becoming stiff or stuck. Heavy oxidation inside the bore holes on the aluminum housing causes the damping sleeves to sit more tightly, which in turn causes the guide bolts to jam.
